NTPC Health & Safety Alert

Asbestos Gasket Material

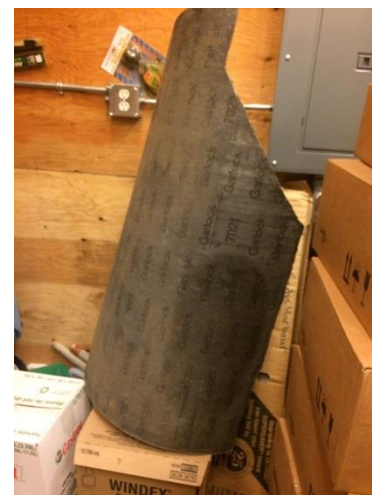
In a recent inspection of a power plant, a roll of rigid gasket material was found that was suspected to contain asbestos. The gasket material was researched and found to be Garlock 7021 Compressed Asbestos Sheets. The gasket material is manufactured in Indonesia and has likely been in the plant for many years.

It becomes a hazard when it has been installed and needs to be removed using grinding/machining of the gasket. This type of operation will require workers to be trained and use appropriate PPE to protect from hazardous dust.

If you have old gasket material in your workplace and suspect it may contain asbestos, contact your regional Health and Safety Coordinator.

With the permission of the applicable municipality this type of gasket material may be disposed of at most local landfills.
