**2021 DAM MONITORING  
GUIDE FOR OPERATORS**

**NORTHWEST TERRITORIES  
POWER CORPORATION**

This Document provides information to assist the Operators in the Inspection of the Dams in The Northwest Territories Power Corporation's Hydro System

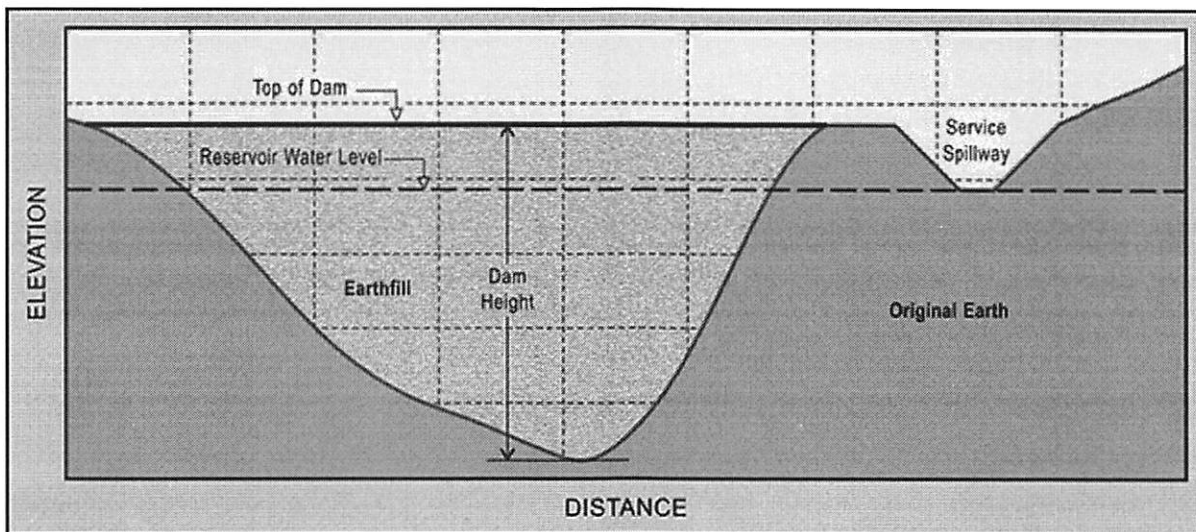
Profile diagram of a simple earthfill dam

While each dam is unique in how it is designed and constructed, most are earthfill dams. These dams are constructed using one or more types of suitable soils to accommodate a variety of factors including the local geology and geography, and the purpose, size and risk associated with the dam. The following diagrams show a cross section and profile of a simple earthfill dam.

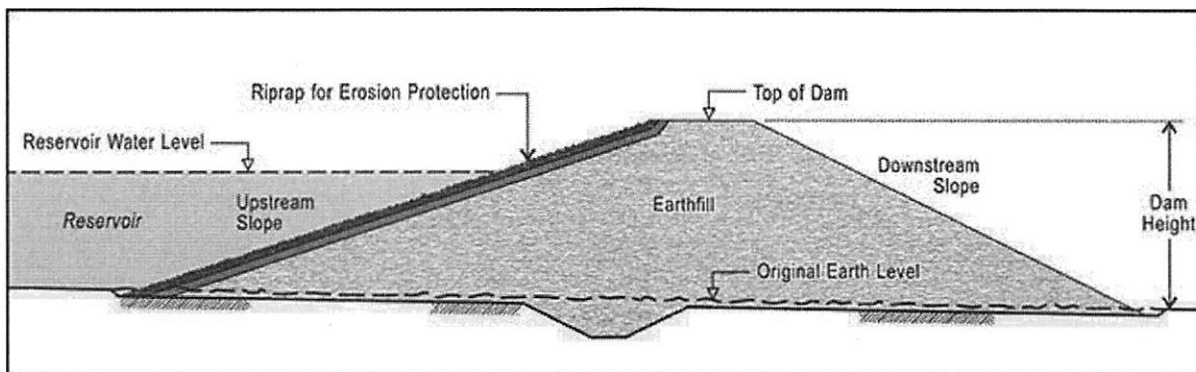
Cross-section diagram of a simple homogenous earthfill dam. "Top of Dam" also termed "Crest".

Dams have 3 visible faces:

- upstream slope (the face of the dam facing the reservoir/pond)
- downstream slope (the face of the dam facing away from the reservoir/pond)
- crest (the top of the dam, which is often used as the foundation for a road)

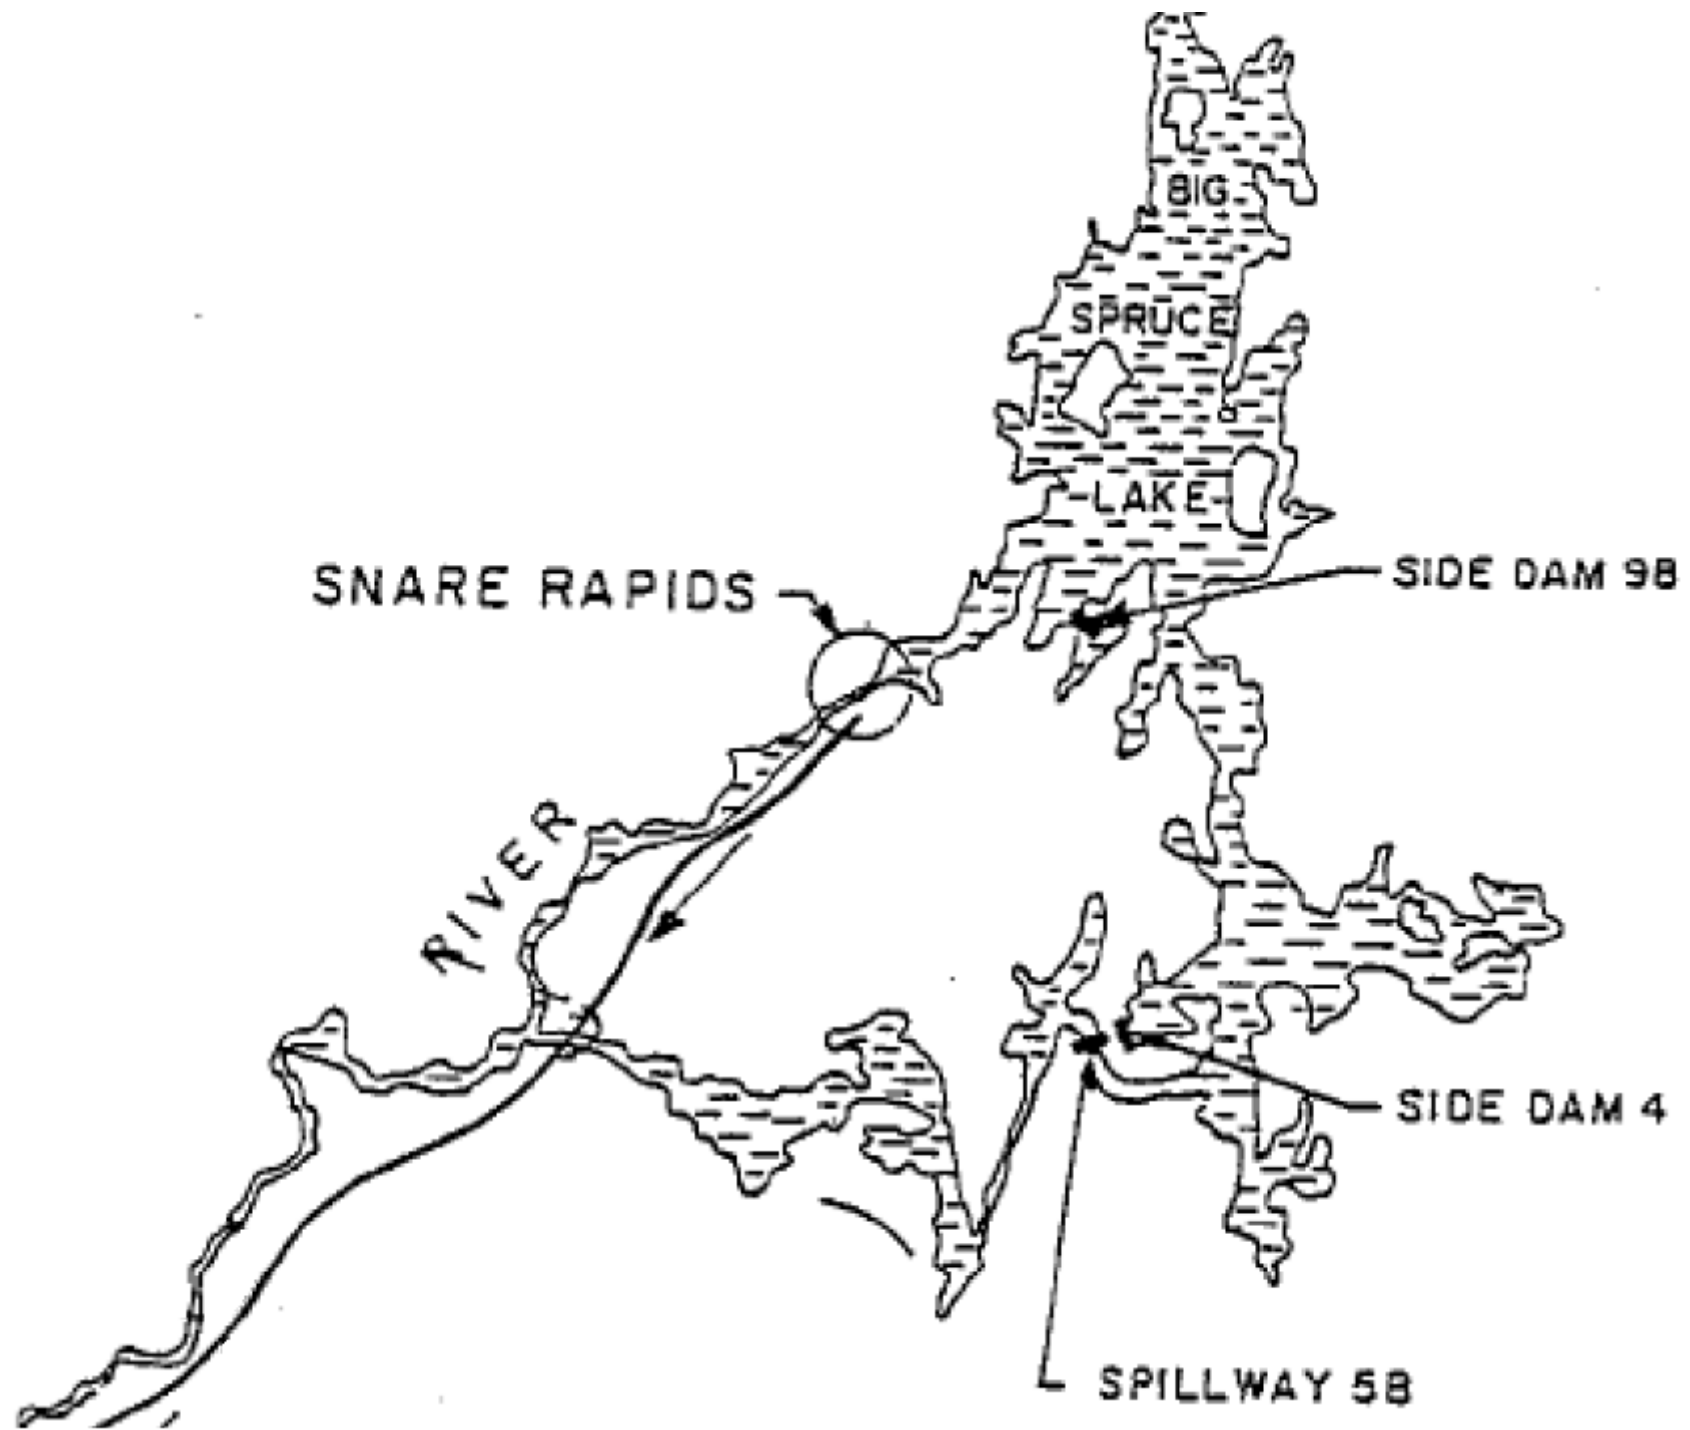
Snare Rapids – Site Plan

**Structure:** Snare Rapids Dam  
**Location:** Uppermost site on the Snare system, located approximately 145 km northwest of Yellowknife on the Snare River.

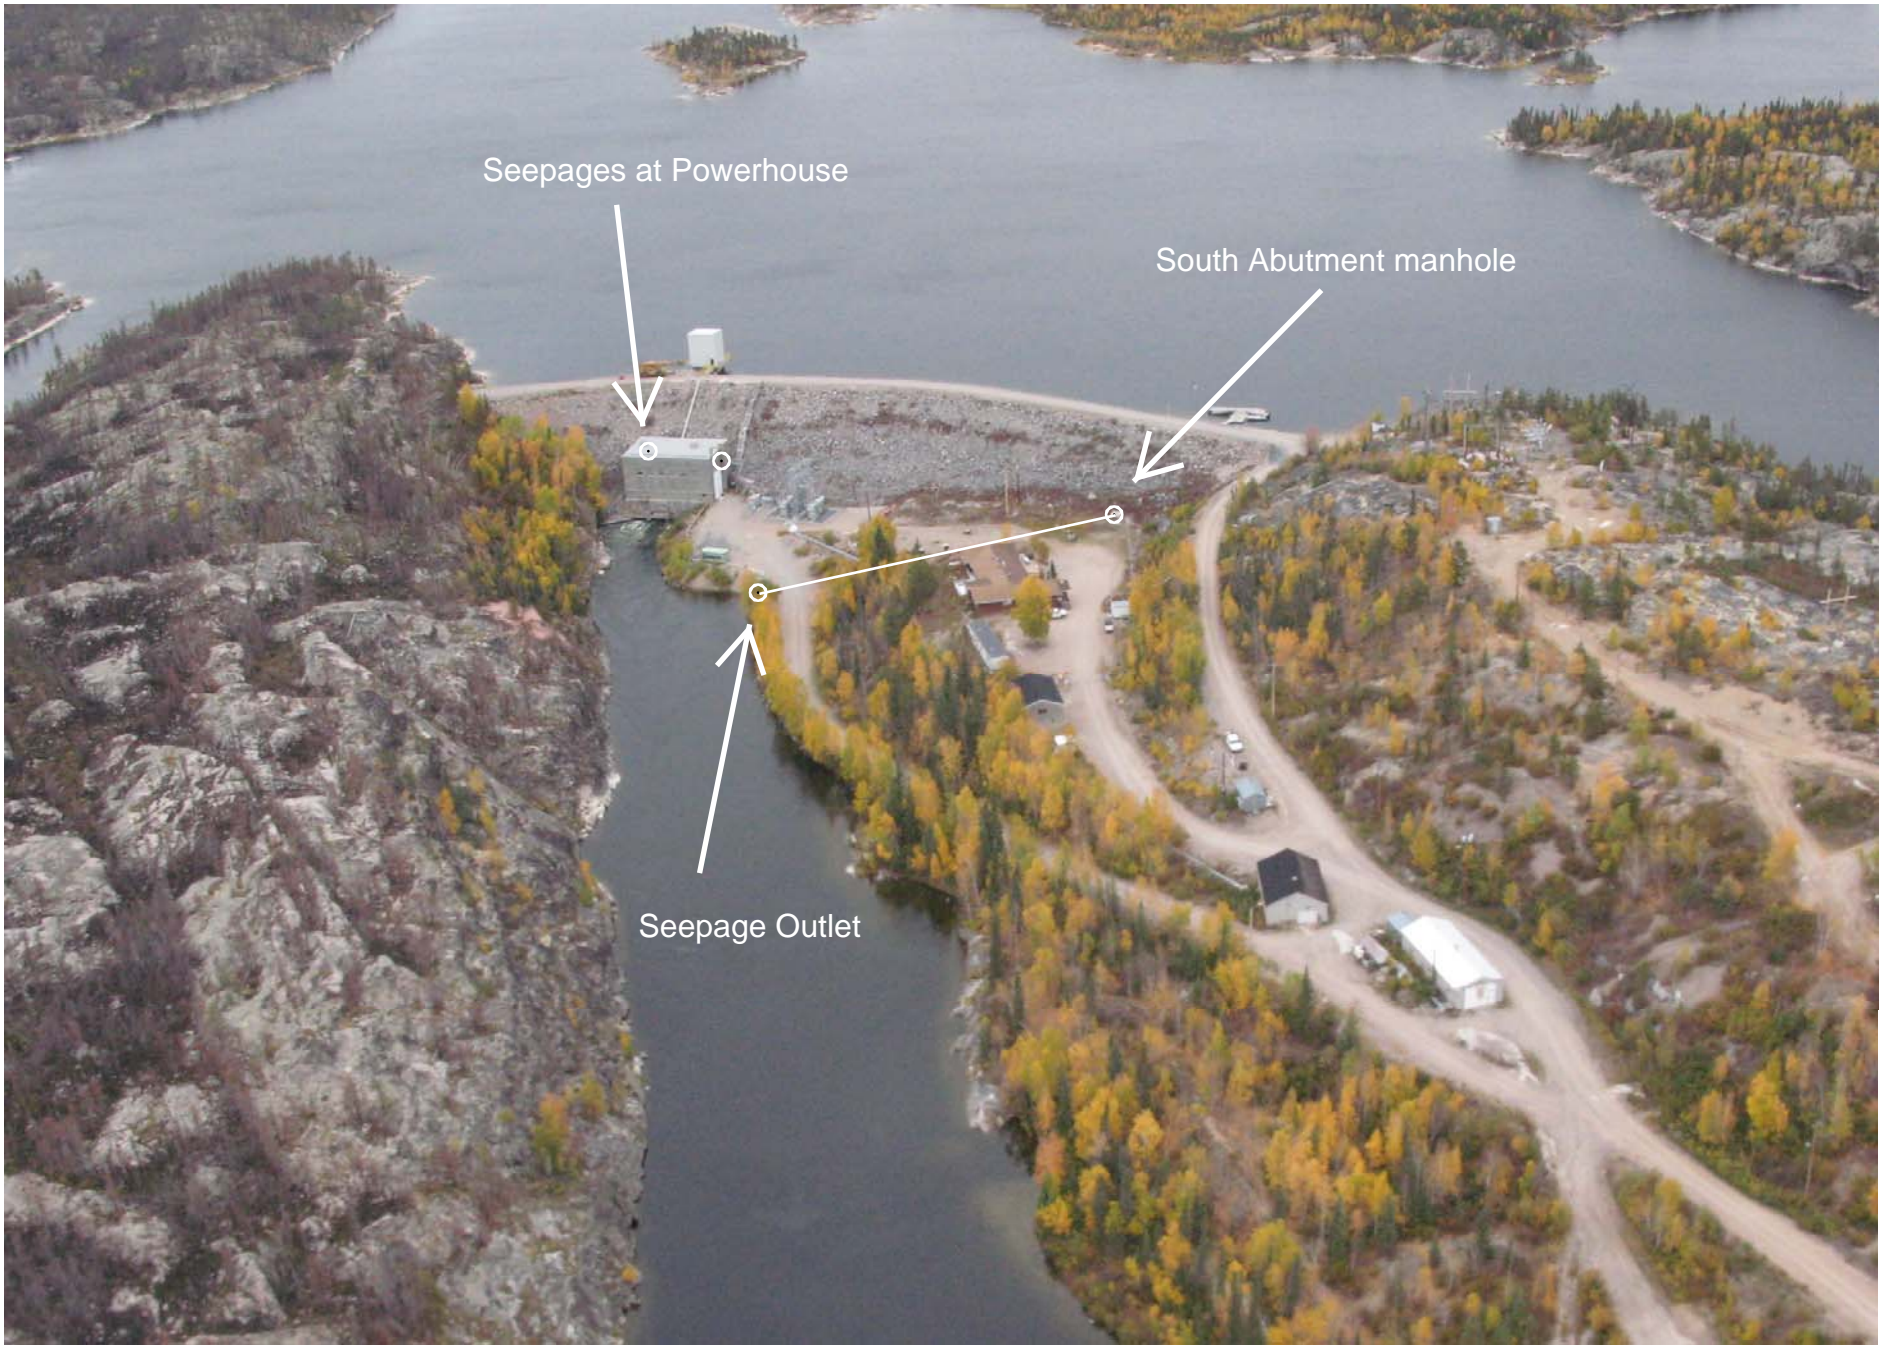
Seepages at Powerhouse

South Abutment manhole

Seepage Outlet

Snare Rapids Site

- Thermistor in the top 6 m of the dam records temperature fluctuations at 0.5 m intervals in the core and top of the dam. Located approximately 60 m from the south abutment.

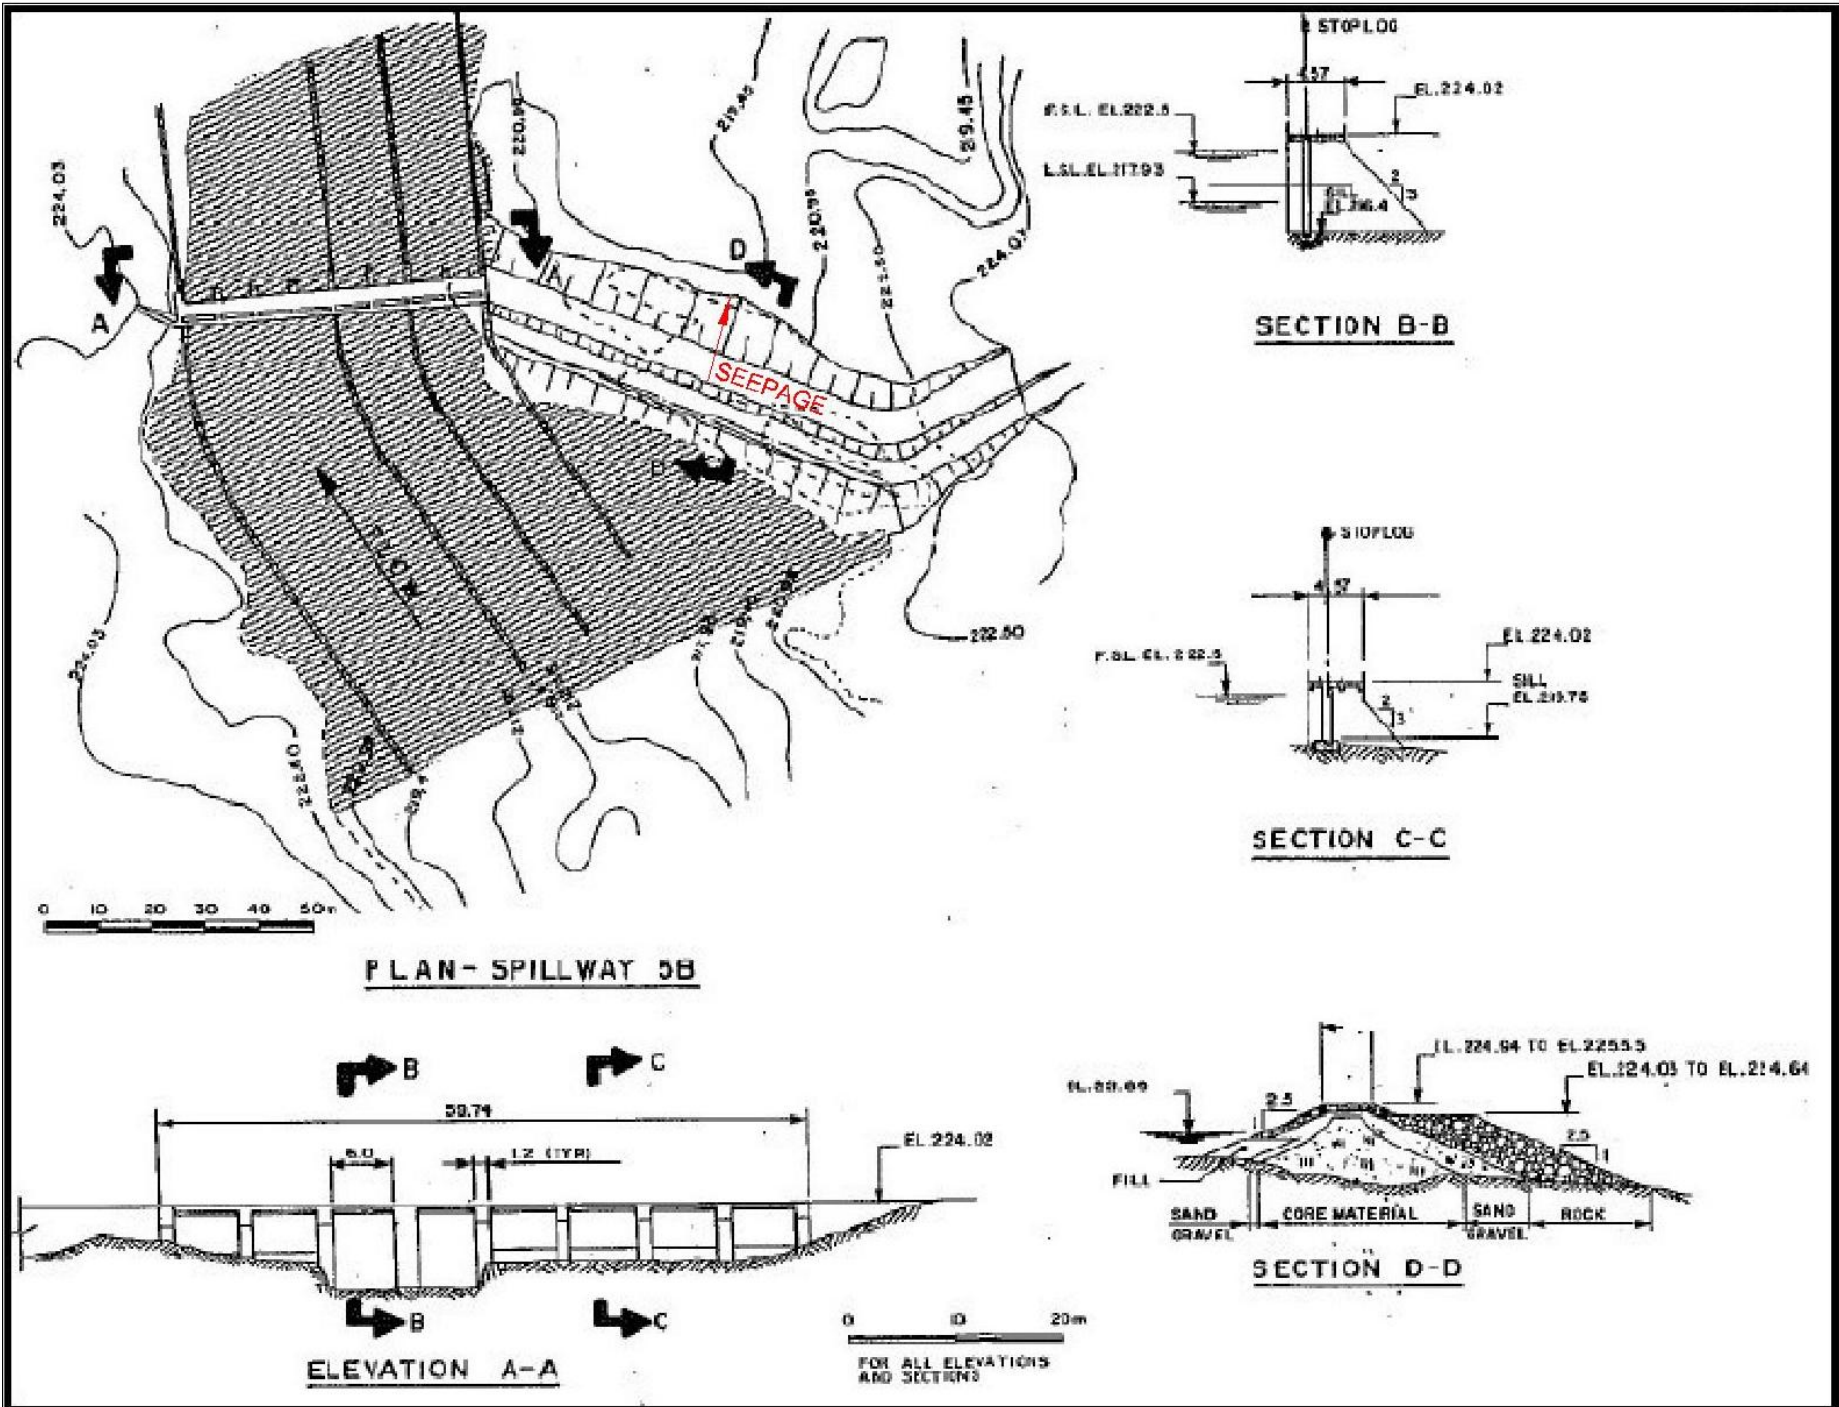
5B Spillway – Plan, Sections & Seepage Location

### **Side Dam**

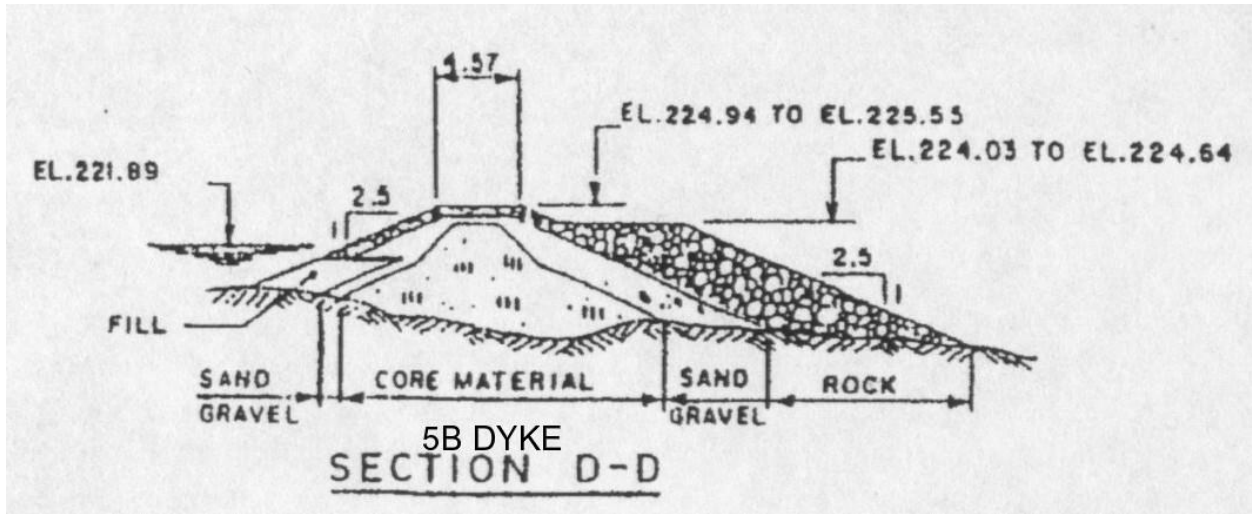
5B X-Section Zoned Earthfill Dyke

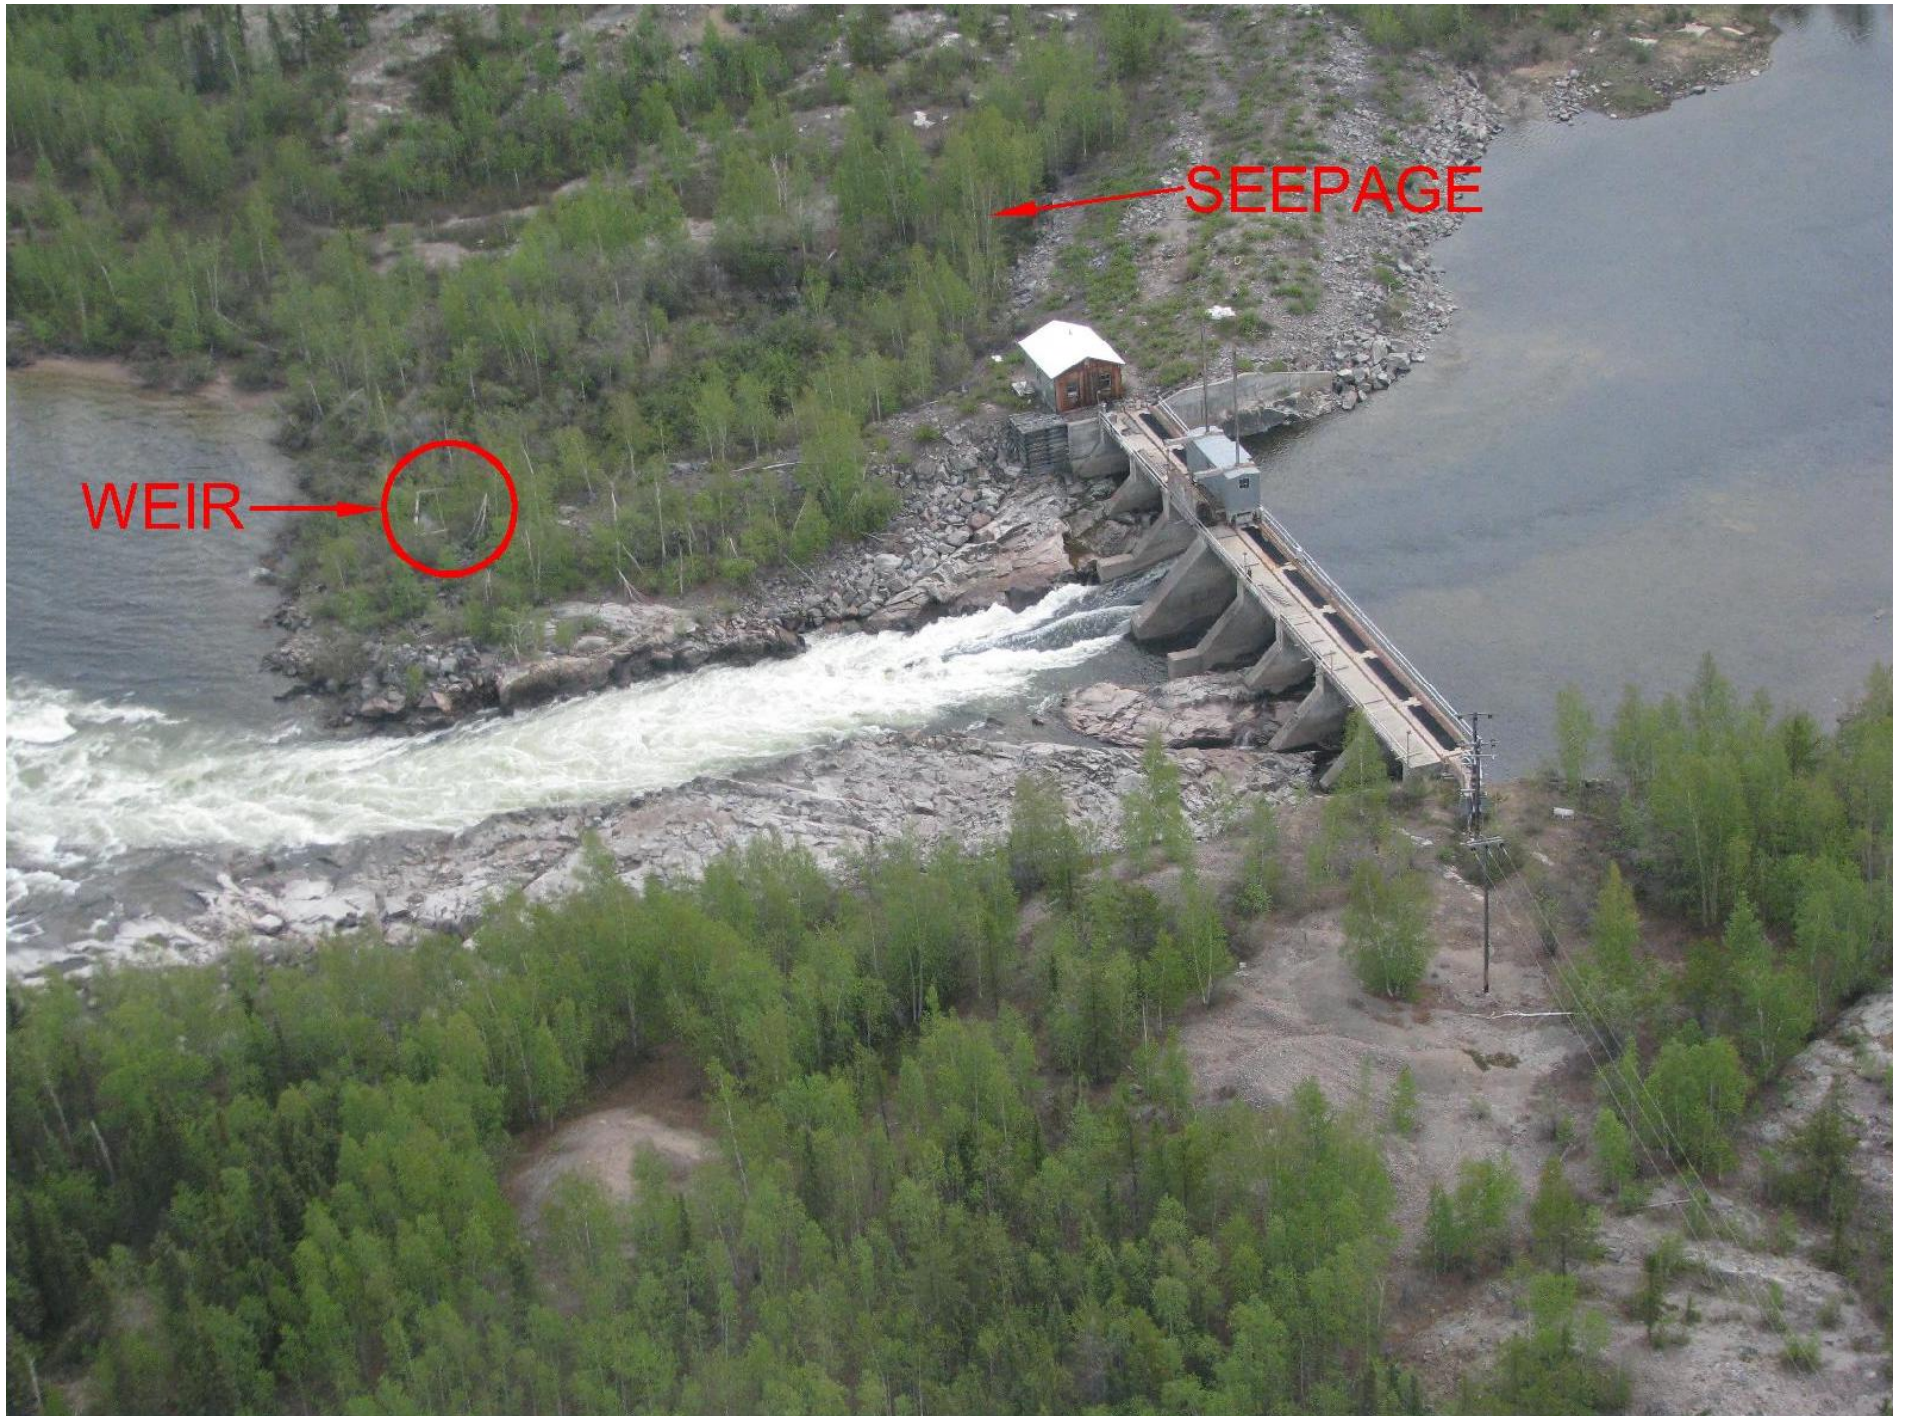
5B Spillway Seepage and Weir Location

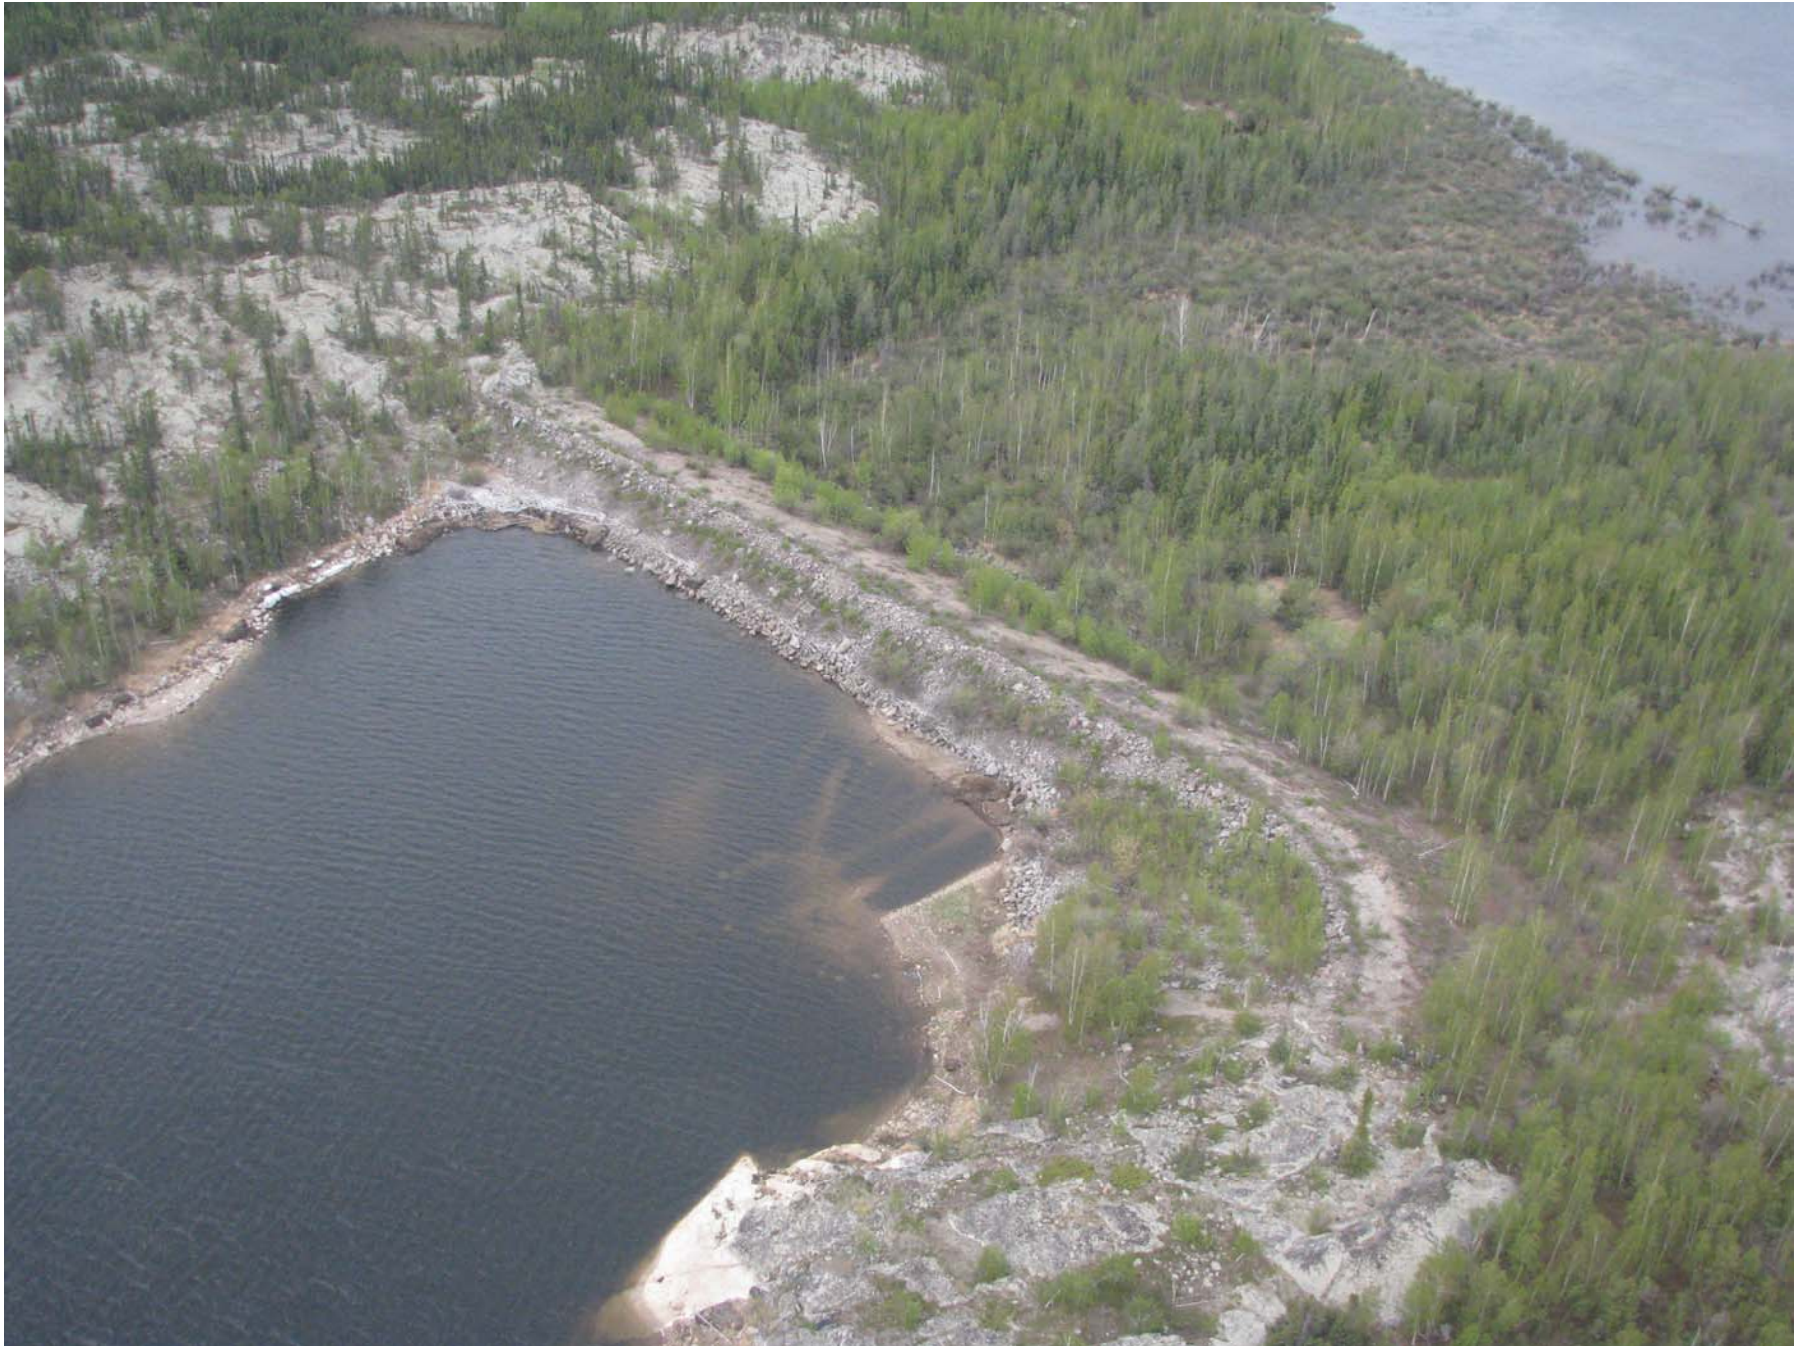
Side Dam 4 – Aerial Photo

**Structure:** Side Dam 4  
**Location:** Located approximately 6 km southeast of the Snare Rapids main dam, impounding Big Spruce Lake.  
**Constructed:** 1960  
**Type:** Zoned Earth Fill Embankment  
**Core:** Compacted Silt  
**Length:** 130 m (427 ft)  
**Height:** 8 m (26 ft)  
**Foundation:** Bedrock  
**CDA Consequence**  
**Classification:** High, due to economics  
**Elevations<sup>1</sup>:** Core: 224.40 m (736.0ft)  
Crest: 225.25m (739.0 ft)  
Spillway: Variable (See 5B Spillway)  
**Allowable Res. Levels<sup>2</sup>:** Minimum: 217.90 m (714.9 ft)  
Normal Max: 222.30 m (729.3 ft)  
High Flow Max: 222.50 m (730.0 ft)

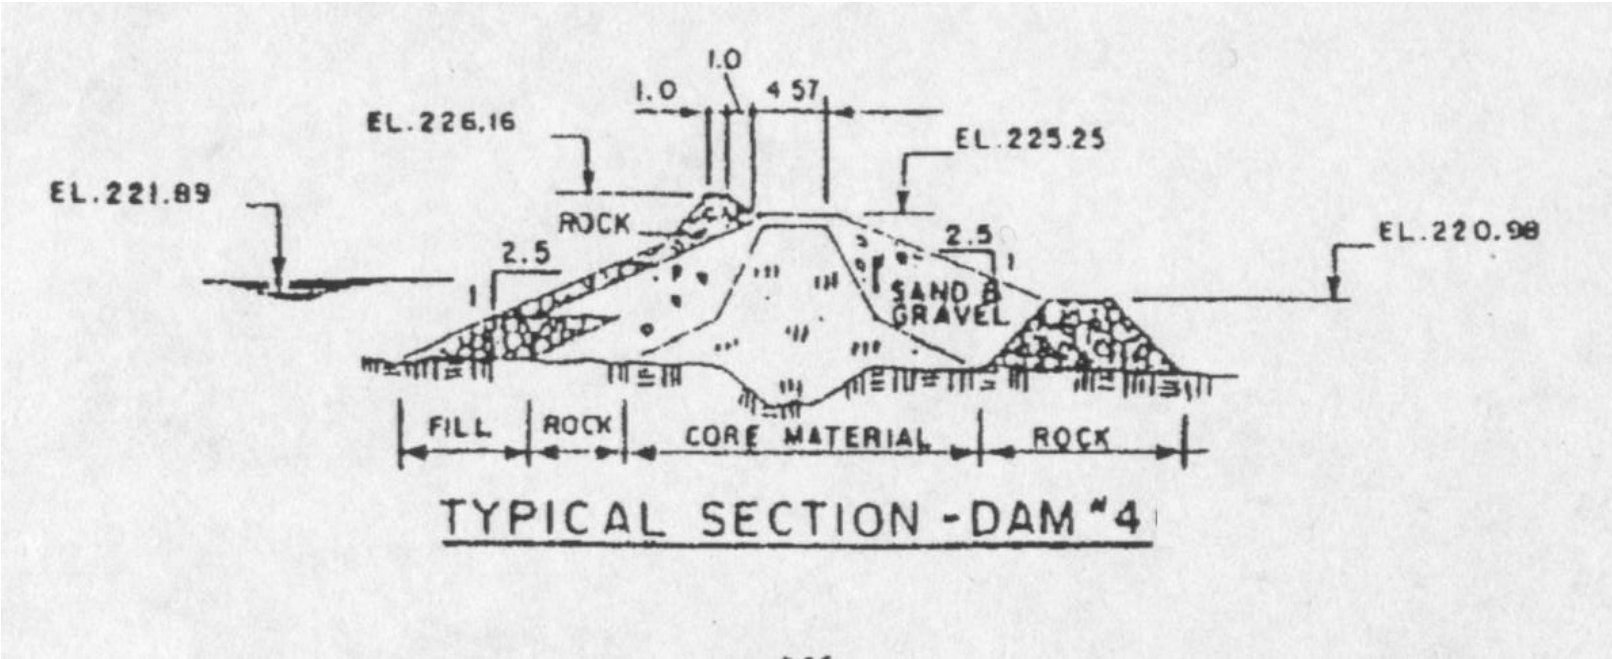
Snare 4B Dam Section

Figure X-Section of Dam 4

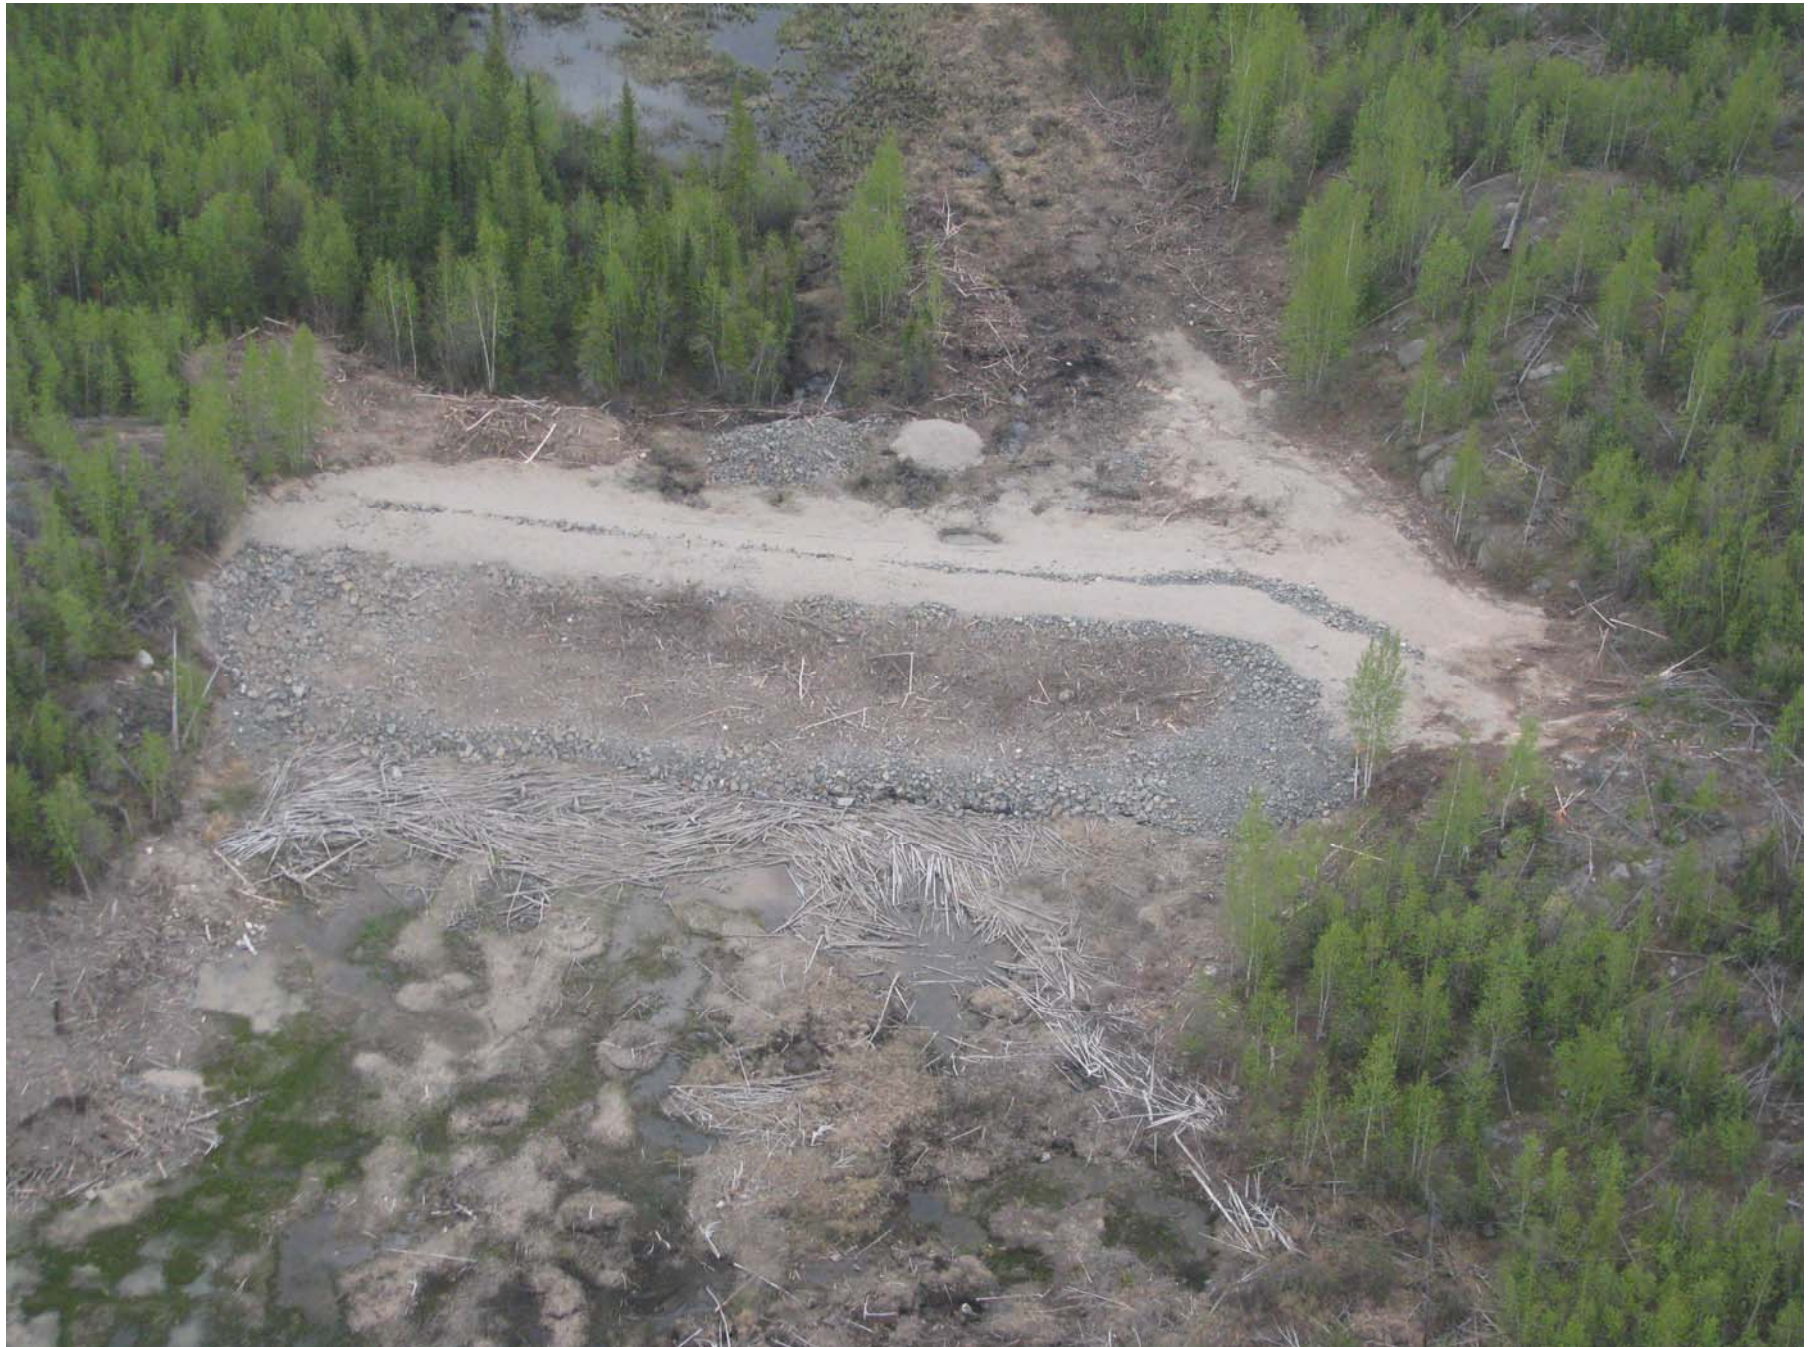
Side Dam 9B – Aerial Photo (Upstream Face Shown)

**Structure:** Side Dam 9B  
**Location:** Located approximately 3 km east northeast of the Snare Rapids main dam on Big Spruce Lake.  
**Constructed:** 1960  
**Type:** Sand Fill Embankment with Upstream Clay Blanket  
**Core:** None  
**Length:** 50 m (164 ft)  
**Height:** 3 m (10 ft)  
**Foundation:** Bedrock  
**CDA Consequence**  
**Classification:** High, due to economics  
**Elevations<sup>1</sup>:** Core: 224.40 m (736.0ft)  
Crest: 225.25m (739.0 ft)  
Spillway: Variable (See 5B Spillway)  
**Allowable Res. Levels<sup>2</sup>:** Minimum: 217.90 m (714.9 ft)  
Normal Max: 222.30 m (729.3 ft)  
High Flow Max: 222.50 m (730.0 ft)

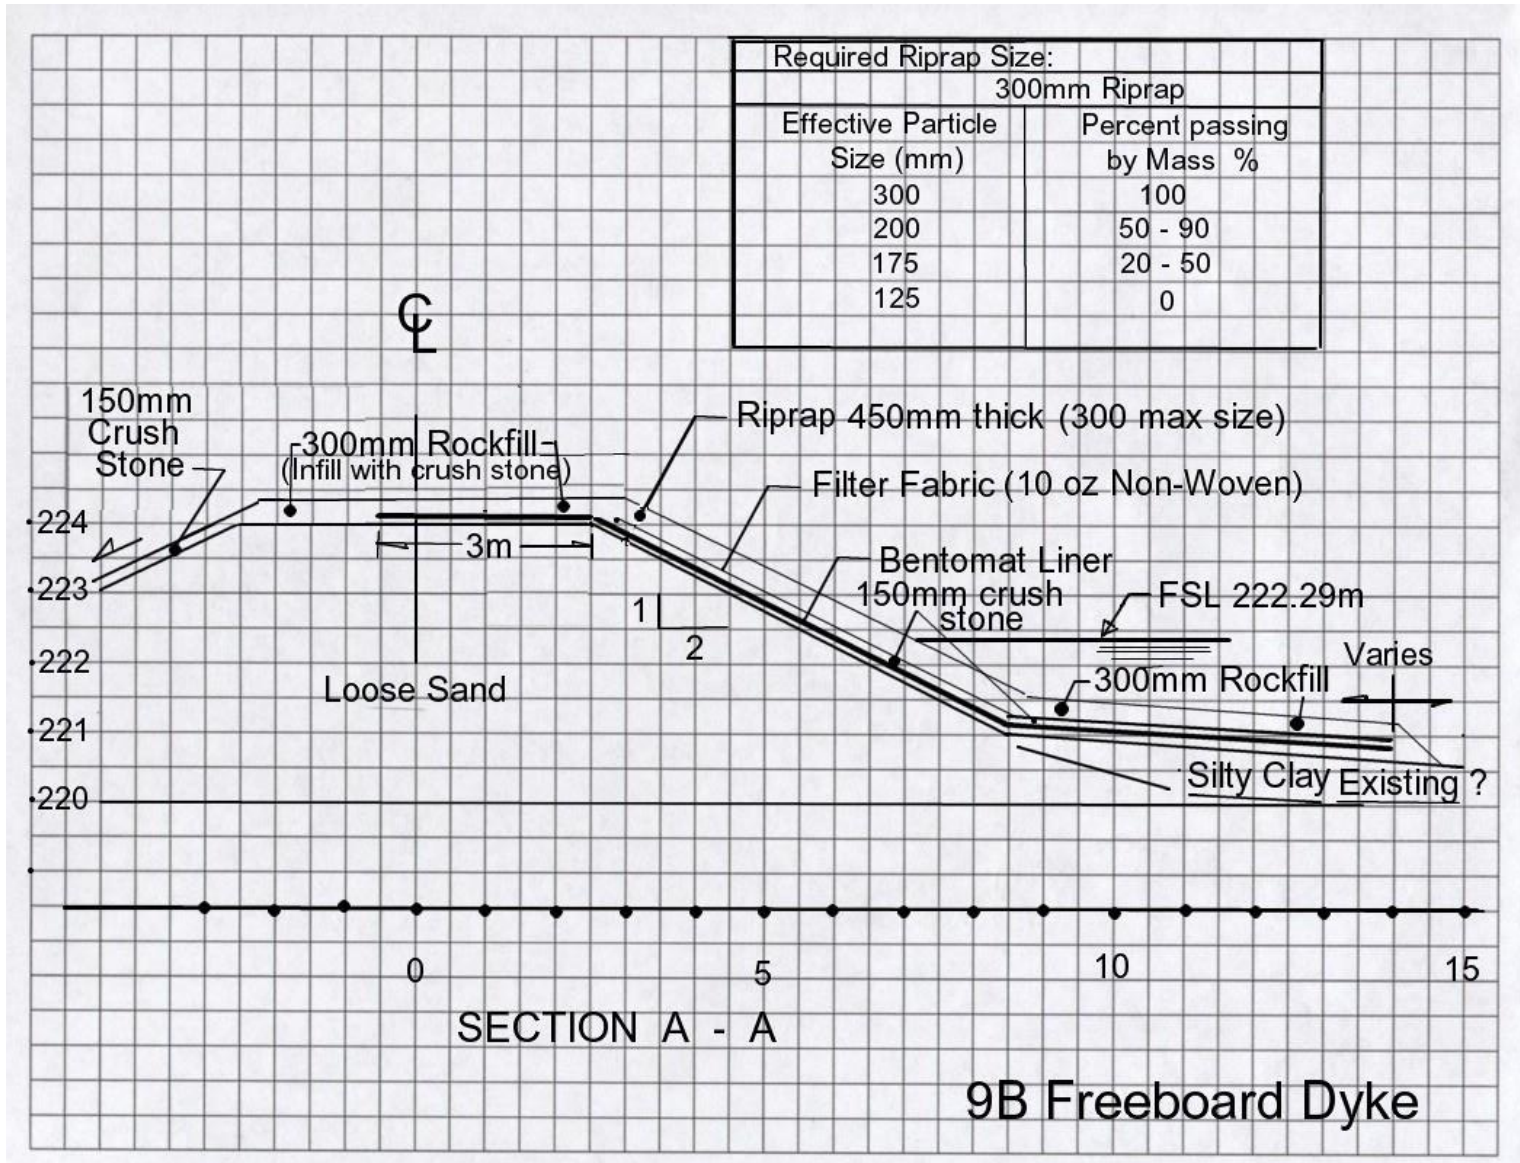
# 9B Dam Section

FIGURE X-SECTION 9B FREEBOARD DYKE

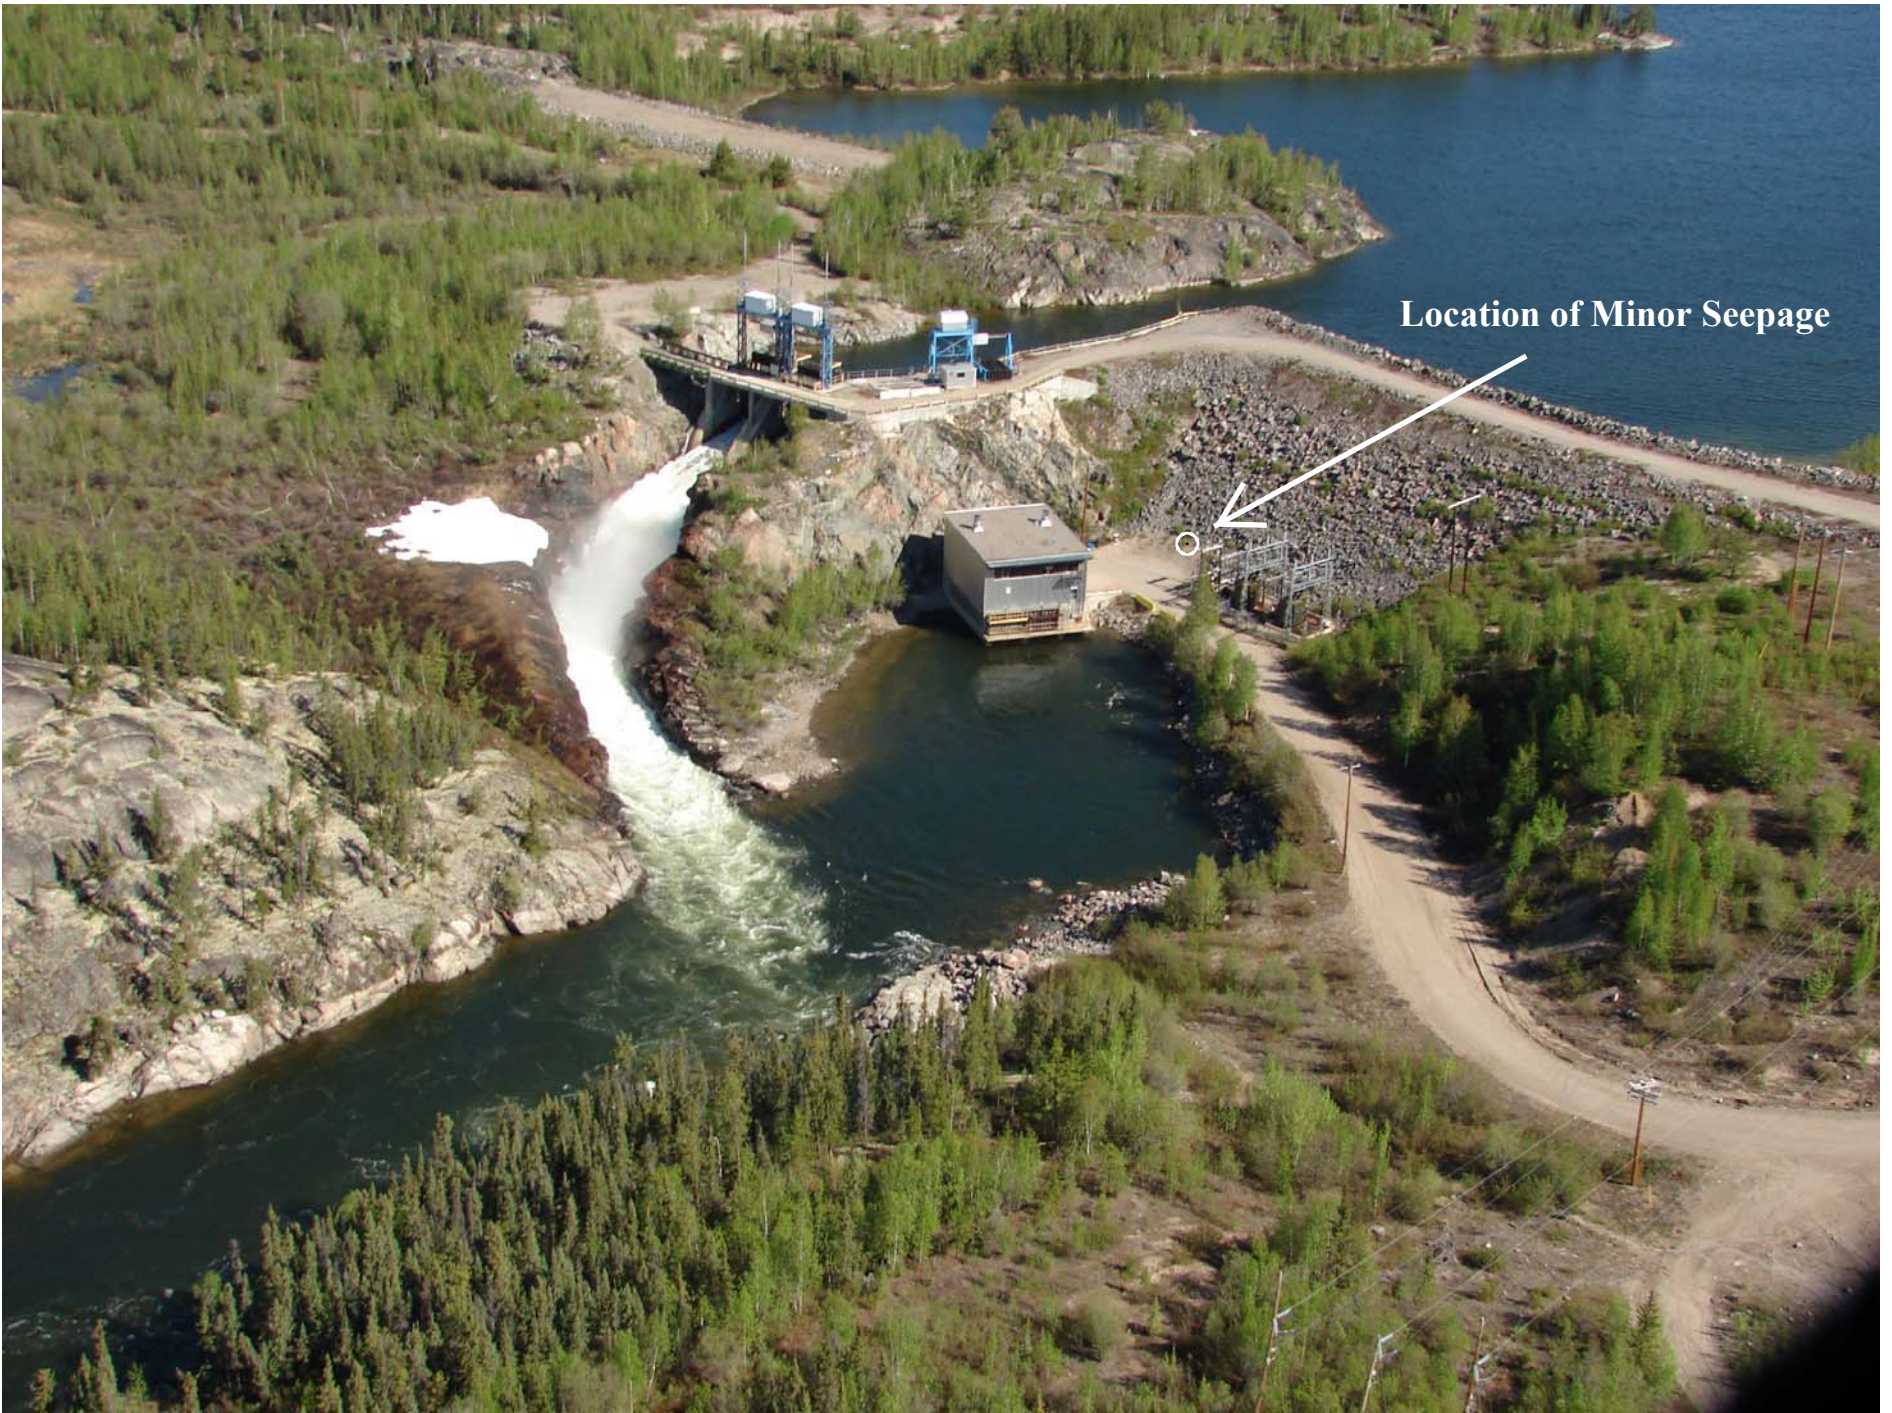
Location of Minor Seepage

Snare Falls Site
