**2021 DAM MONITORING  
GUIDE FOR OPERATORS**

**NORTHWEST TERRITORIES  
POWER CORPORATION**

This Document provides information to assist the Operators in the Inspection of the Dams in The Northwest Territories Power Corporation's Hydro System

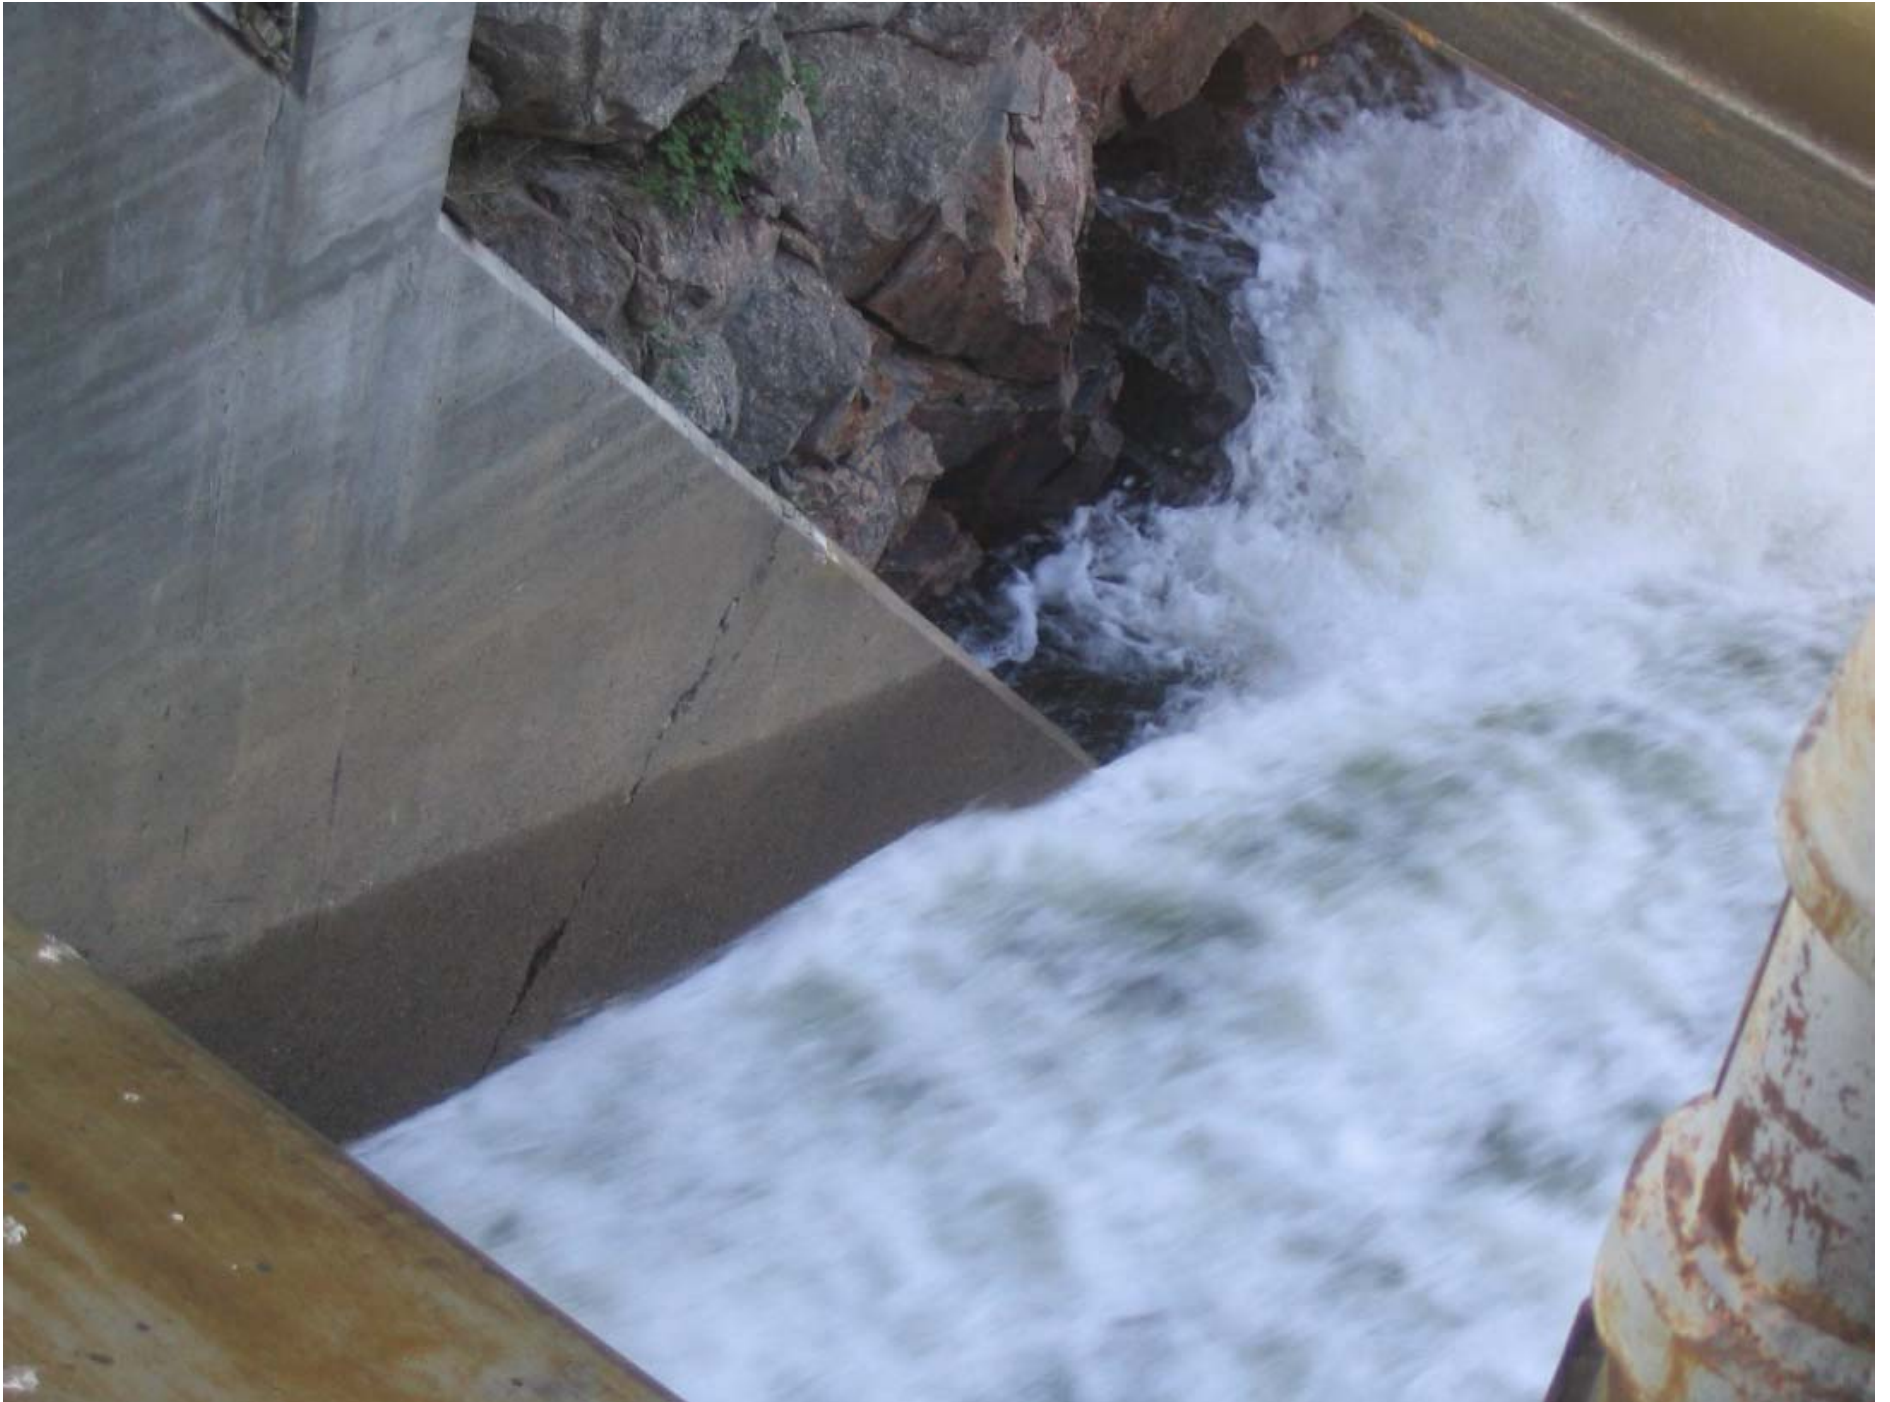
Snare Falls Spillway – Diagonal Cracks on Downstream Pier

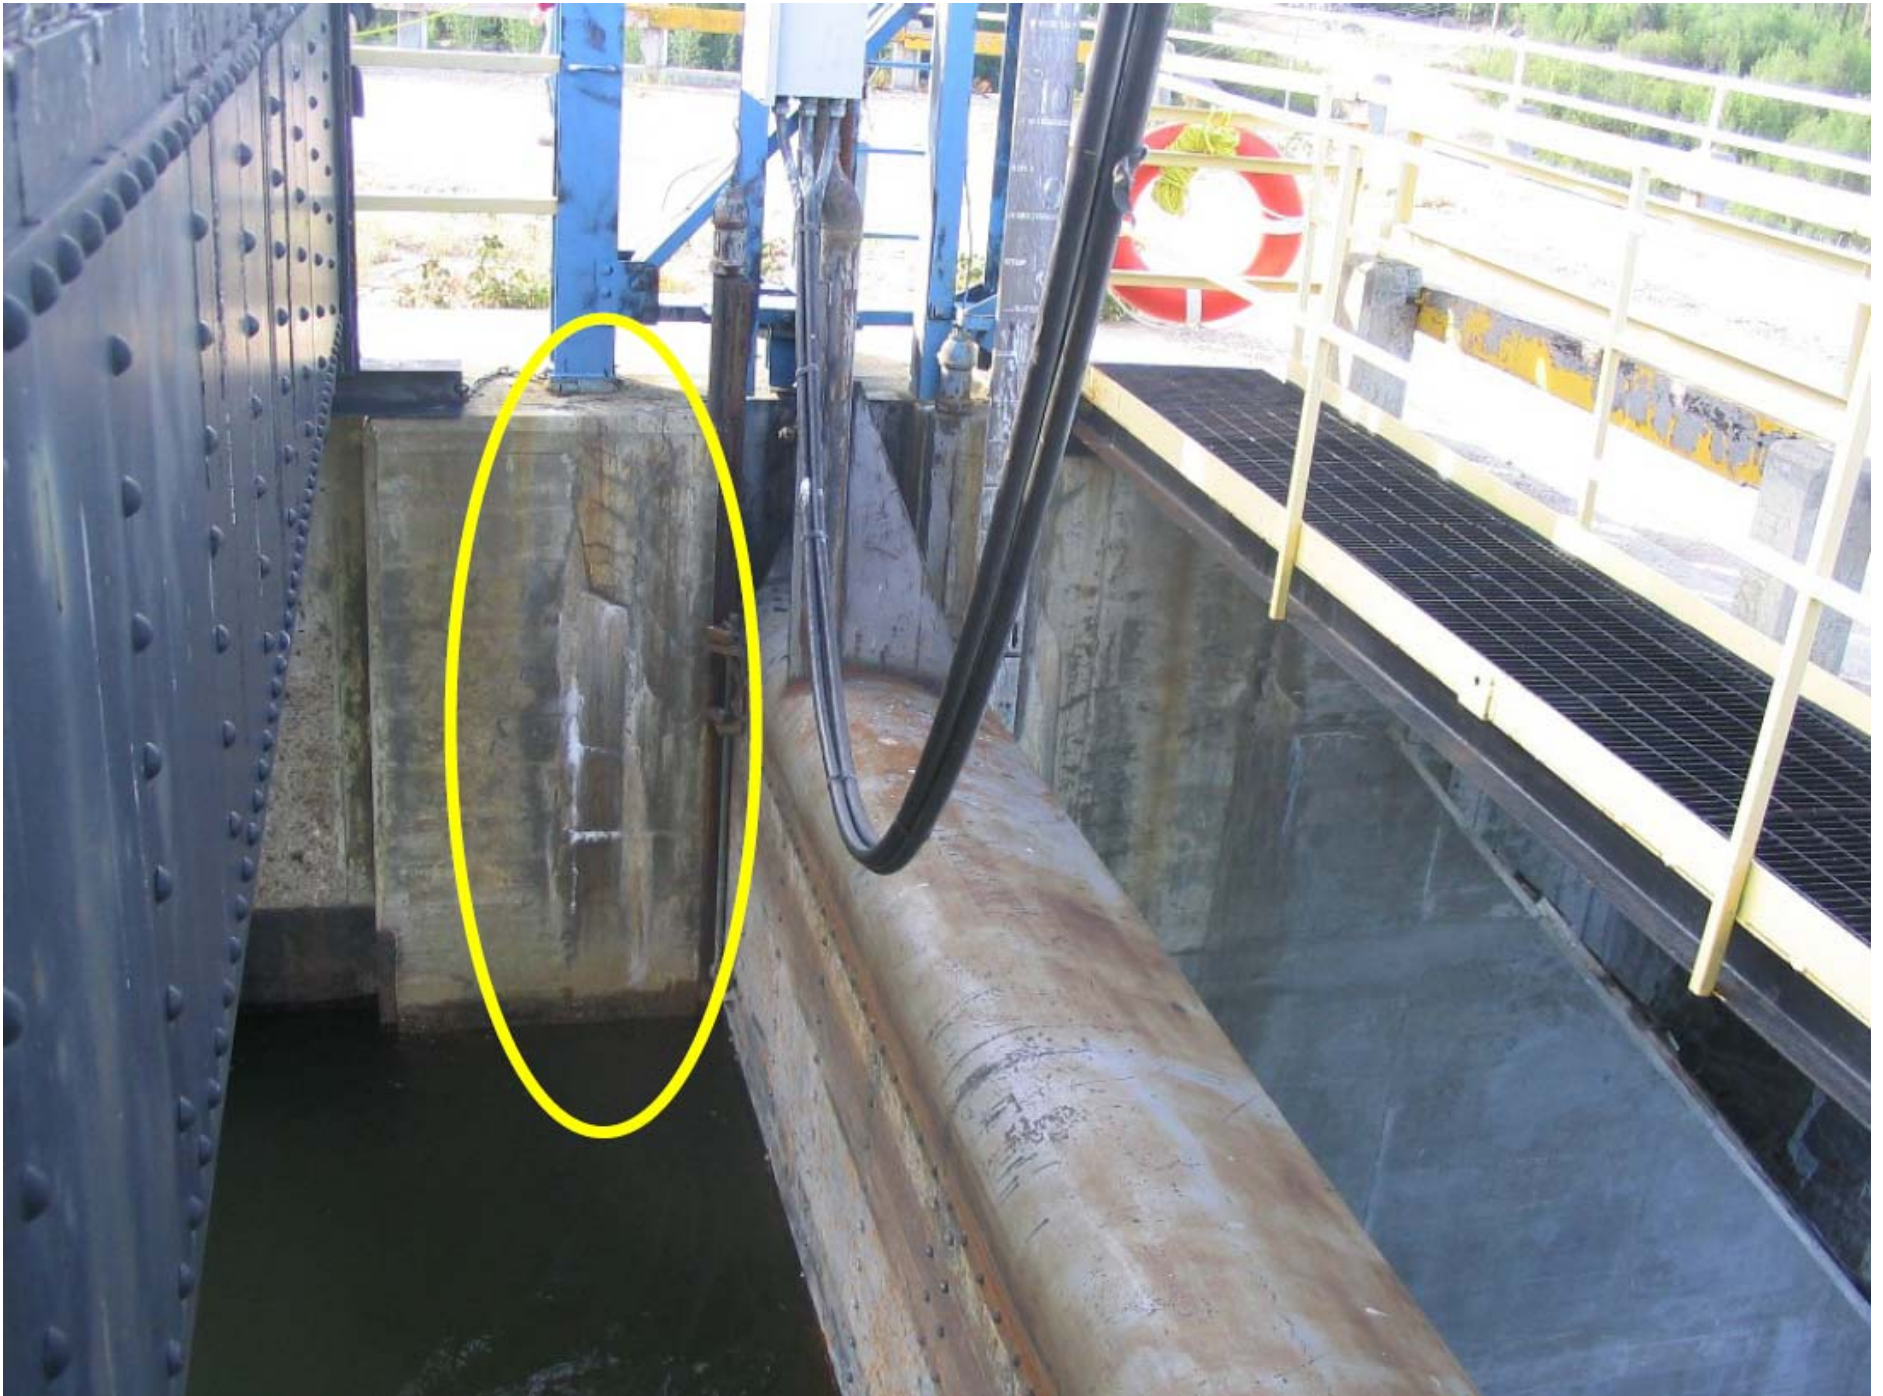
Snare Falls Spillway – Vertical Cracks Adjacent to Gate Guides

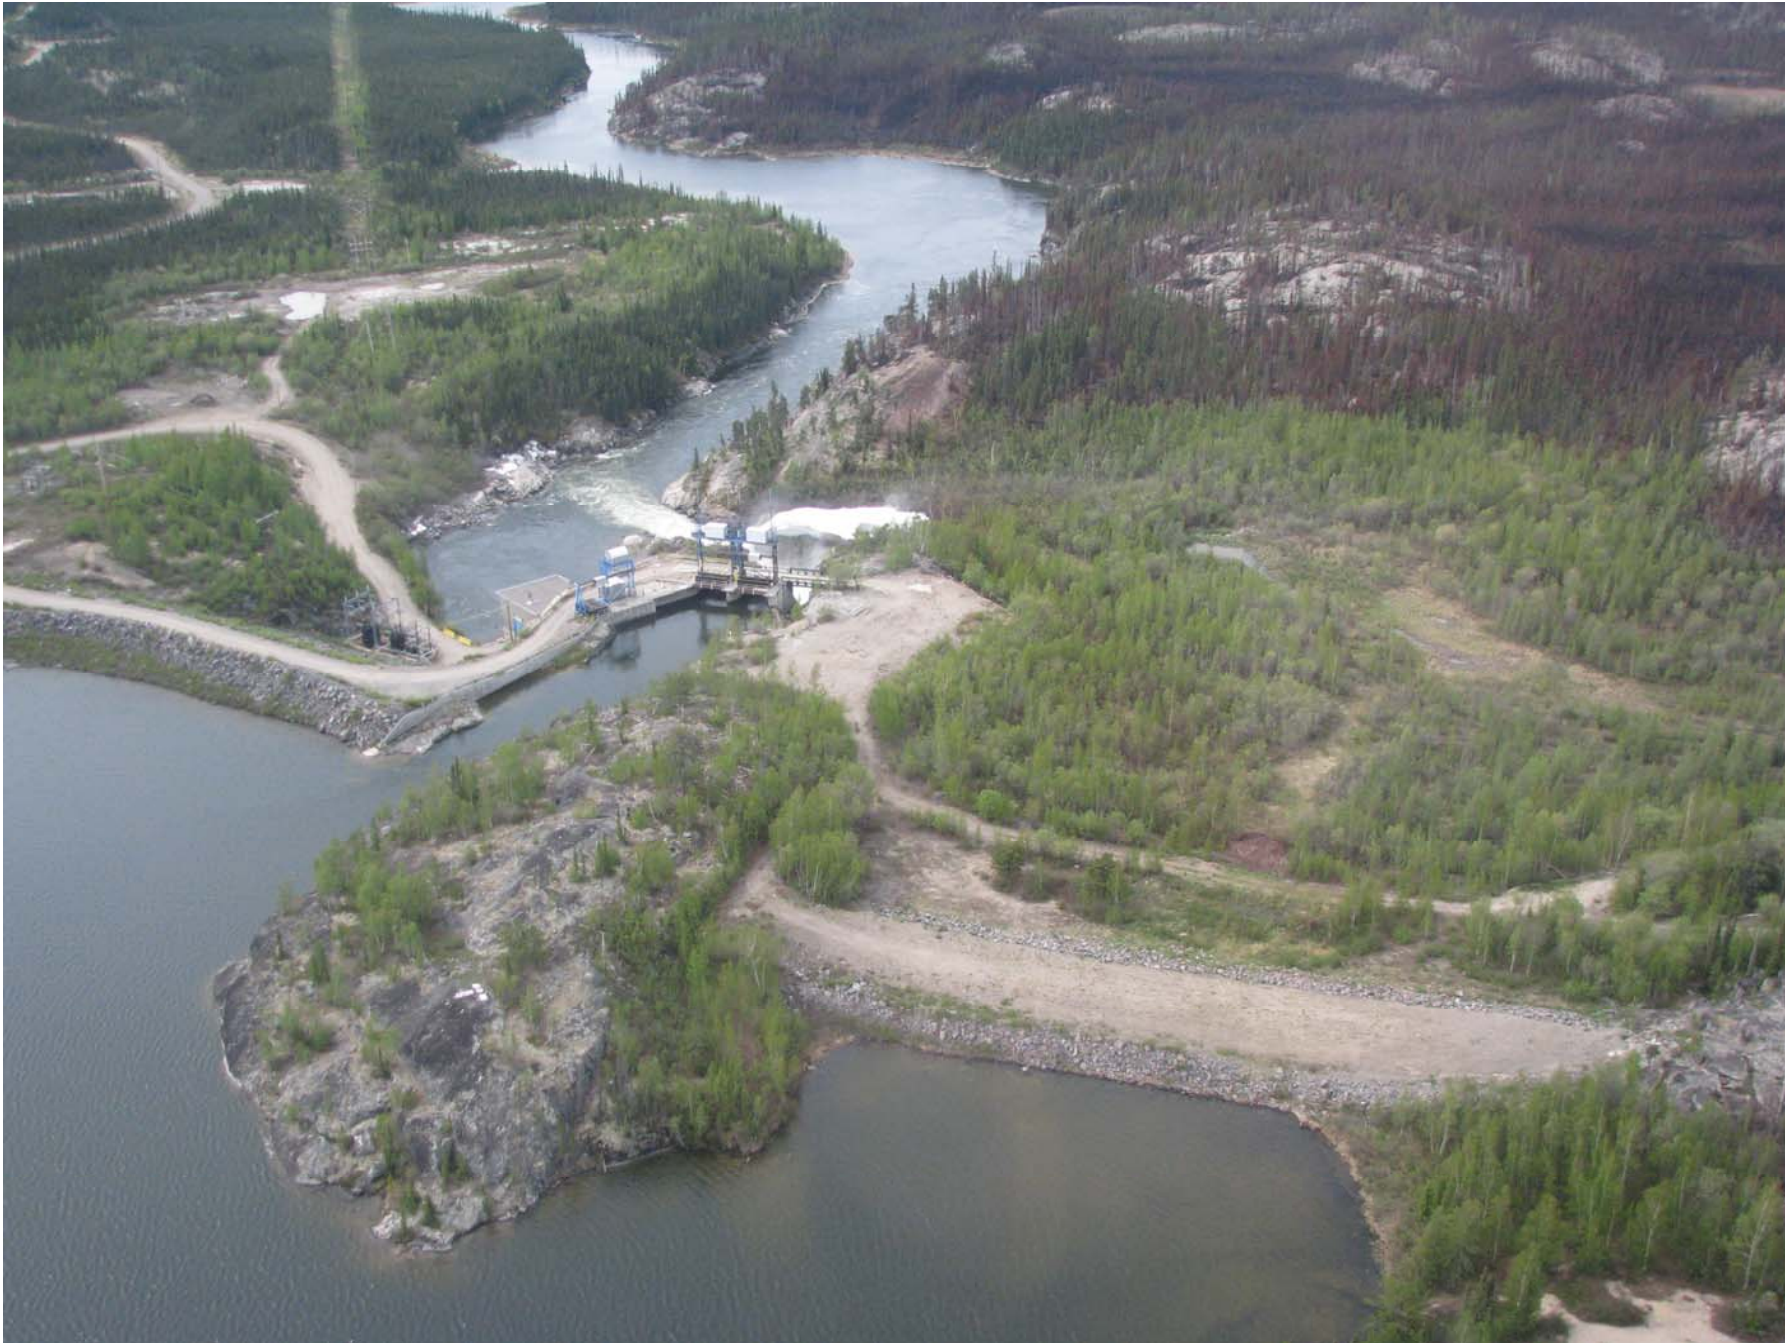
Snare Falls Saddle Dam No. 1

**Structure:** Snare Falls Saddle Dam No. 1  
**Location:** Located approximately 100 m North of Snare Falls main dam  
**Constructed:** 1960  
**Type:** Zoned Earth Fill Embankment  
**Core:** None  
**Foundation:** Granite Bedrock  
**CDA Consequence**  
**Classification:** High, due to economics  
**Length:** 100 m (328 ft)  
**Height:** 2.6 m (8.5 ft)  
**Crest Elevation<sup>1</sup>:** 204.5 m (670.9 ft)  
**Allowable Res. Levels<sup>2</sup>:**     Minimum:                 201.80 m (662.1 ft)  
  Normal Max:                 202.40 m (664.0 ft)  
  High Flow Max:             203.60 m (668.0 ft)  
**Other:** Modified in 2003 to act as a “fuse plug” spillway to provide emergency flood handling. Crest was lowered approximately 2.7 m.

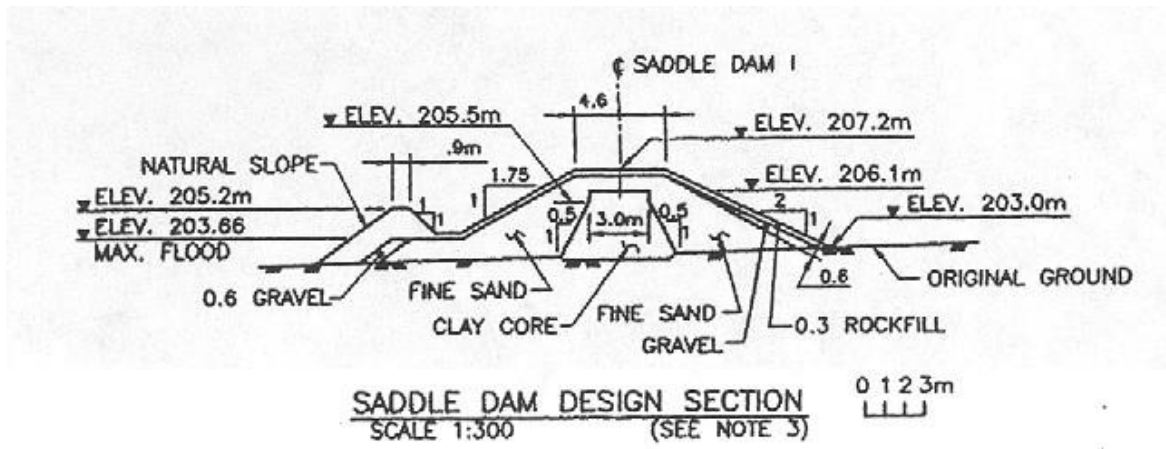
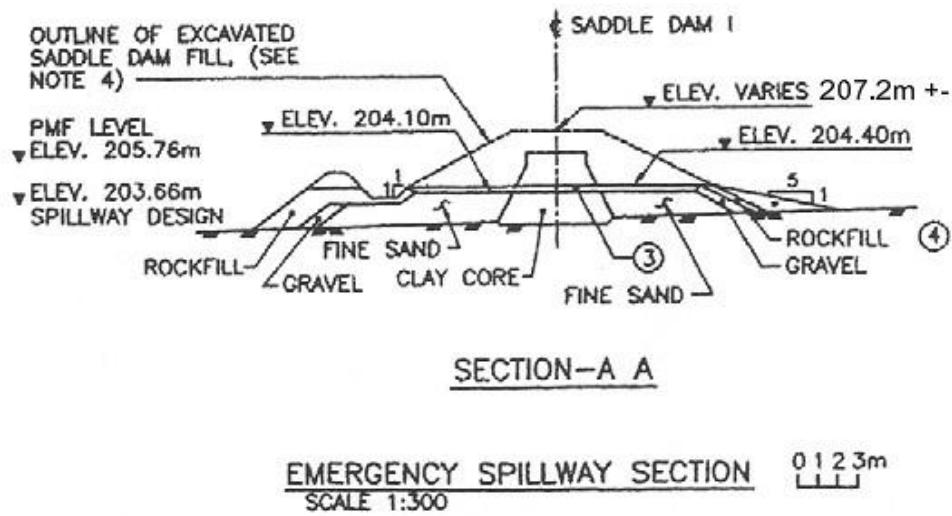
# Snare Falls Side Dam #1 Section

FIGURE  
2003 Modifications to Falls Side Dam #1  
Emergency overflow Spillway

- Strong Foundation.
- Provided with riprap erosion protection to act as an emergency spillway.
- Heating of the second spillway gate will enhance the Falls spillway reliability such that operation of the emergency spillway won't be needed.

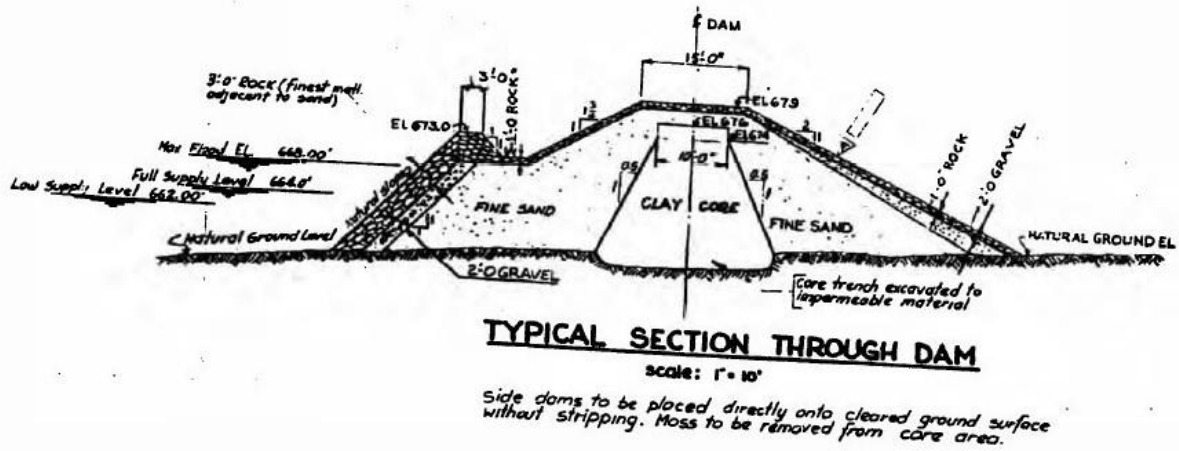
# Snare Falls Side Dam # 2 Section

Ref Dwg: Montreal Engineering  
NCP - 13899 Rev A  
Side Dams 1 & 2, Plan & Section  
Dated Aug 18 1959

**Structure:** Snare Falls Saddle Dam No. 2  
**Location:** Located approximately 250 m west of Snare Falls main dam  
**Constructed:** 1960  
**Type:** Zoned Earth Fill Embankment  
**Core:** None  
**Foundation:** Soil  
**CDA Consequence**  
**Classification:** High, due to economics  
**Length:** 90 m (328 ft)  
**Height:** 8 m (26 ft)  
**Crest Elevation<sup>1</sup>:** 207.26 m (675.0 ft)  
**Allowable Res. Levels<sup>2</sup>:**     Minimum:             201.80 m (662.1 ft)  
  Normal Max:           202.40 m (664.0 ft)  
  High Flow Max:       203.60 m (668.0 ft)

- More vulnerable to foundation settlement than other dams because of soil foundation.
- Very low head on this structure.

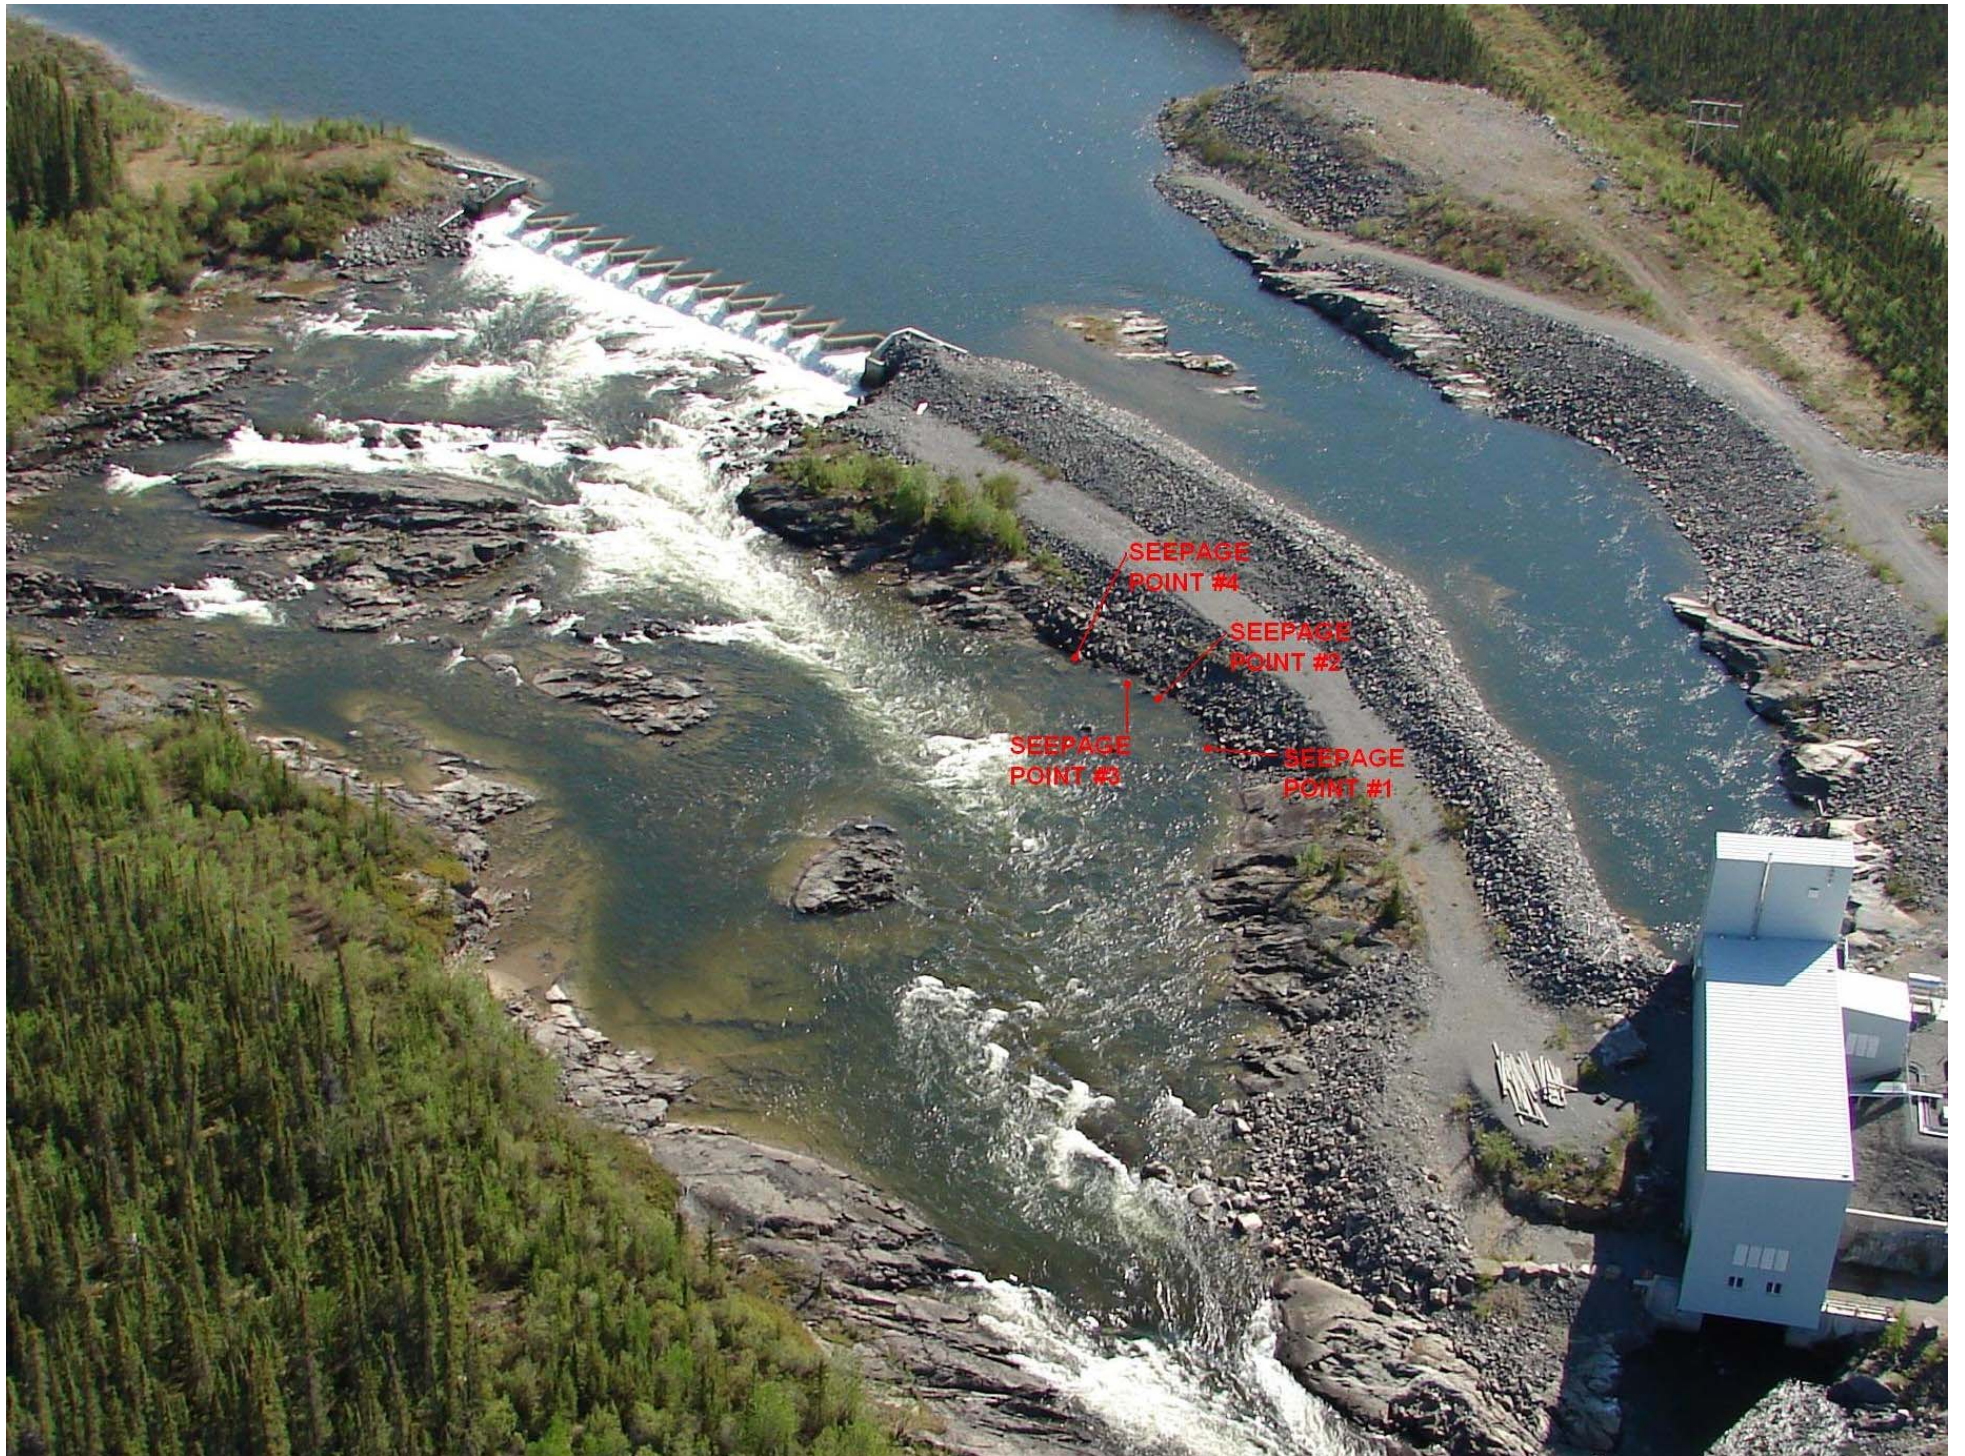
Snare Cascades – Seepage Locations

The four identified leaks are all observed within a 10 m radius at approximately the midpoint of the dyke. The pool that the seepages flow into has previously been observed to be cloudy. This most likely from rain and melt water washing out the finer particles from the rock fill and is not a concern since the core is concrete. As these leaks are too low to be observed when water is flowing over the spillway, regular inspections may not be possible and operations personnel will have to inspect them whenever the water is low enough.

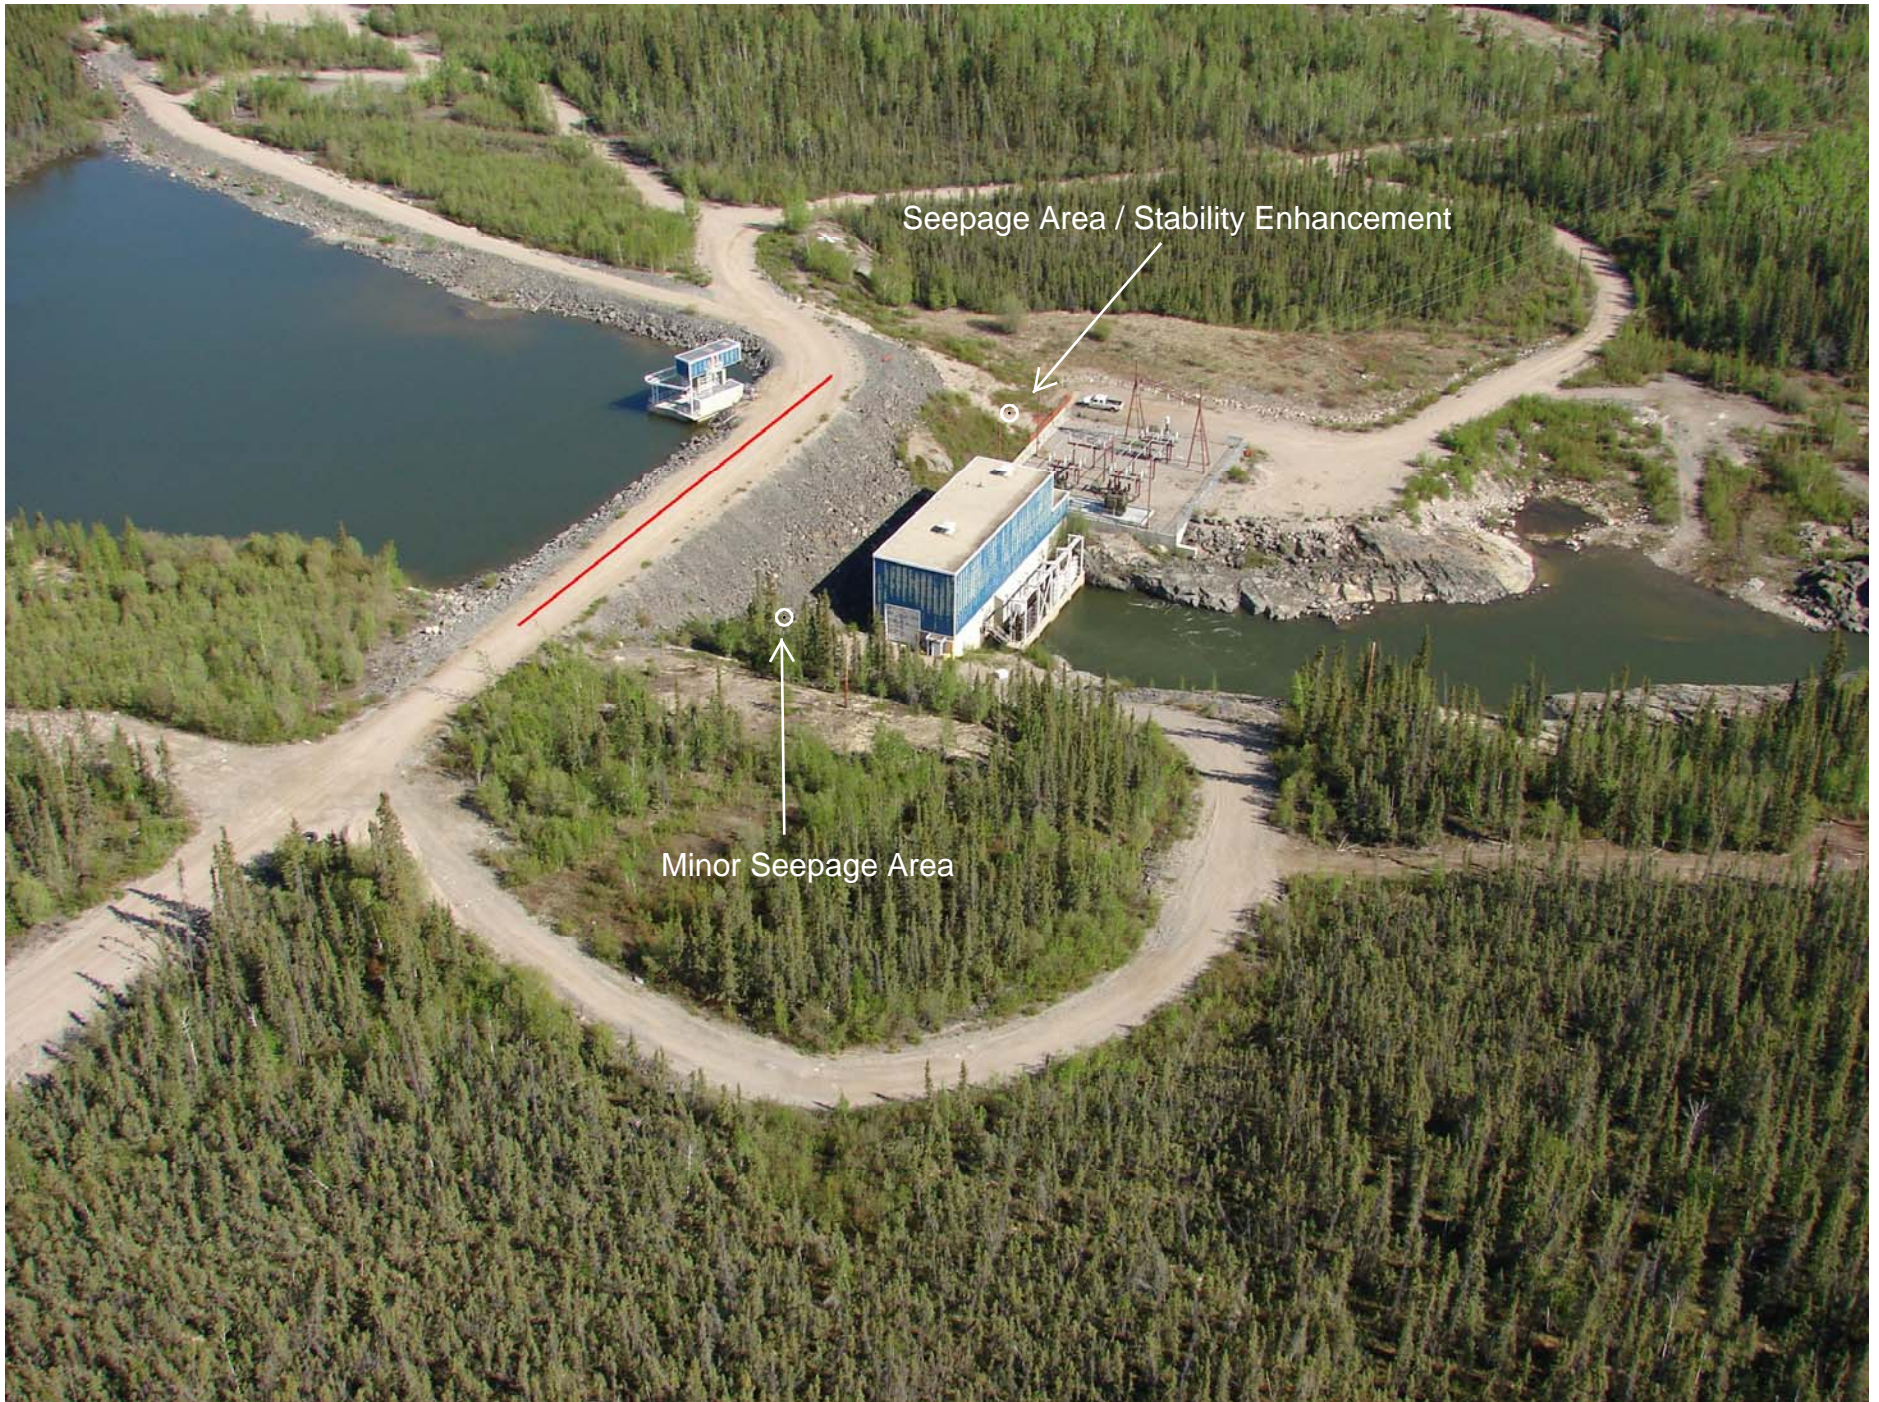
Seepage Area / Stability Enhancement

Minor Seepage Area

- Seepage flow exists at the toe of Strutt Dam near the entrance to the Plant walkway. In 2019 a boil was observed at this location which was attributed to pent-up water within the overburden along the toe which was released during spring thaw.
- As an enhancement to stability, a 1m cover of clean crush gravel filter material was placed over this area in 2020.
- Seepage has rarely occurred at the right abutment, the flow appears as a wet area and is not measurable but should be visually inspected.

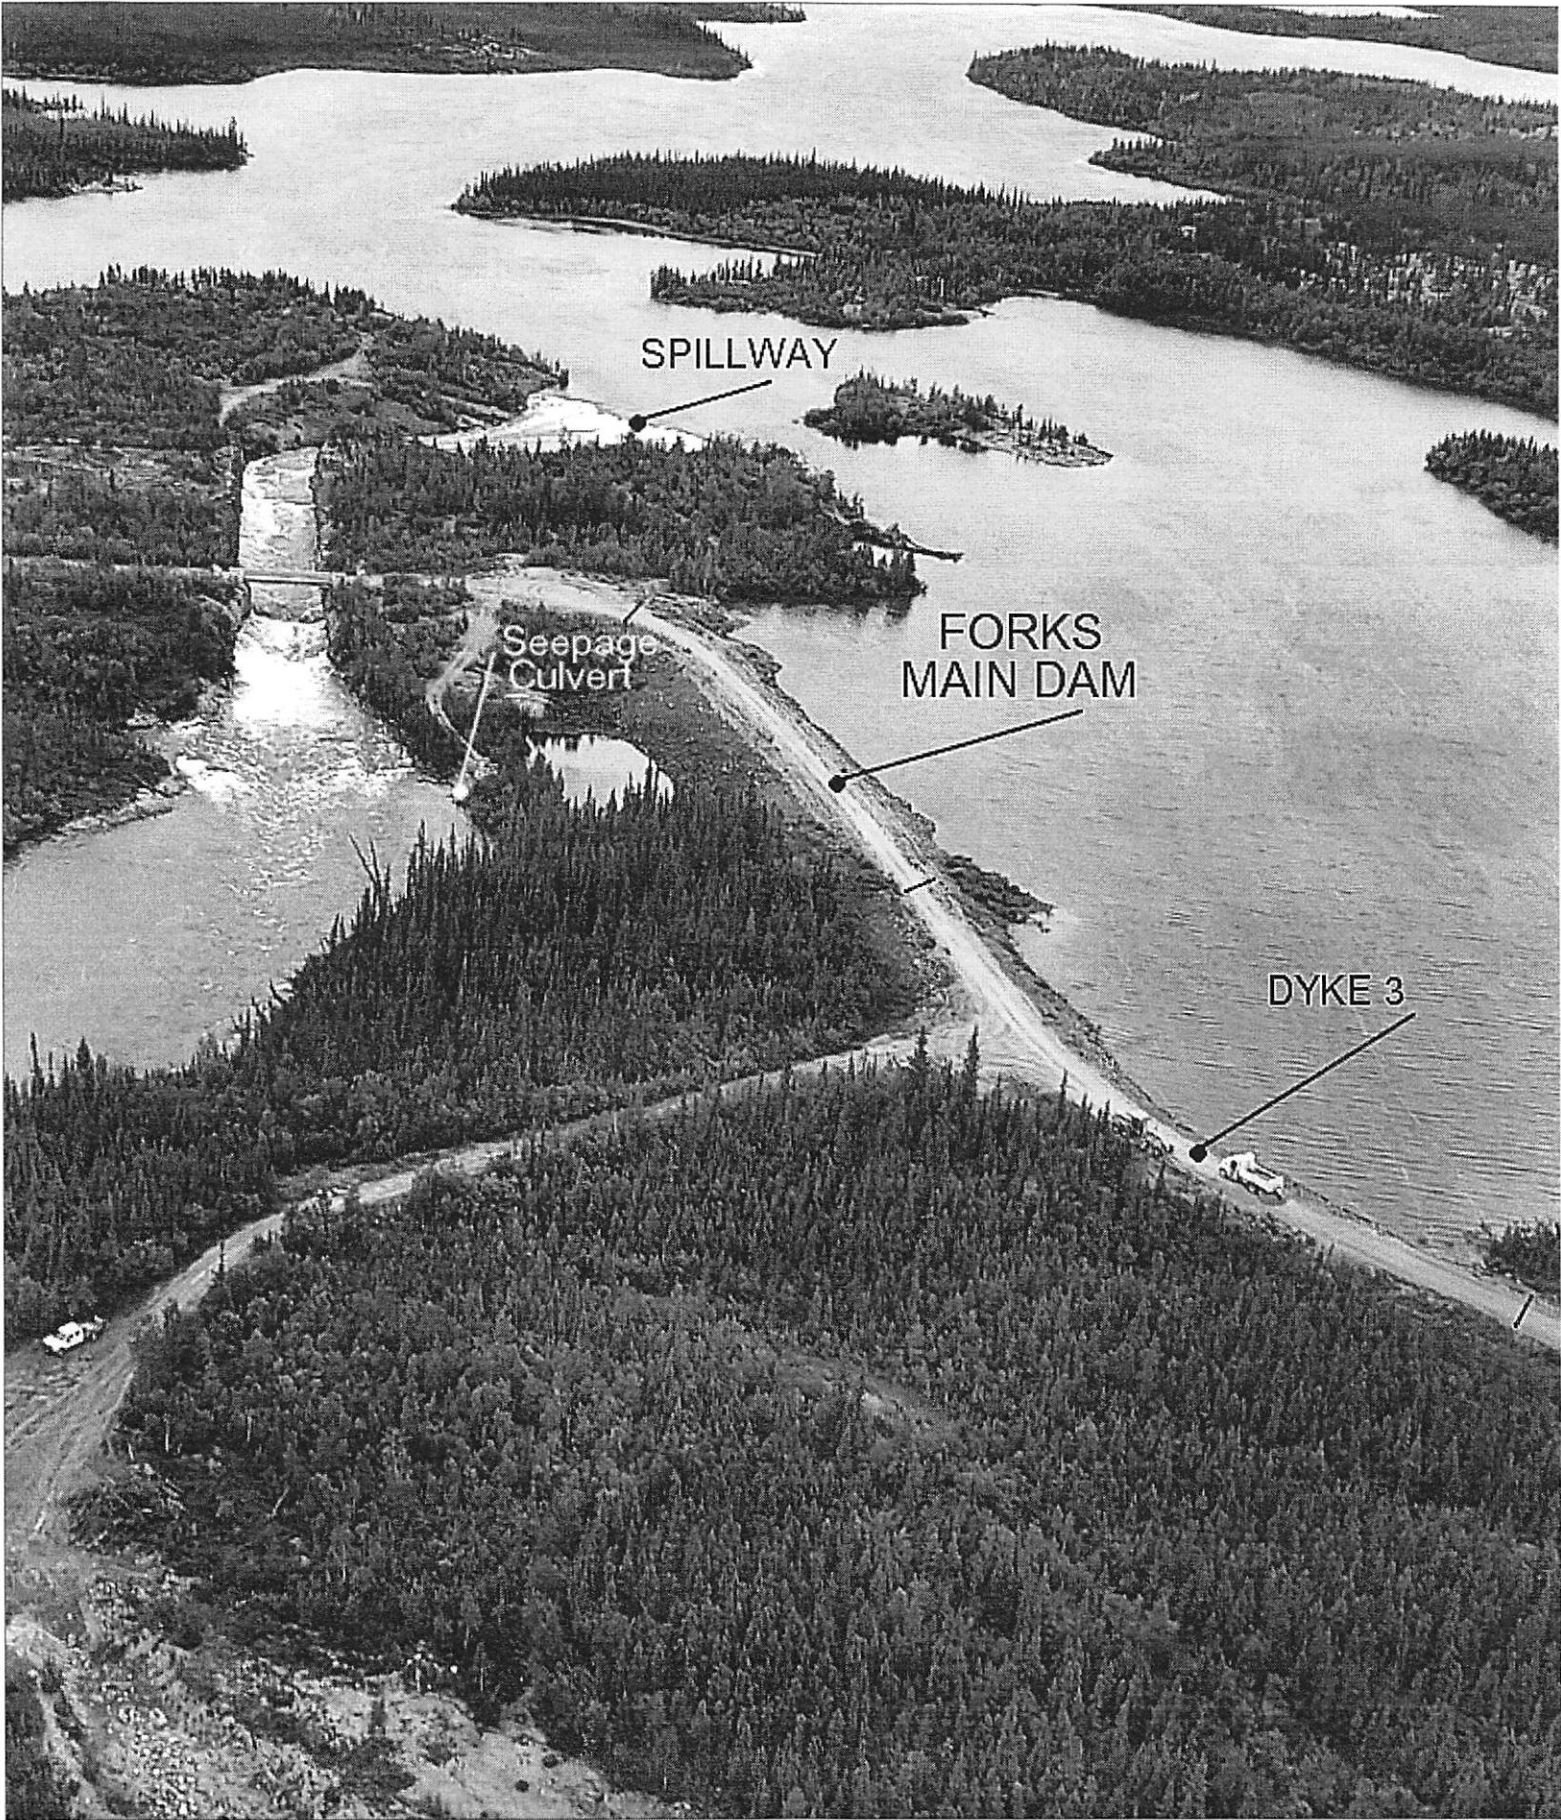
SPILLWAY

Seepage  
Culvert

FORKS  
MAIN DAM

DYKE 3

- Small amount of seepage through a culvert in the downstream. Only visible when spillway channel is dry.
- It is recommended that monthly seepage readings are taken at the berm culvert when the spillway is not overflowing.

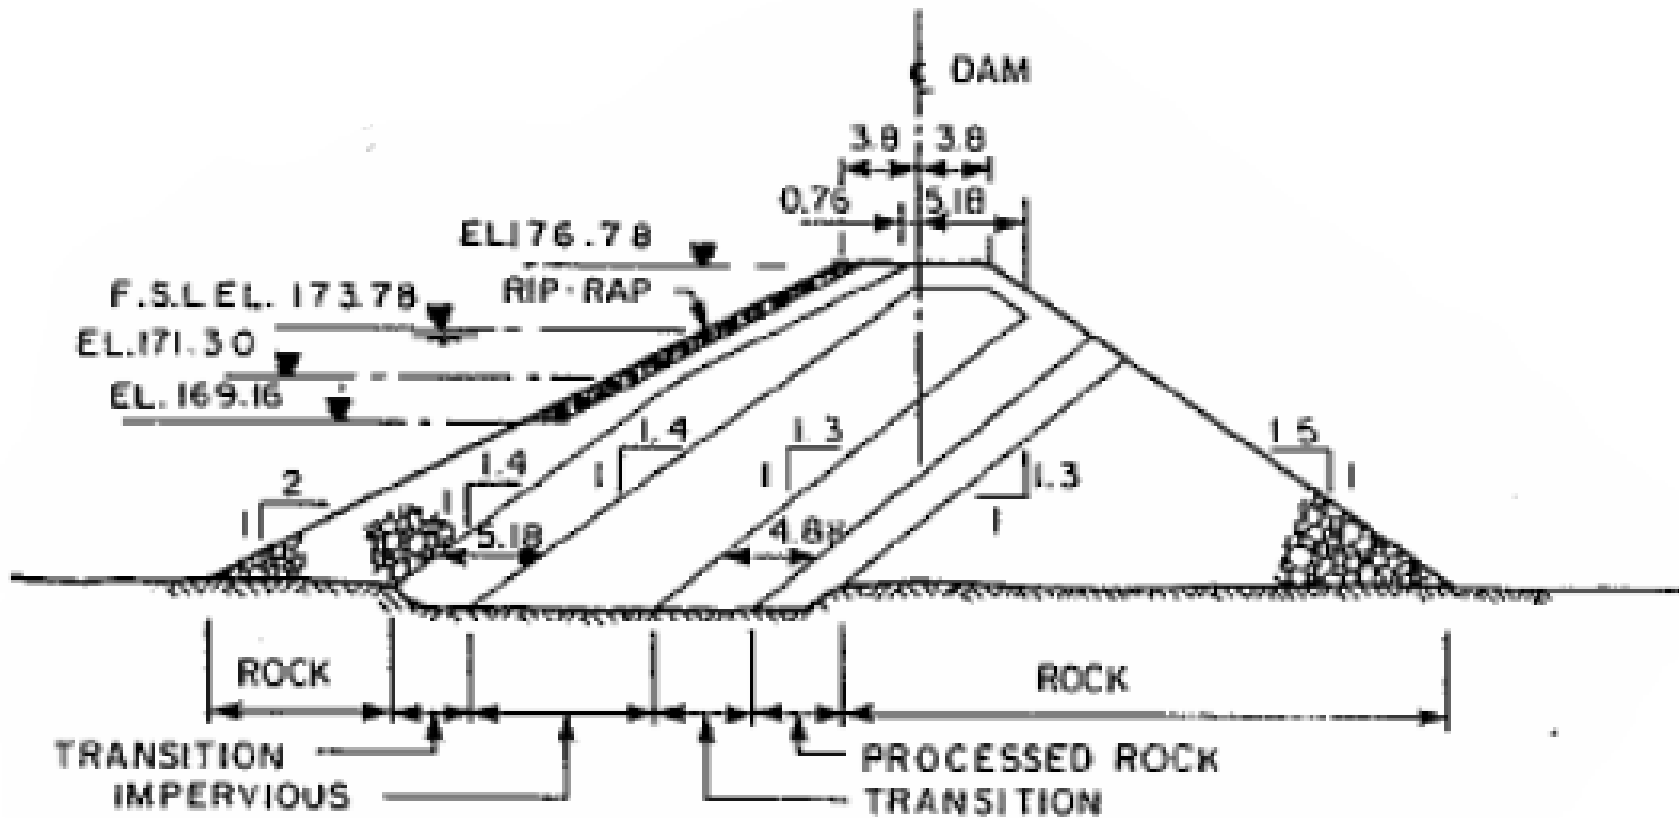
Snare Forks Dam – Typical Section

**Structure:** Snare Forks Dam  
**Location:** North of Dyke #3. Impounds the north channel of Snare River.  
**Constructed:** 1976  
**Type:** Zoned Earth Fill Embankment  
**Core:** Sloping Till Core  
**Length:** 105 m (345 ft)  
**Height:** 10 m (33 ft)  
**Foundation:** Bedrock  
**CDA Consequence**  
**Classification:** High, due to economics  
**Elevations<sup>1</sup>:** Core: 175.58 m (576.1 ft)  
Crest<sup>2</sup>: 176.79 m (580.0 ft)  
Spillway: 173.74 m (570.0 ft)  
**Allowable Res. Levels<sup>3</sup>:** Minimum: 173.13 m (568.0 ft)  
Normal Max: 173.73 m (570.0 ft)  
High Flow Max: 175.26 m (575.0 ft)

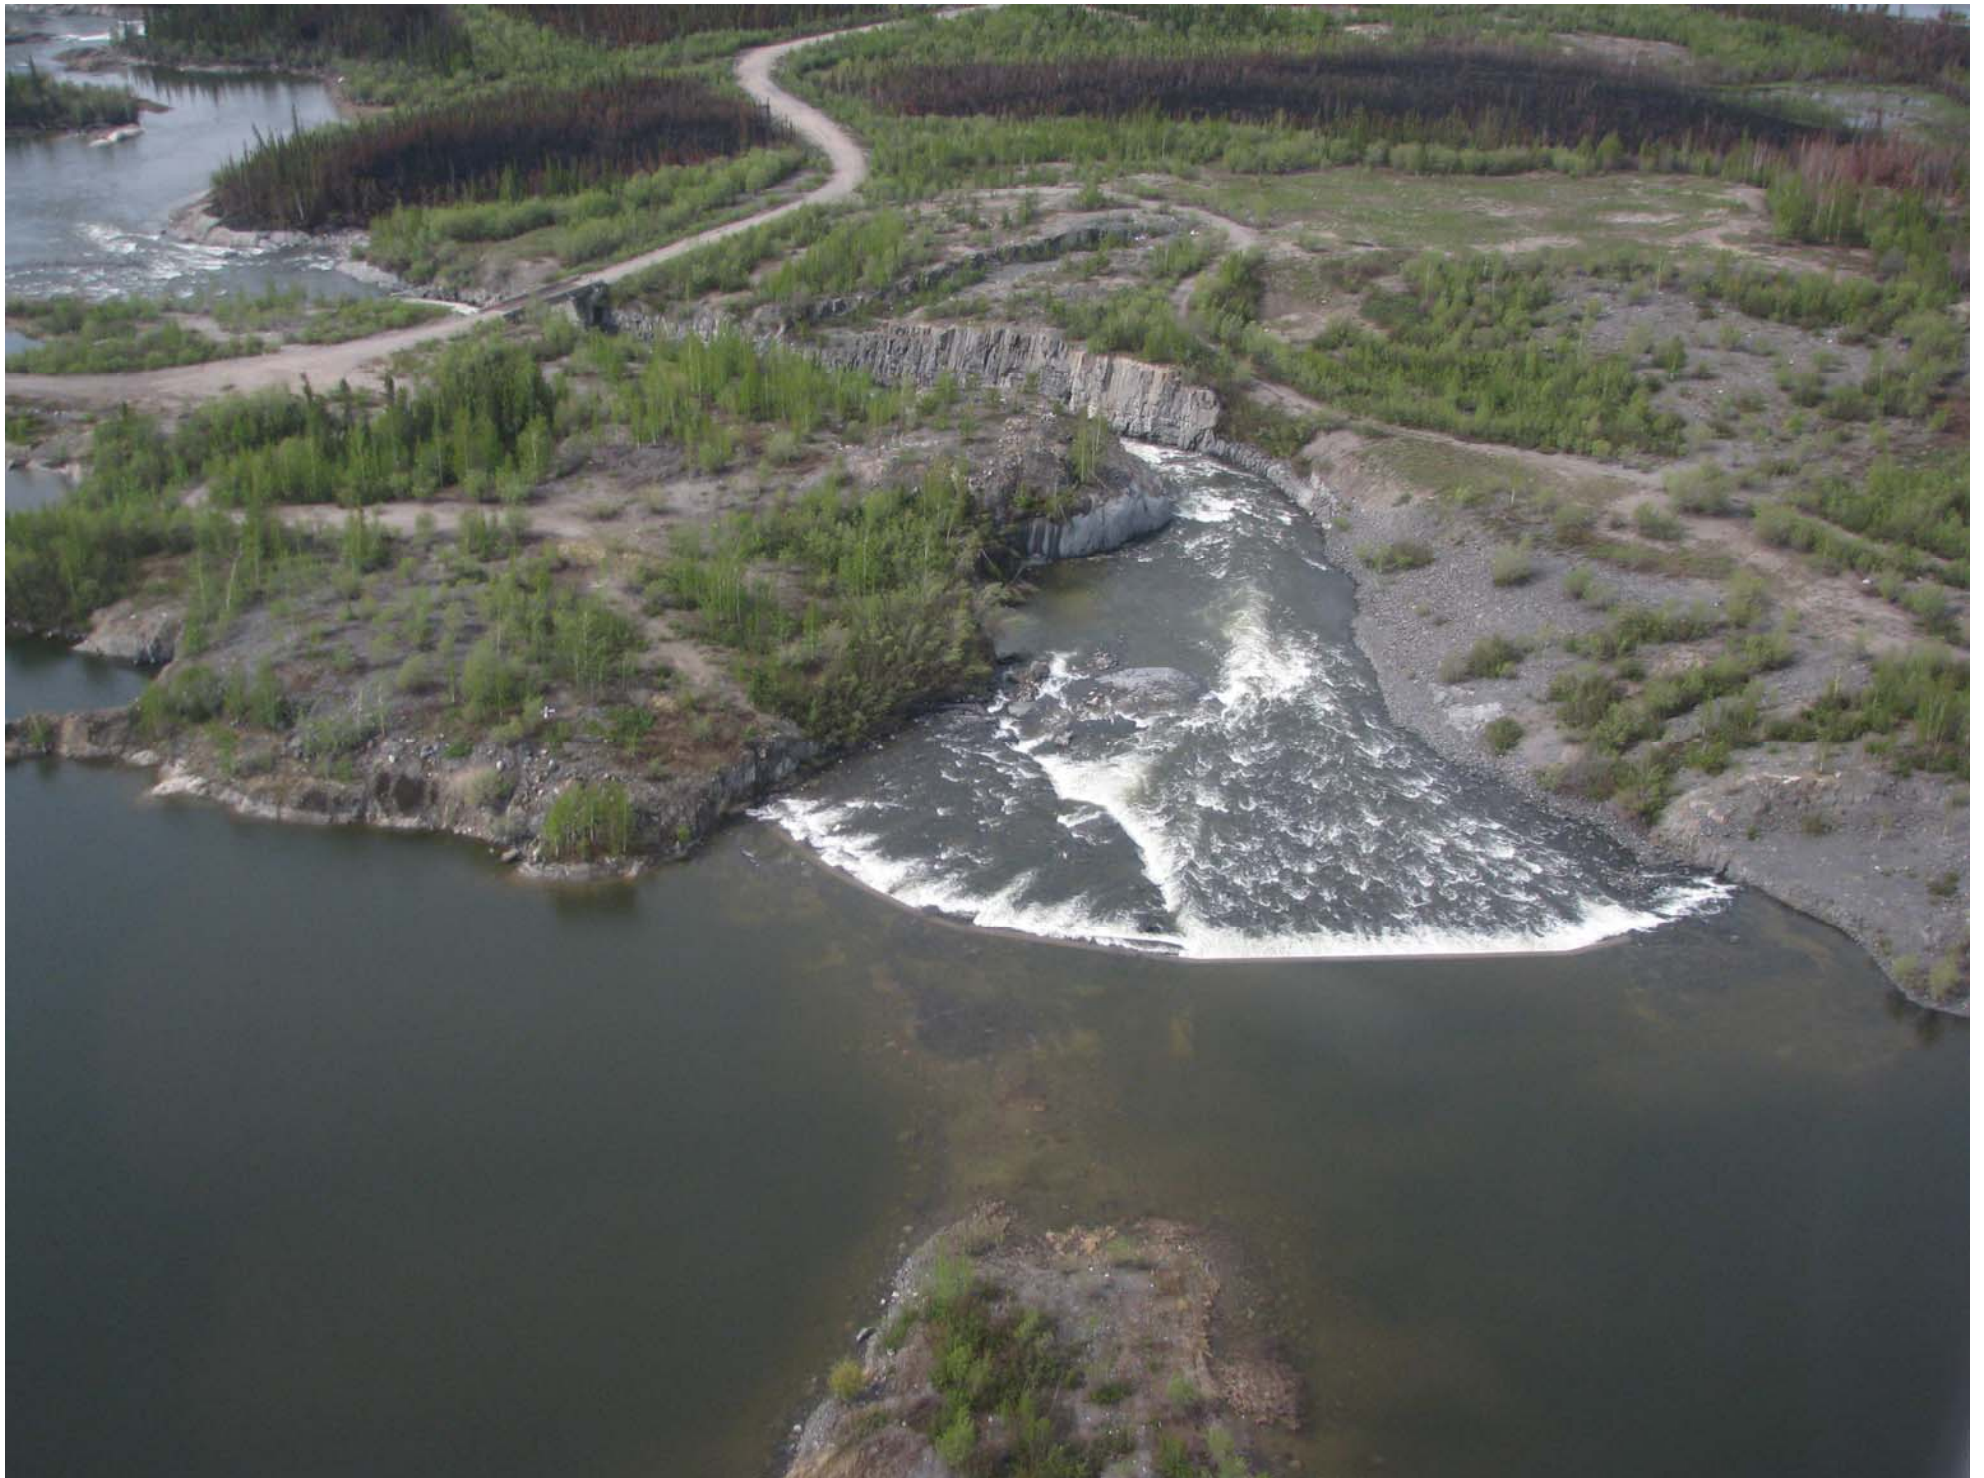
Snare Forks Spillway – Aerial Photo

**Structure:** Snare Forks Spillway  
**Location:** Approximately 300 m north of Snare Forks Dam  
**Constructed:** 1976  
**Type:** Free-Flow Concrete Weir  
**Length:** 100 m (328 ft)  
**Height:** 2.25 m  
**Foundation:** Bedrock  
**CDA Consequence**  
**Classification:** High, due to economics  
**Crest Elevation<sup>1</sup>:** 173.74 m (570.0 ft)  
**Allowable Res. Levels<sup>2</sup>:** Minimum: 173.13 m (568.0 ft)  
Normal Max: 173.73 m (570.0 ft)  
High Flow Max: 175.26 m (575.0 ft)

- Most vulnerable to frost action causing concrete erosion and crack propagation.
- Rock erosion protection was placed along the downstream face, enhancing the stability of the Weir.
