**2021 DAM MONITORING  
GUIDE FOR OPERATORS**

**NORTHWEST TERRITORIES  
POWER CORPORATION**

This Document provides information to assist the Operators in the Inspection of the Dams in The Northwest Territories Power Corporation's Hydro System

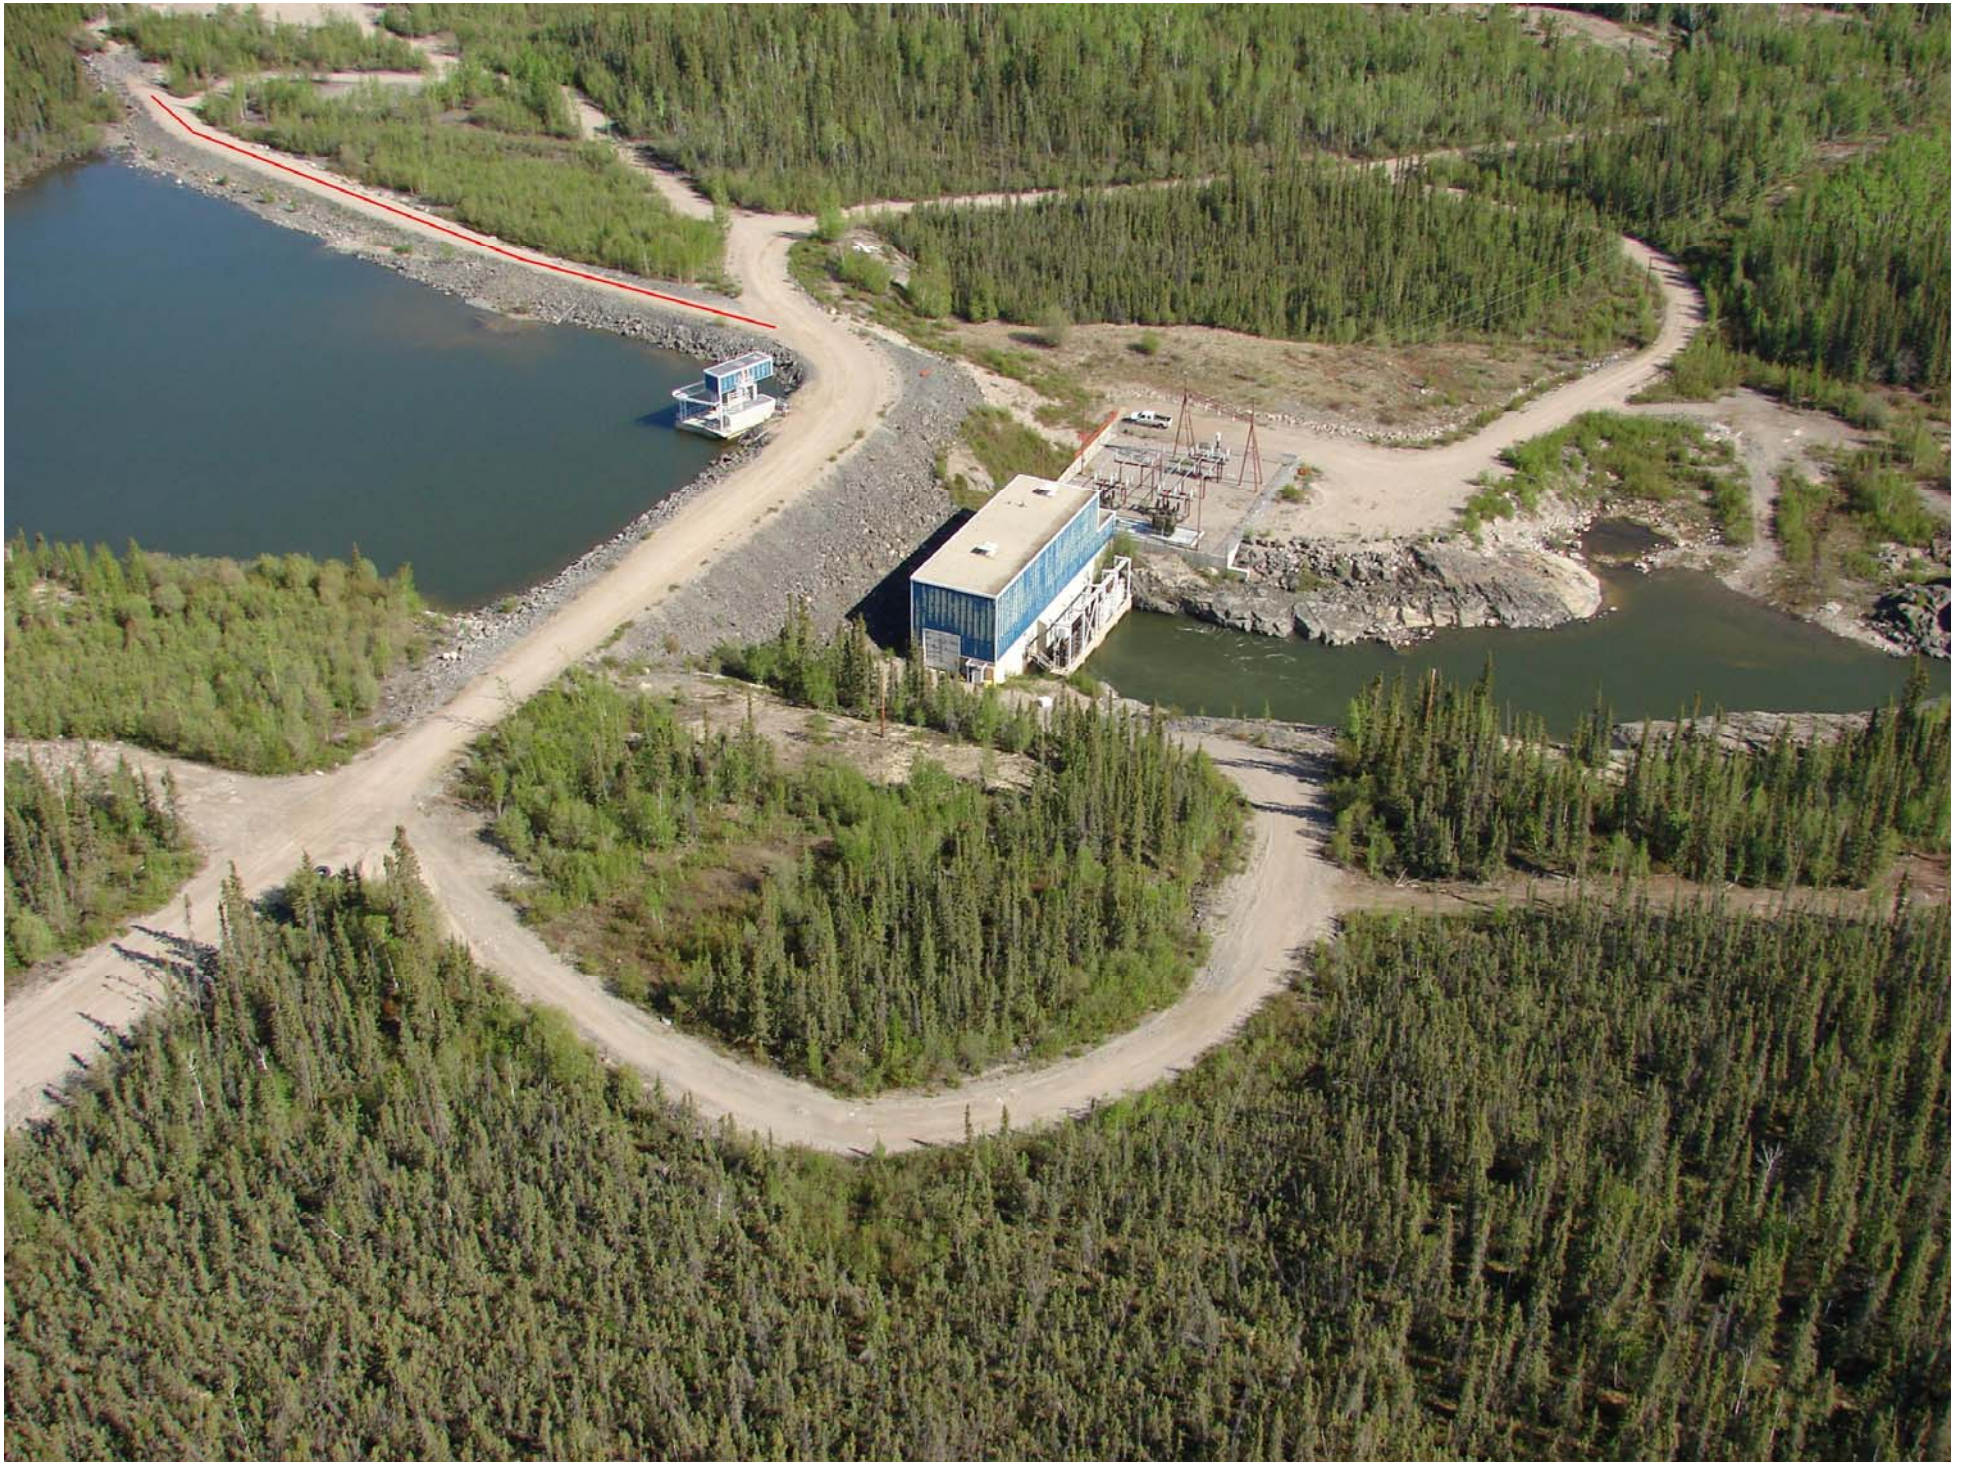
Snare Forks North Dyke – Aerial Photo

**Structure:** Snare Forks North Dyke  
**Location:** Extends to the northwest from the north abutment of Strutt Lake Dam  
**Constructed:** 1976  
**Type:** Zoned Earth Fill  
**Core:** Rolled Silt  
**Length:** 380 m (1247 ft)  
**Height:** 2.5m (6.56ft)  
**Foundation:** Bedrock  
**CDA Consequence**  
**Classification:** High, due to economics  
**Elevations<sup>1</sup>:** Core:  
Crest: 176.78 m (580.0 ft)  
Spillway: 173.74 m (570.0 ft)  
**Allowable Res. Levels<sup>2</sup>:** Minimum: 173.13 m (568.0 ft)  
Normal Max: 173.73 m (570.0 ft)  
High Flow Max: 175.26 m (575.0 ft)

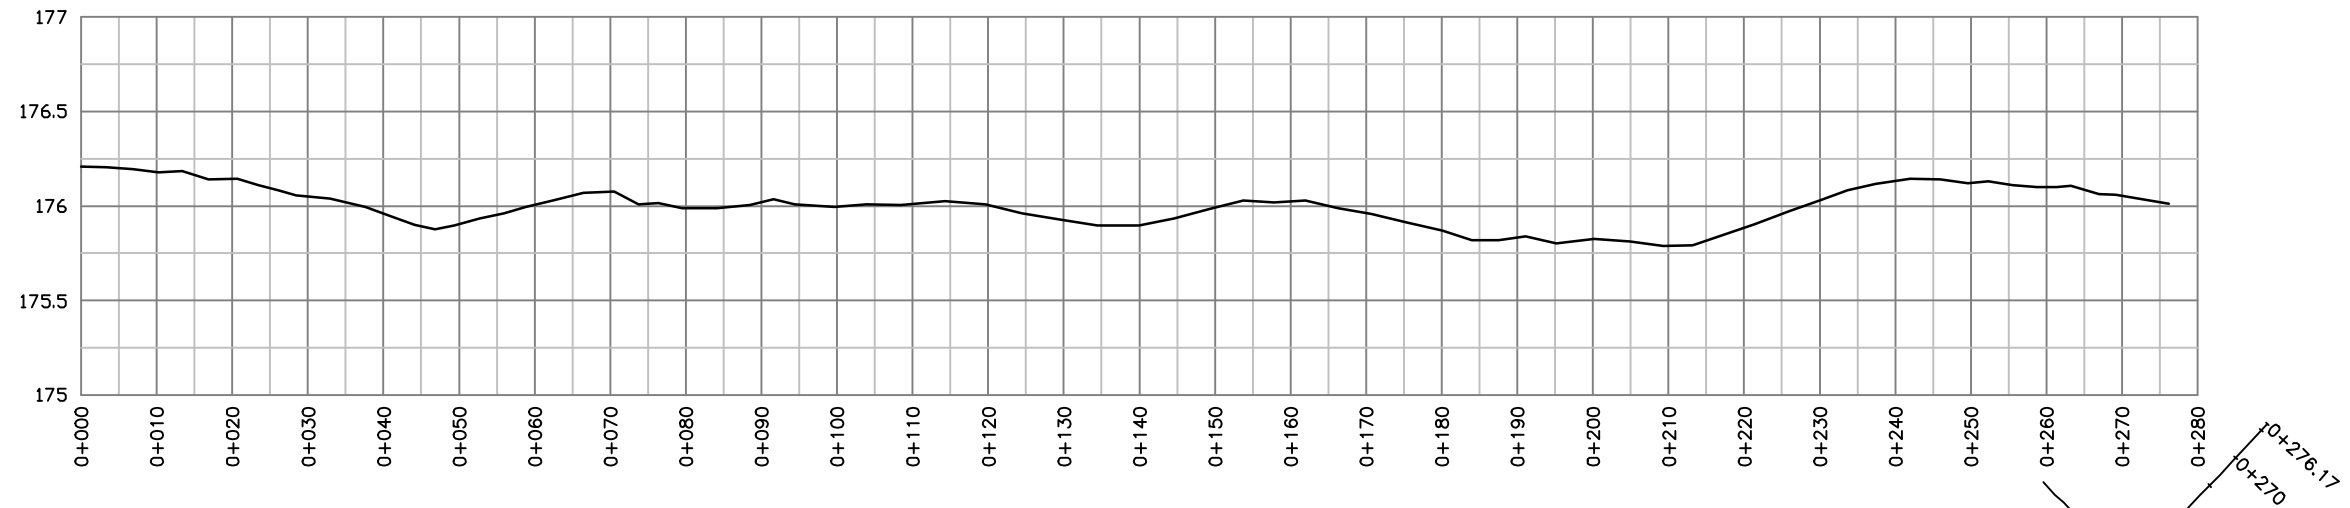
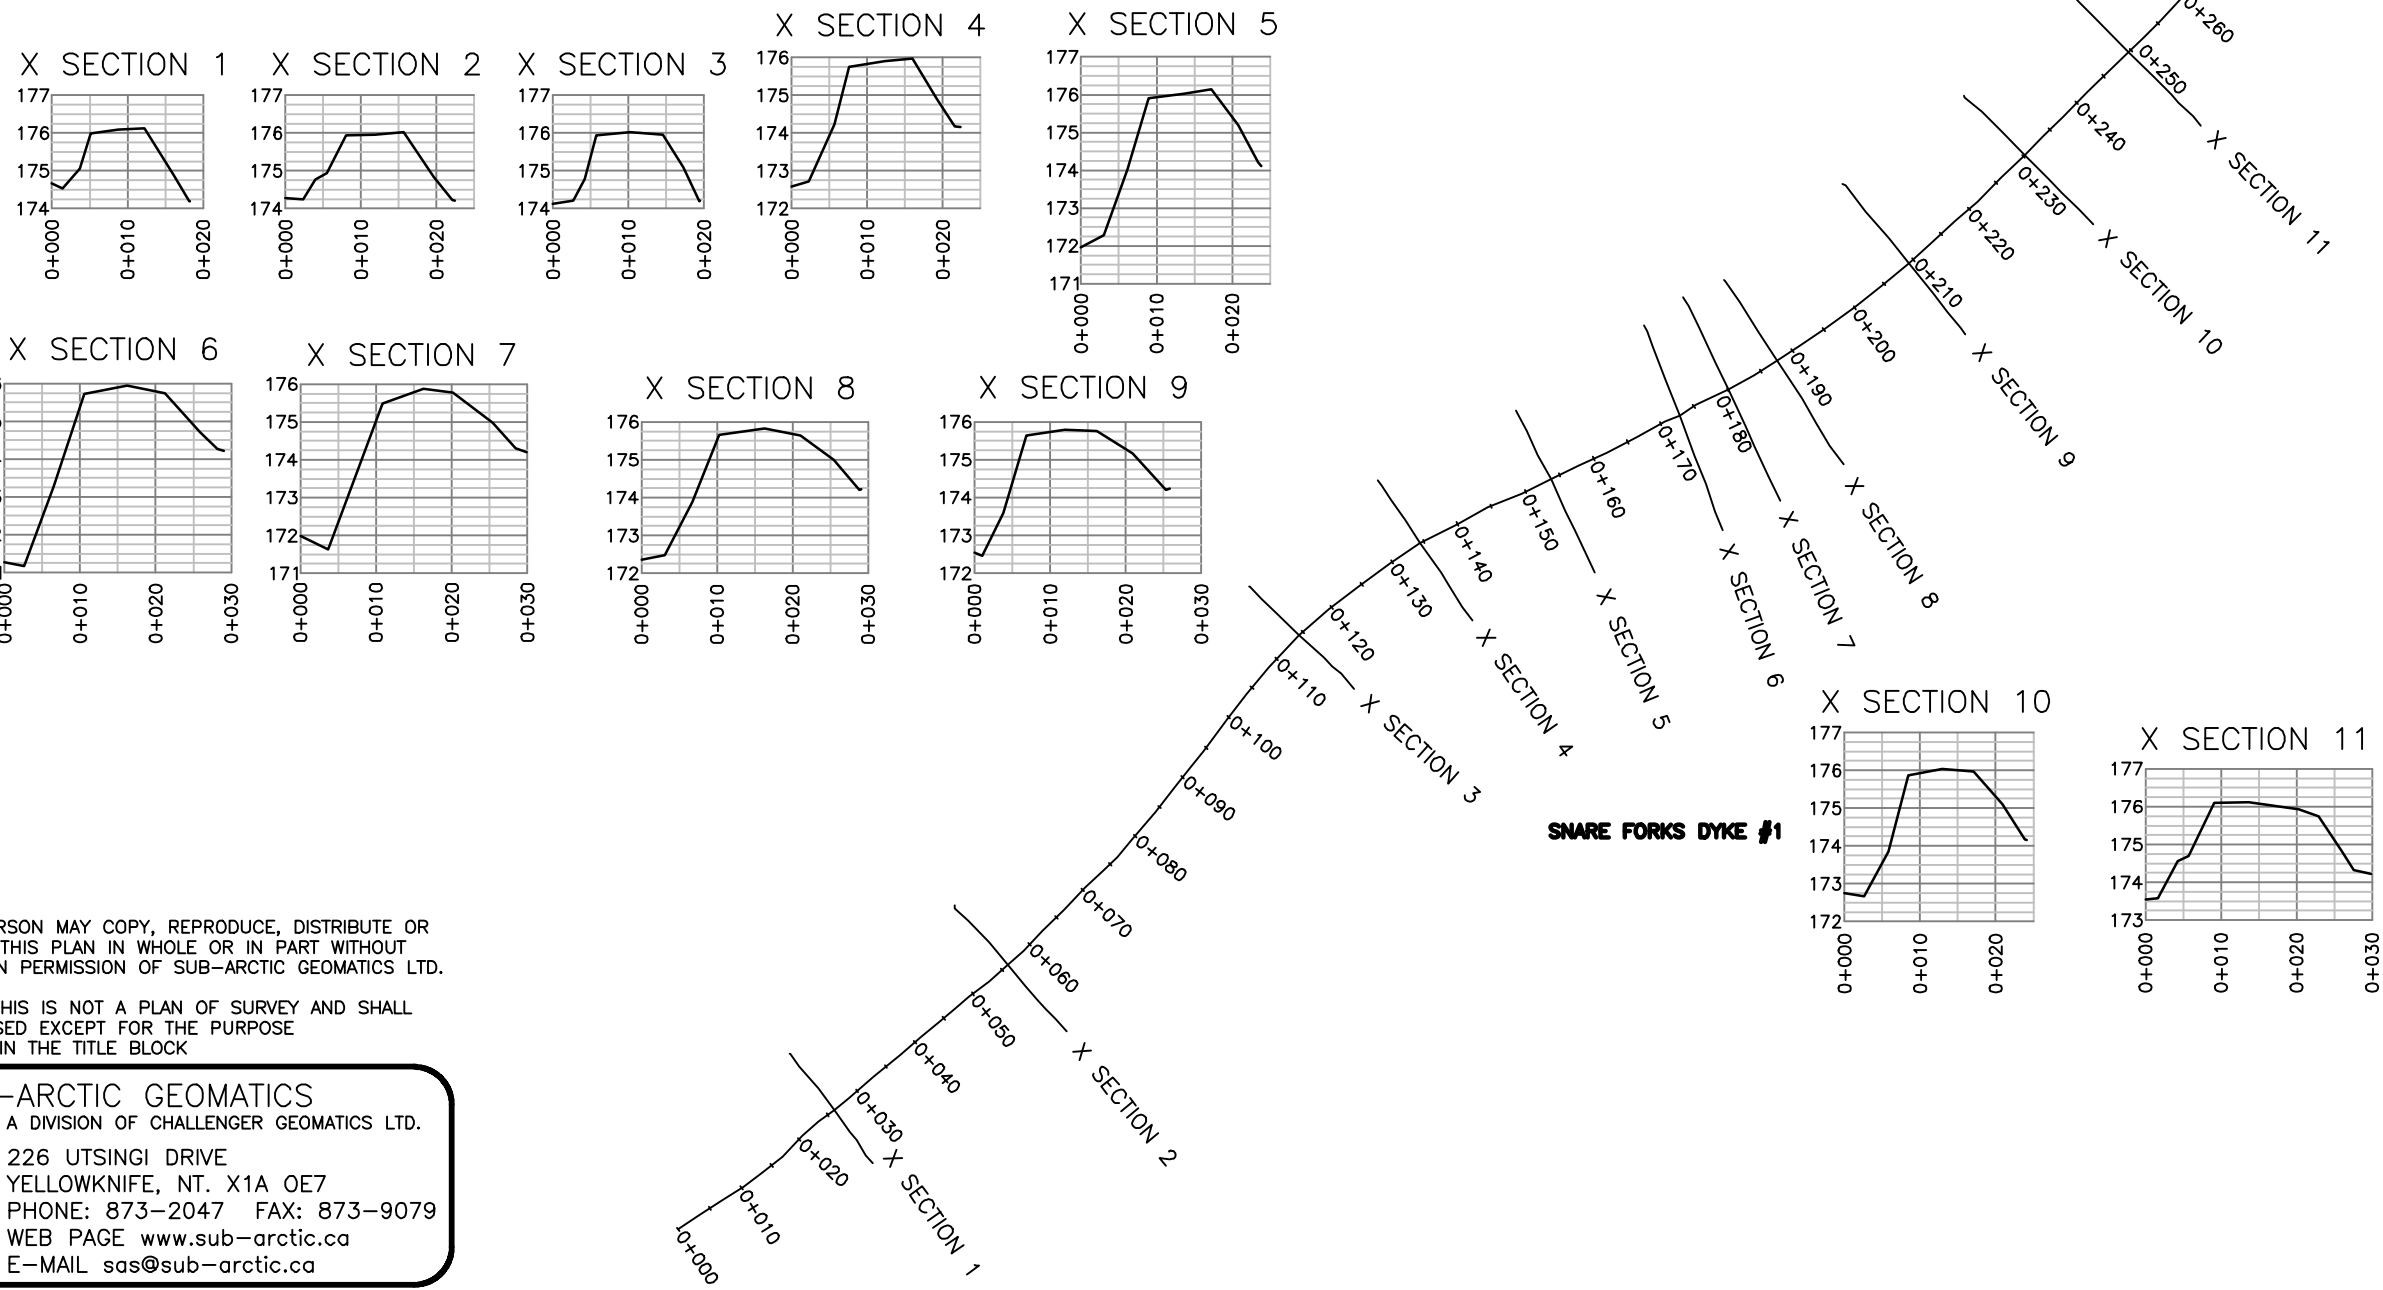
# SNARE FORKS DYKE #1 PROFILE

NOTES:  
 DATE OF SURVEY: OCTOBER 27 TO 29, 2020  
 ALL ELEVATIONS ARE EXPRESSED IN METRES OR DECIMALS THEREOF.  
 SURVEY REFERENCE POINT:  
 BASE 1  
 NORTHING: 7022516.52  
 EASTING: 533965.94  
 ELEVATION: 176.6

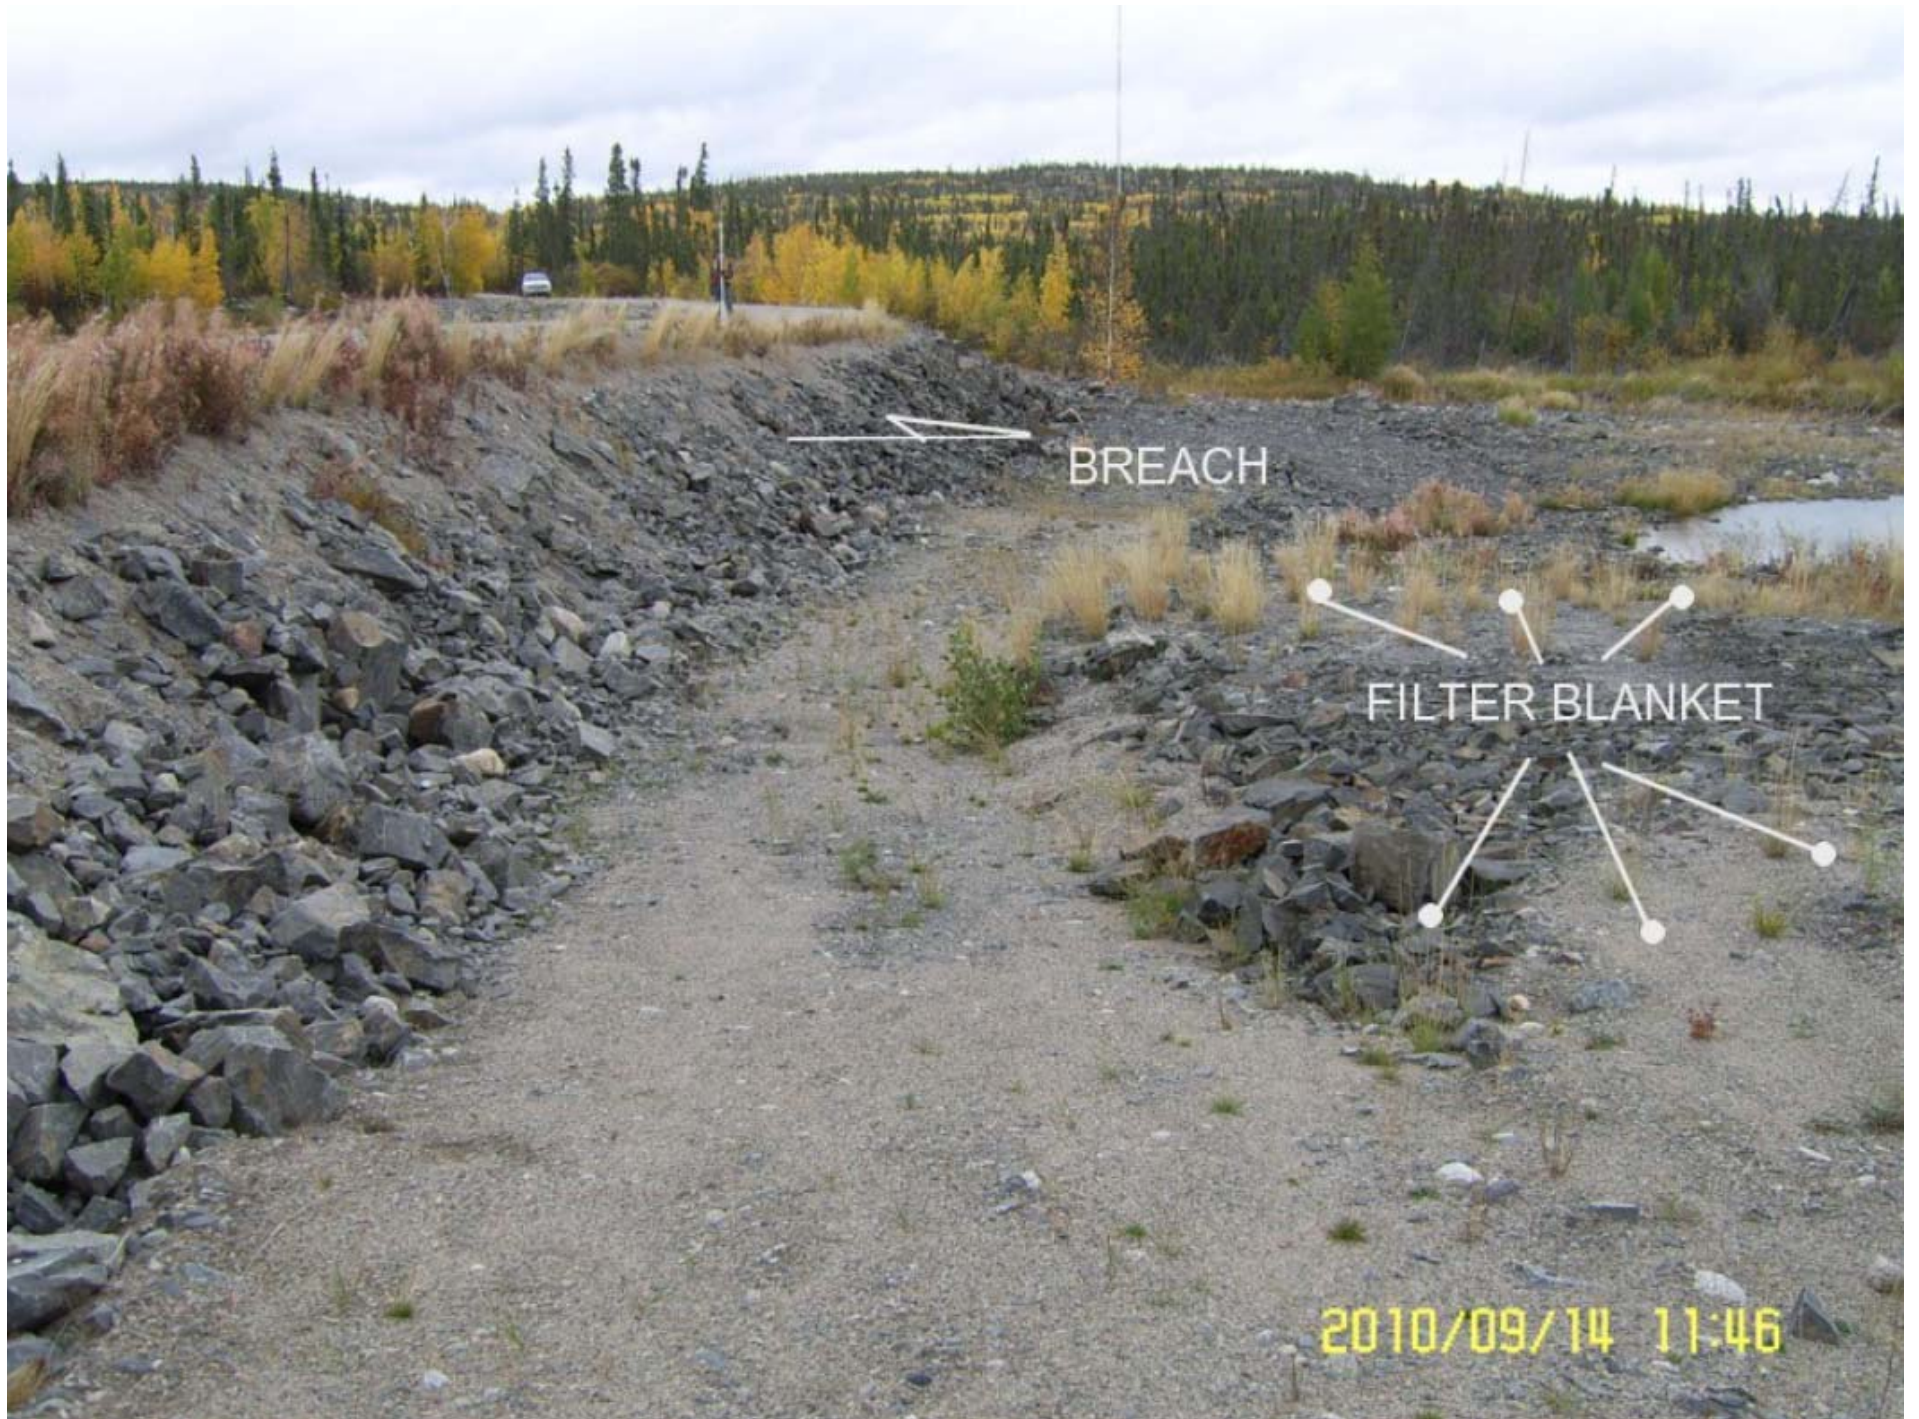
Snare Forks Dyke #1 – Seepage & Filter Blanket Location

- Breached on June 15, 2006.
- Seepage is present at the breach section (approximately midpoint).
- Filter blanket constructed over leakage area to mitigate potential piping.
- Elevation is slightly below design elevation around the location of seepage.
- Seepage water is clear.
- Monitored by a concrete V-notch weir approximately 500 m downstream.
- Weir is accessed by a foot path from the radio tower by the Forks plant.
- Flow through the weir is normally around 2.1 ft<sup>3</sup>/s.

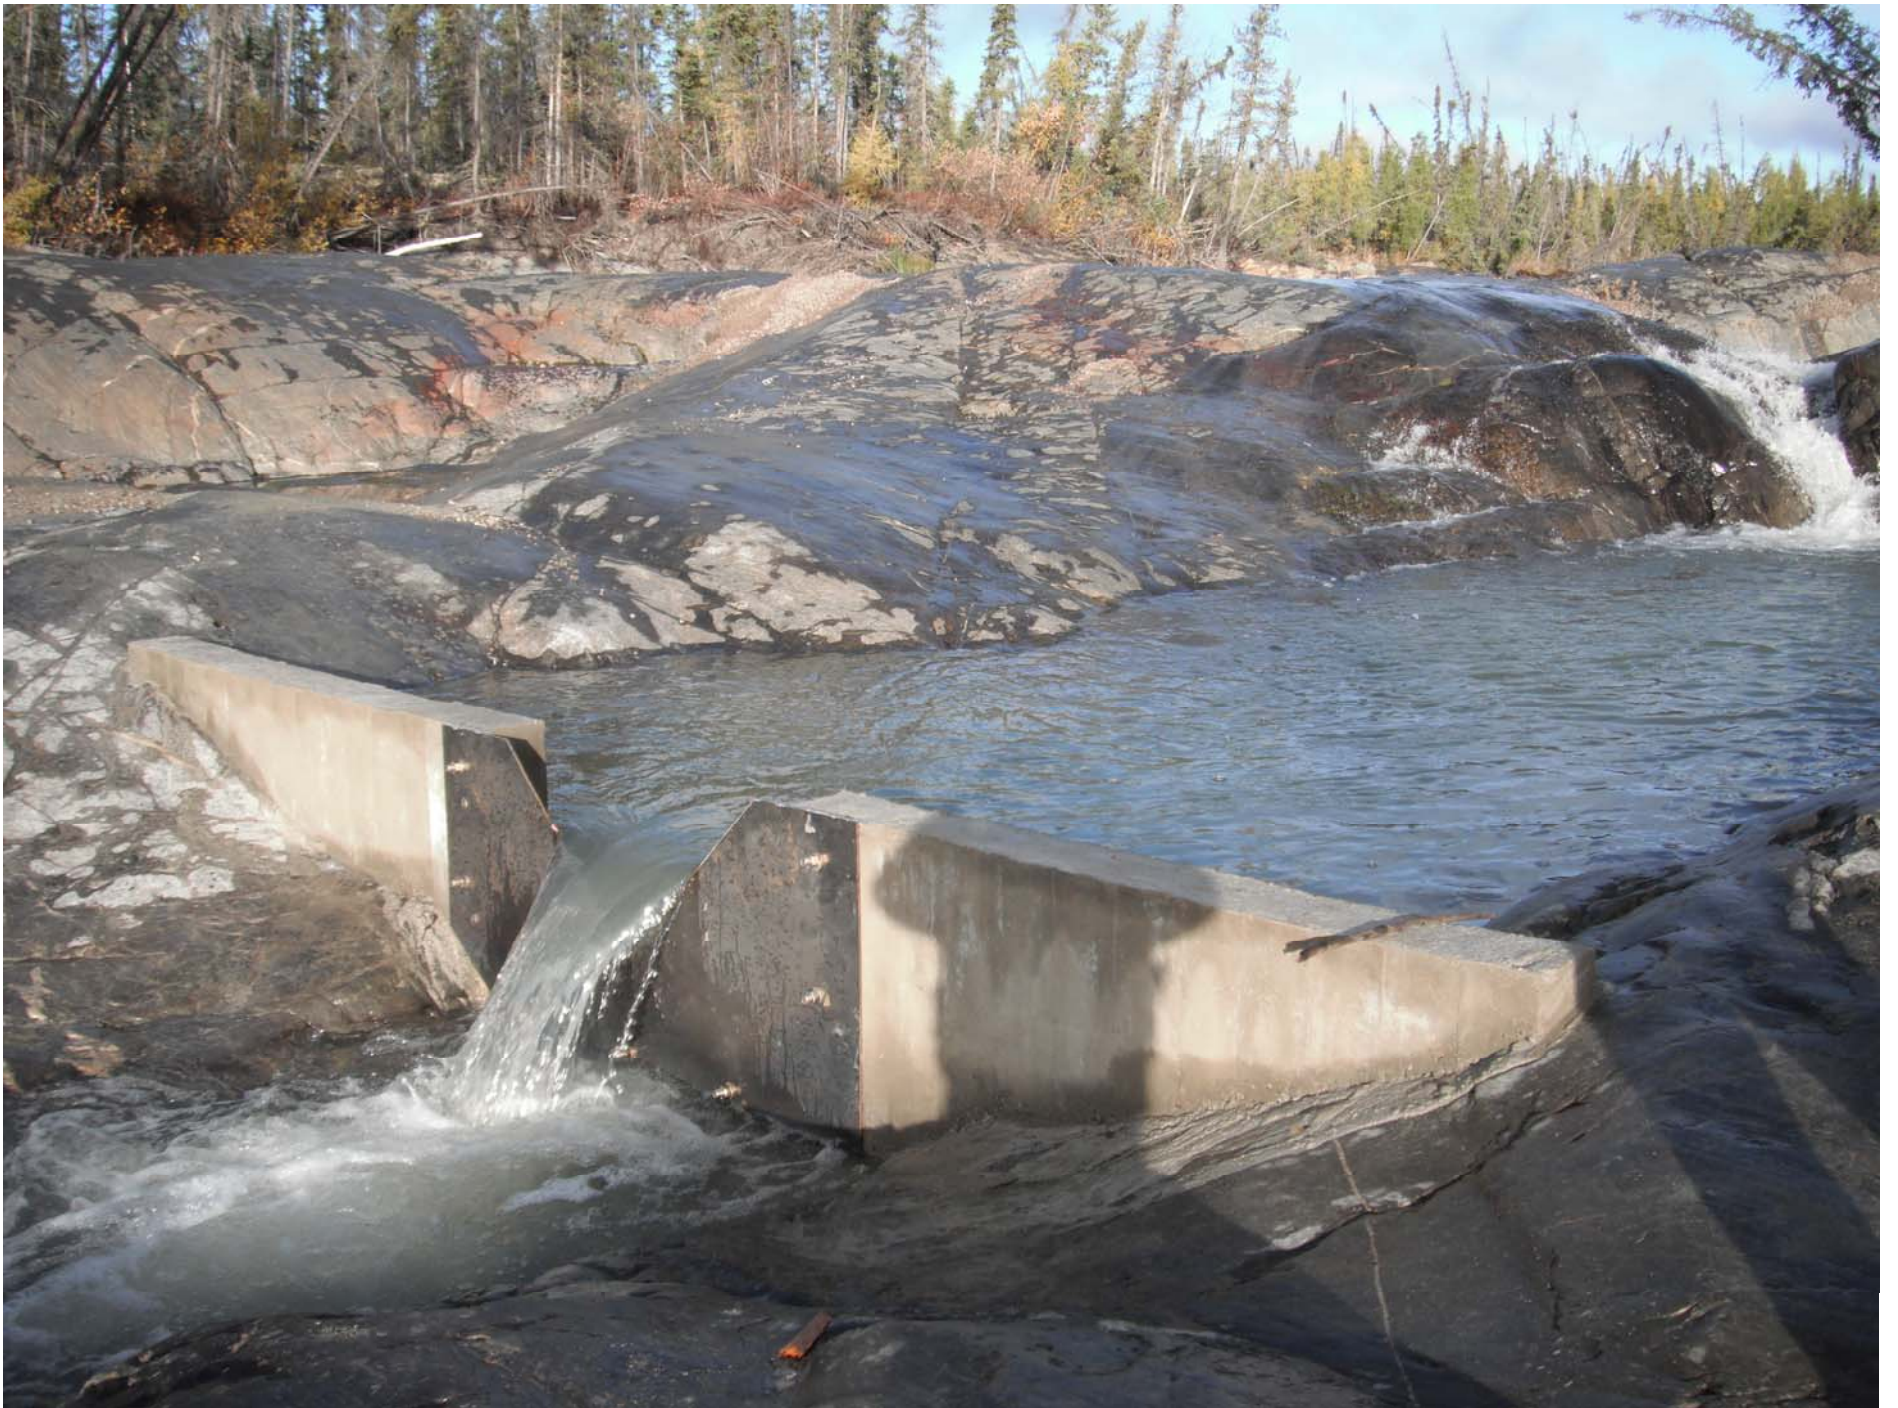
Dyke #1 Weir

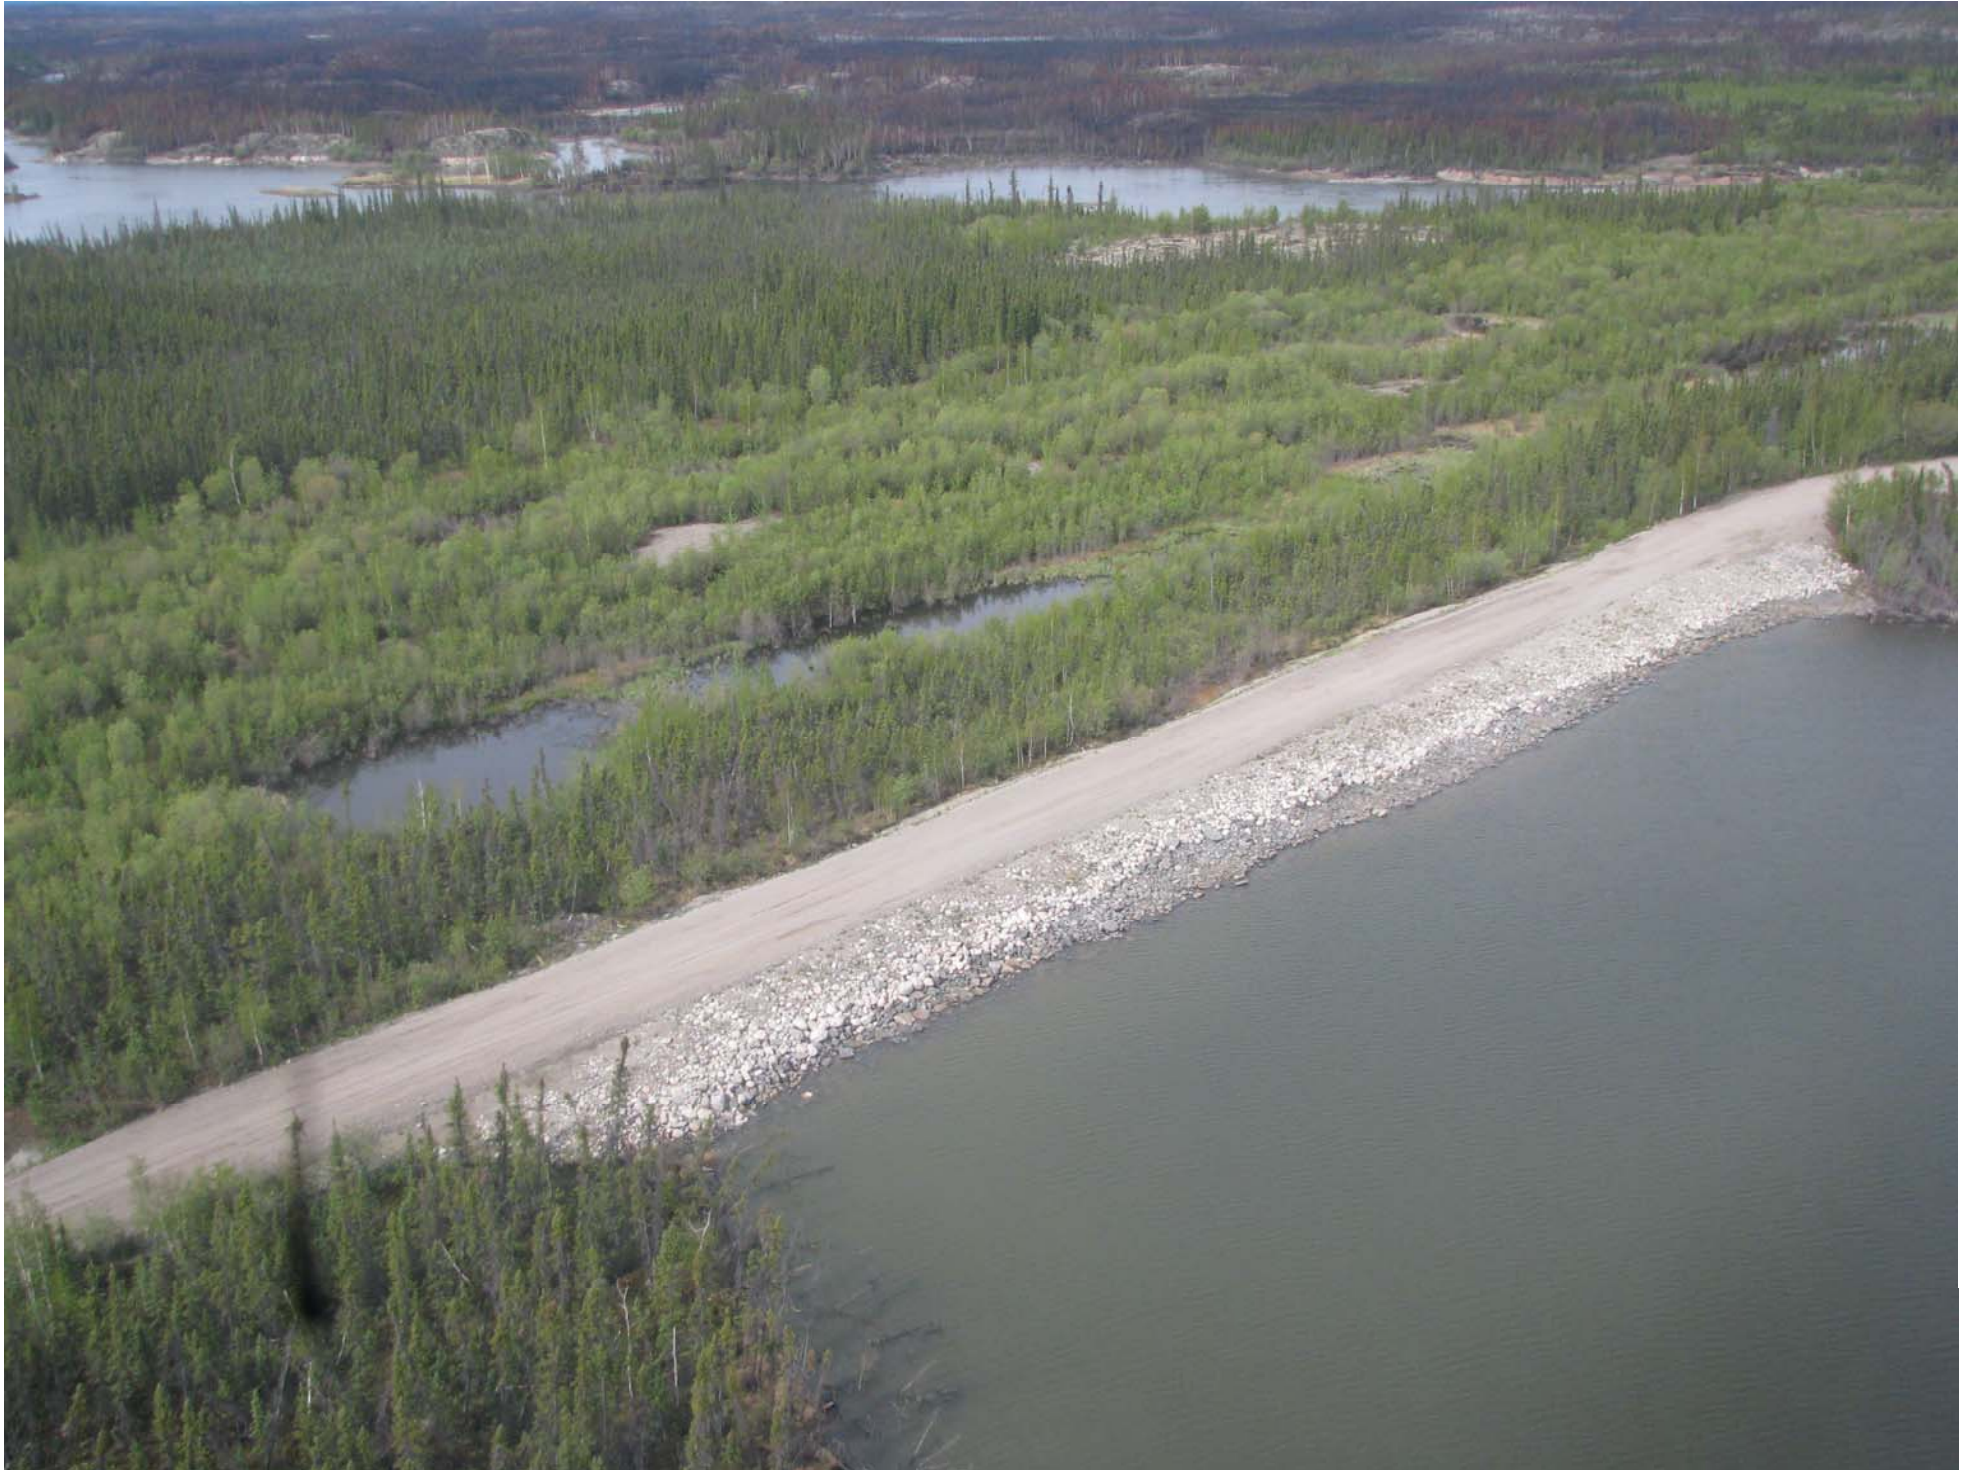
Forks Dyke #2 – Aerial Photo

- A reverse filter was placed on the downstream of the dyke in 2009 to help eliminate the presence of boils found during the 2006 DSR.
- Less vulnerable to foundation settlement (will probably settle if permafrost is lost)
- Not likely to fail due to foundation movement.

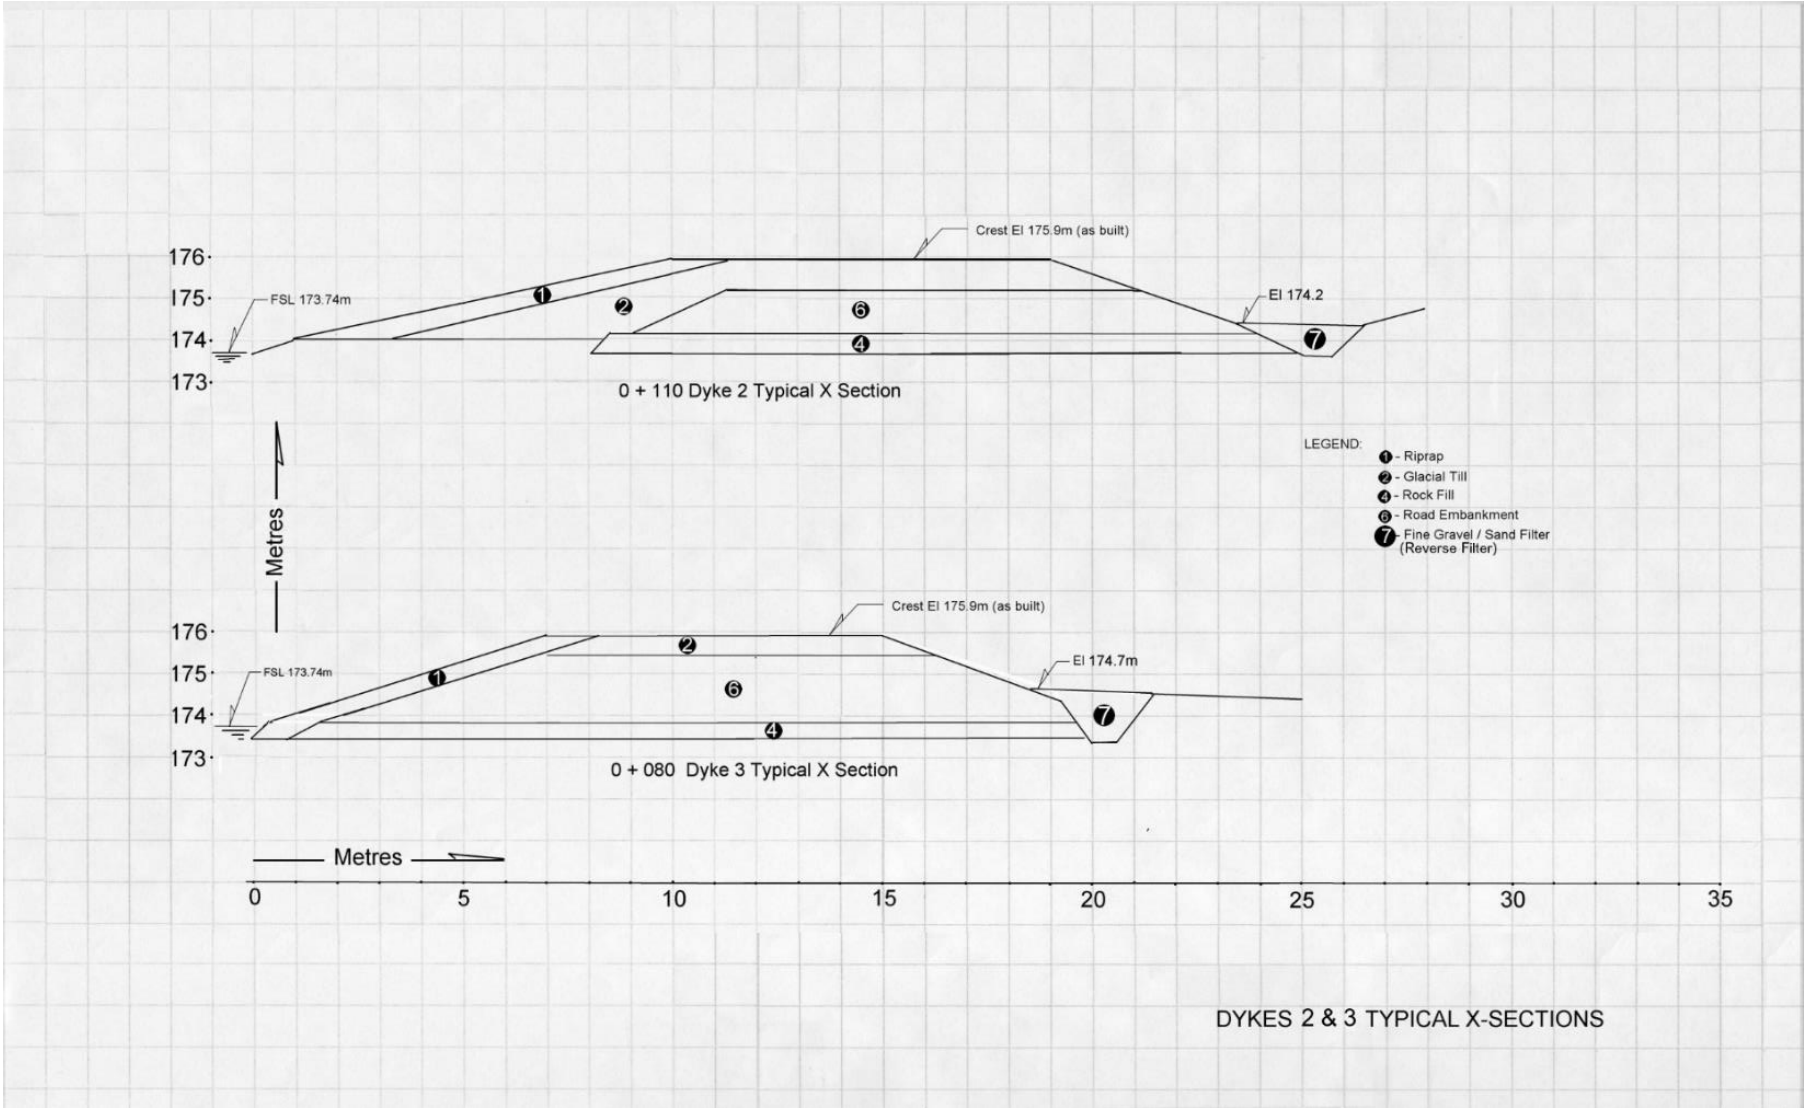
# Forks Dyke 2 & 3 Sections

Figure: Dykes 2 & 3 X-Sections.

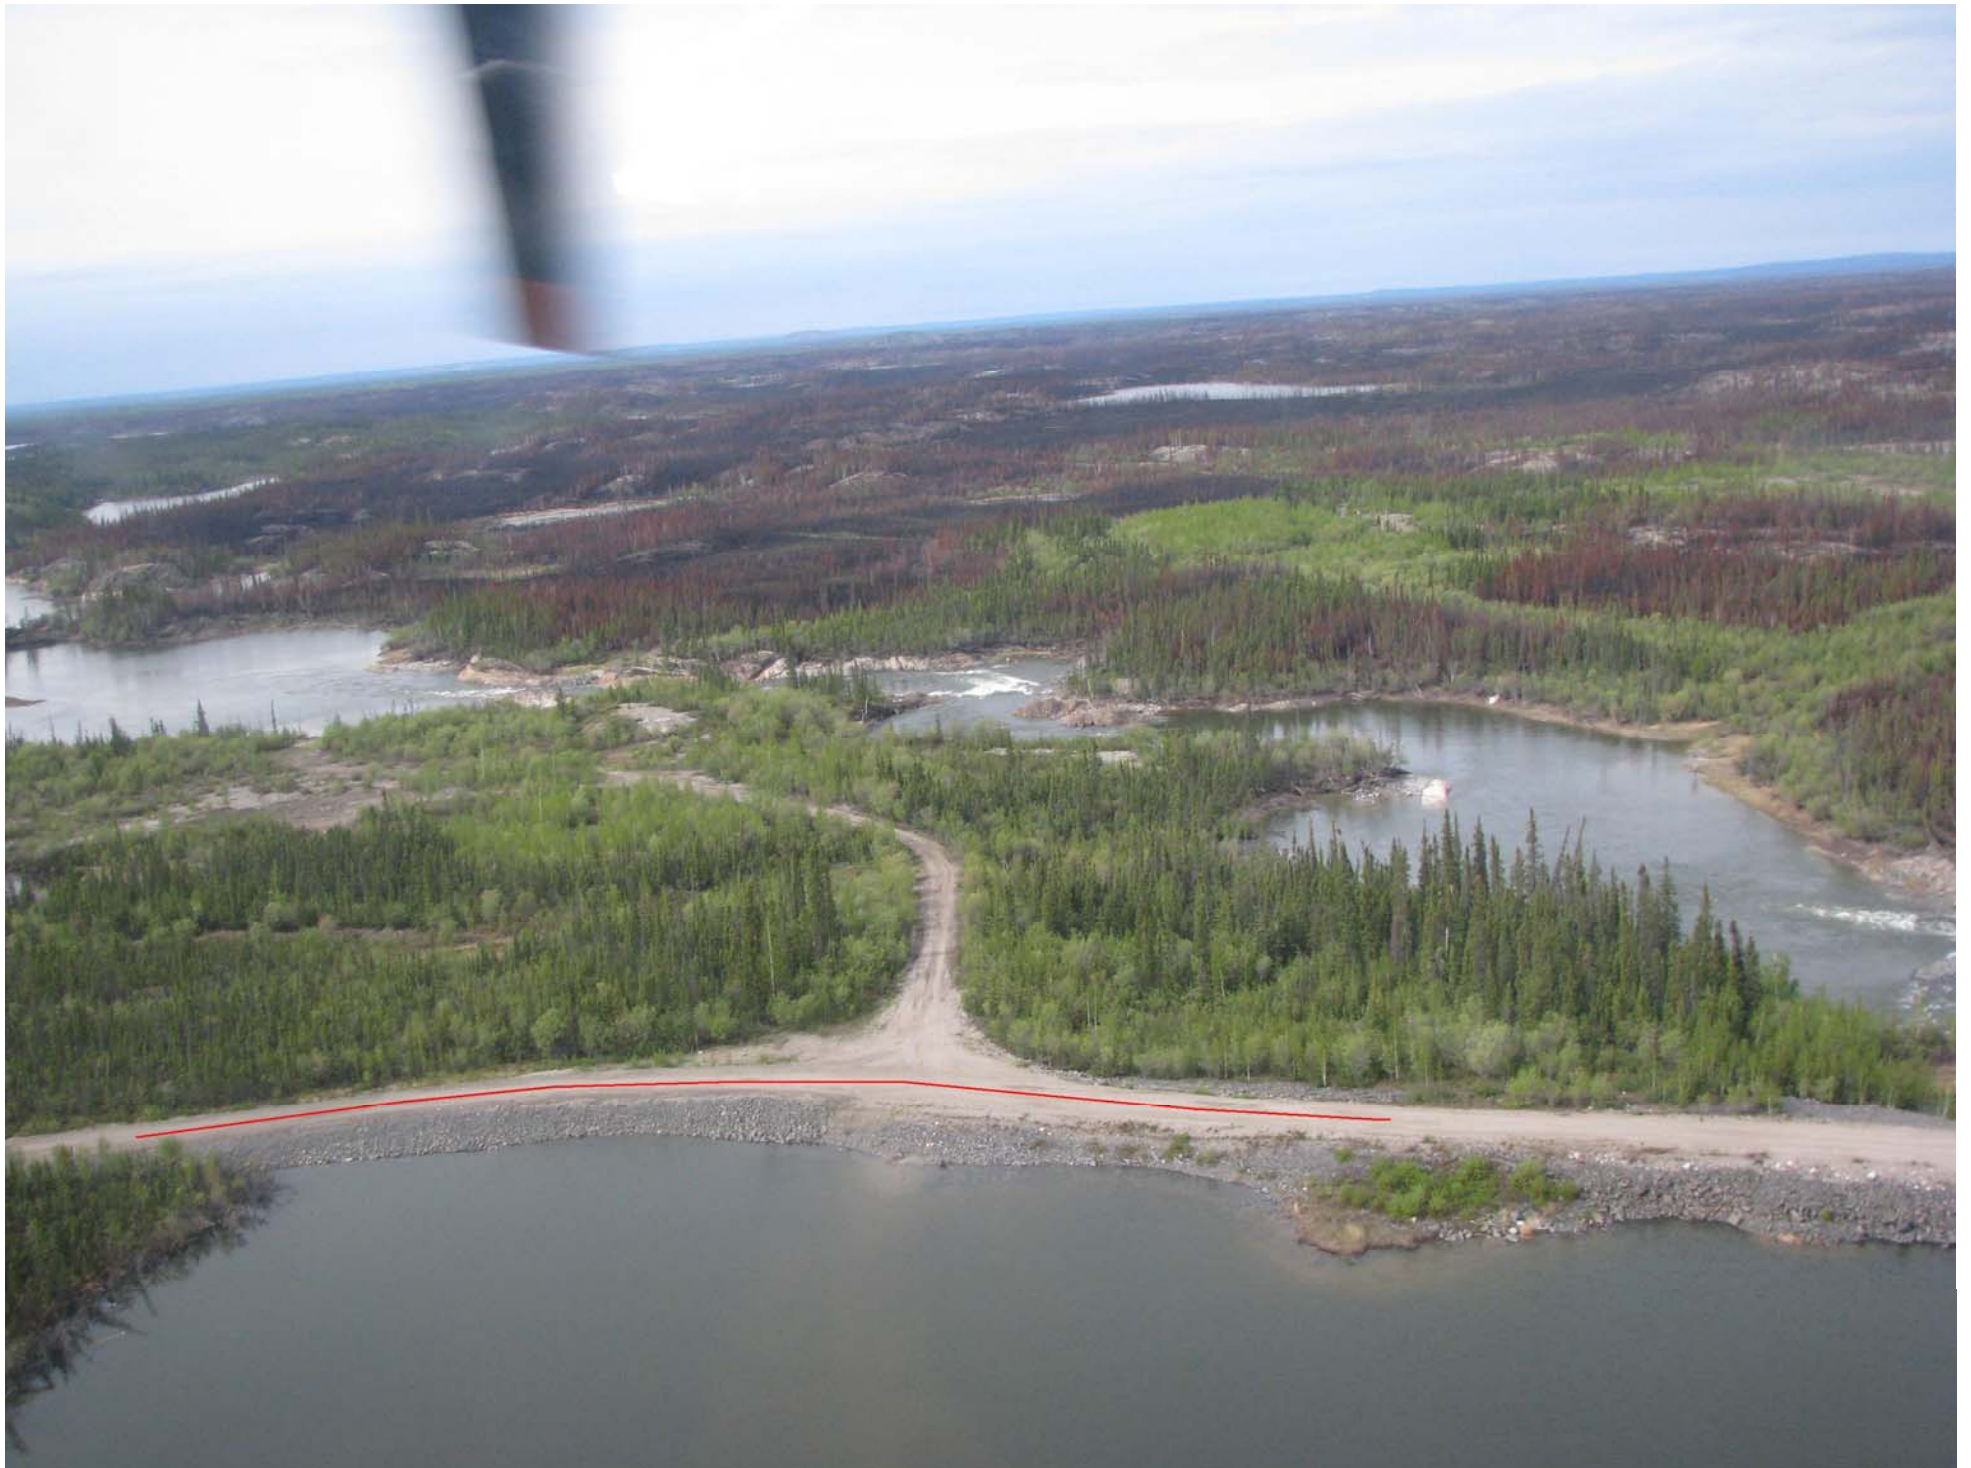
Forks Dyke #3 – Aerial Photo

- Settlement of the dykes may continue due to permafrost melt.
- Crests of all three Forks dykes are surveyed yearly and raised as required to maintain the design elevation.
