**2021 DAM MONITORING  
GUIDE FOR OPERATORS**

**NORTHWEST TERRITORIES  
POWER CORPORATION**

This Document provides information to assist the Operators in the Inspection of the Dams in The Northwest Territories Power Corporation's Hydro System

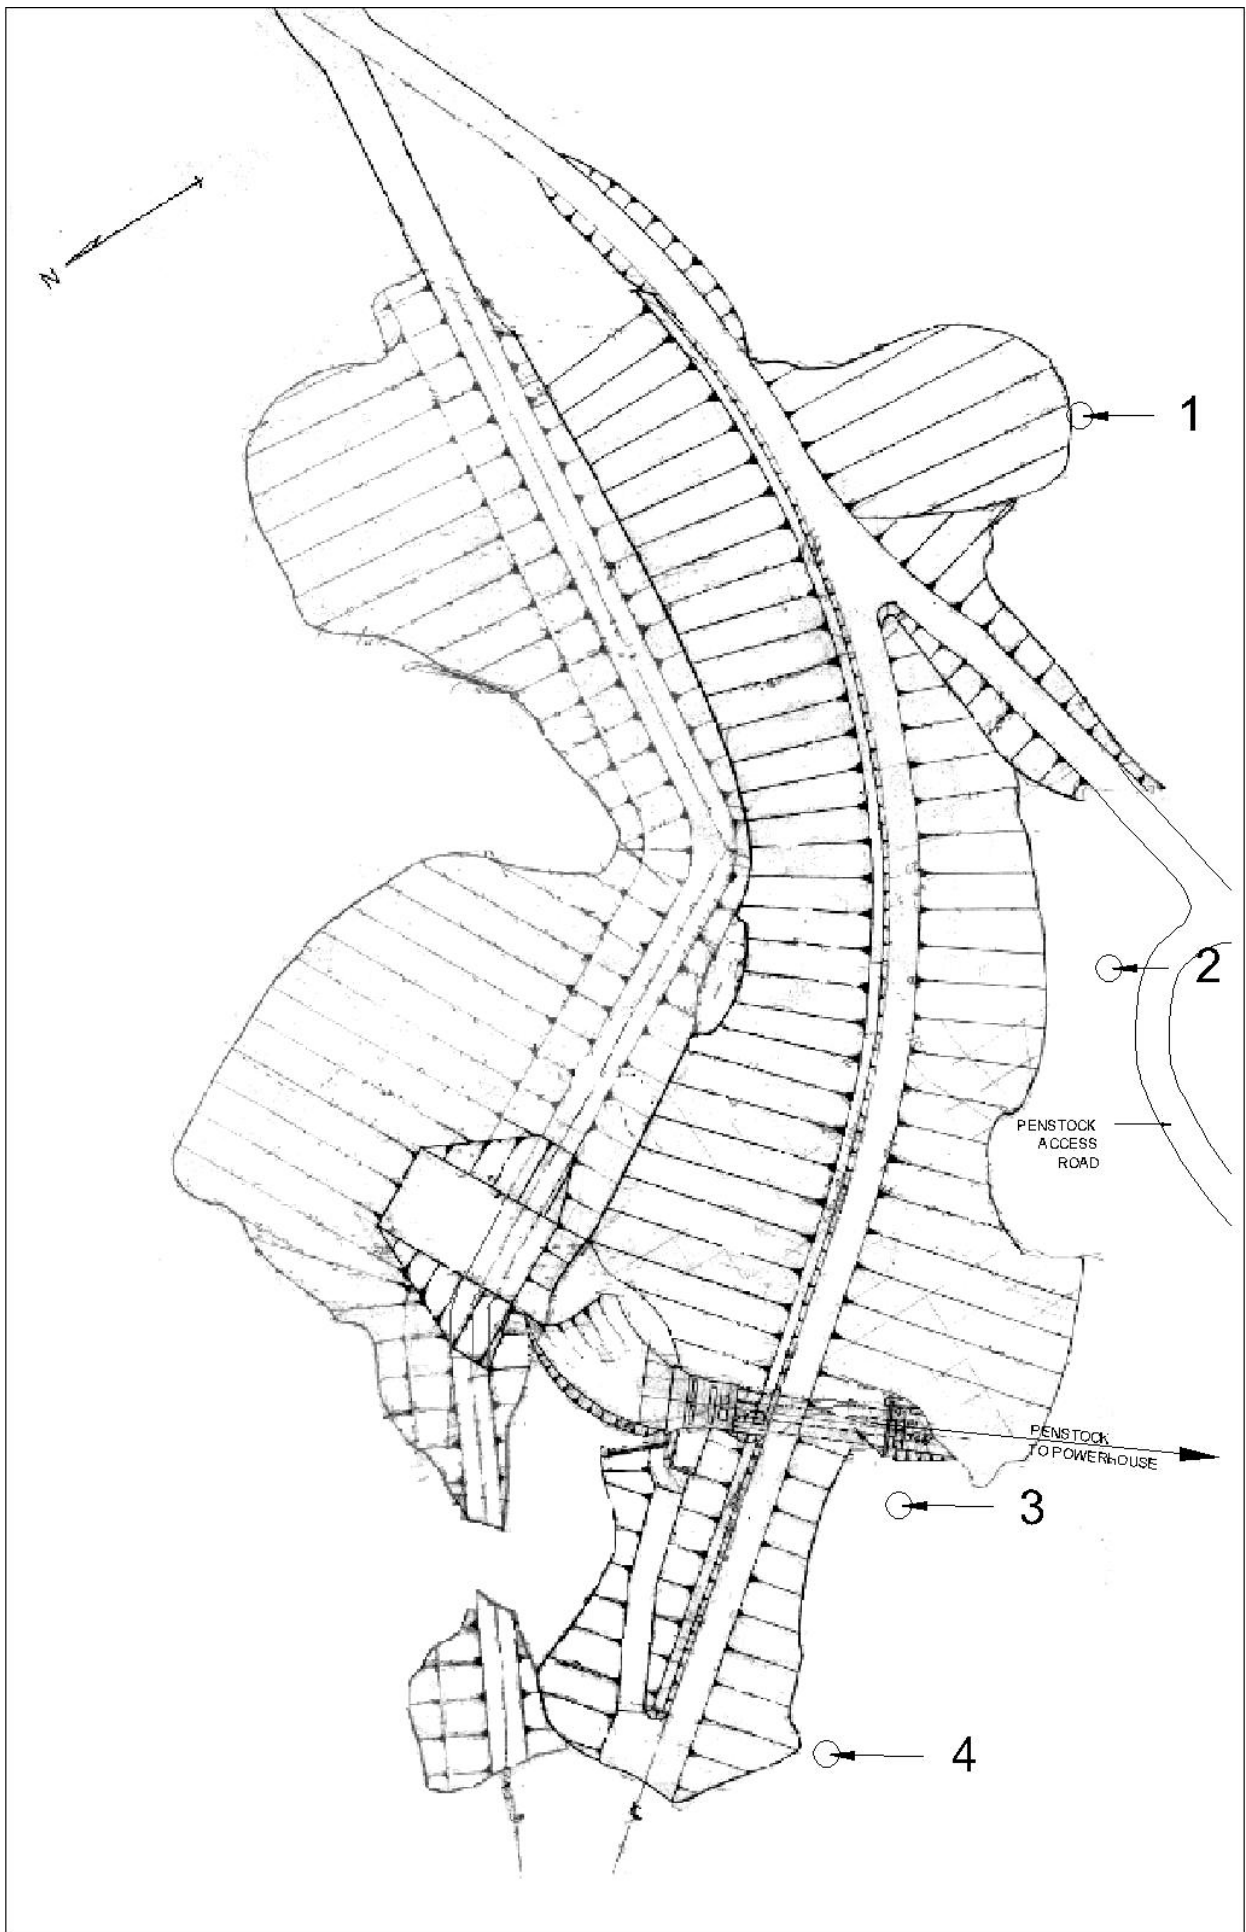
Taltson Dam – Key Plan Showing Seepage Locations

- Occurs between the dam and the large pond at the toe of the dam
- Approximately 2 m from the edge of the large pond.
- Water may be turbid
- May be due to:
  - Inadequate core filtering
  - Piping of infilling in bedrock features not sealed by grouting
  - Piping of native soil beneath the downstream shell of the dam
- Several other small, non-turbid seepages located on various bedrock outcrops

- Located at a bedrock outcrop to the east of the penstock
- Non-turbid
- Only visible at the source
- Seepage rate varies throughout the year
- Causes ice build-up on the access road

- Seepage located in gorge on the east side of the powerhouse
- Likely due to regional groundwater discharge
- Has caused severe ice build-up in the past and continues to cause ice build-up
- Seepage collection and discharge measures include:
  - Covered and heated concrete catch basins and
  - Heat traced discharge pipes

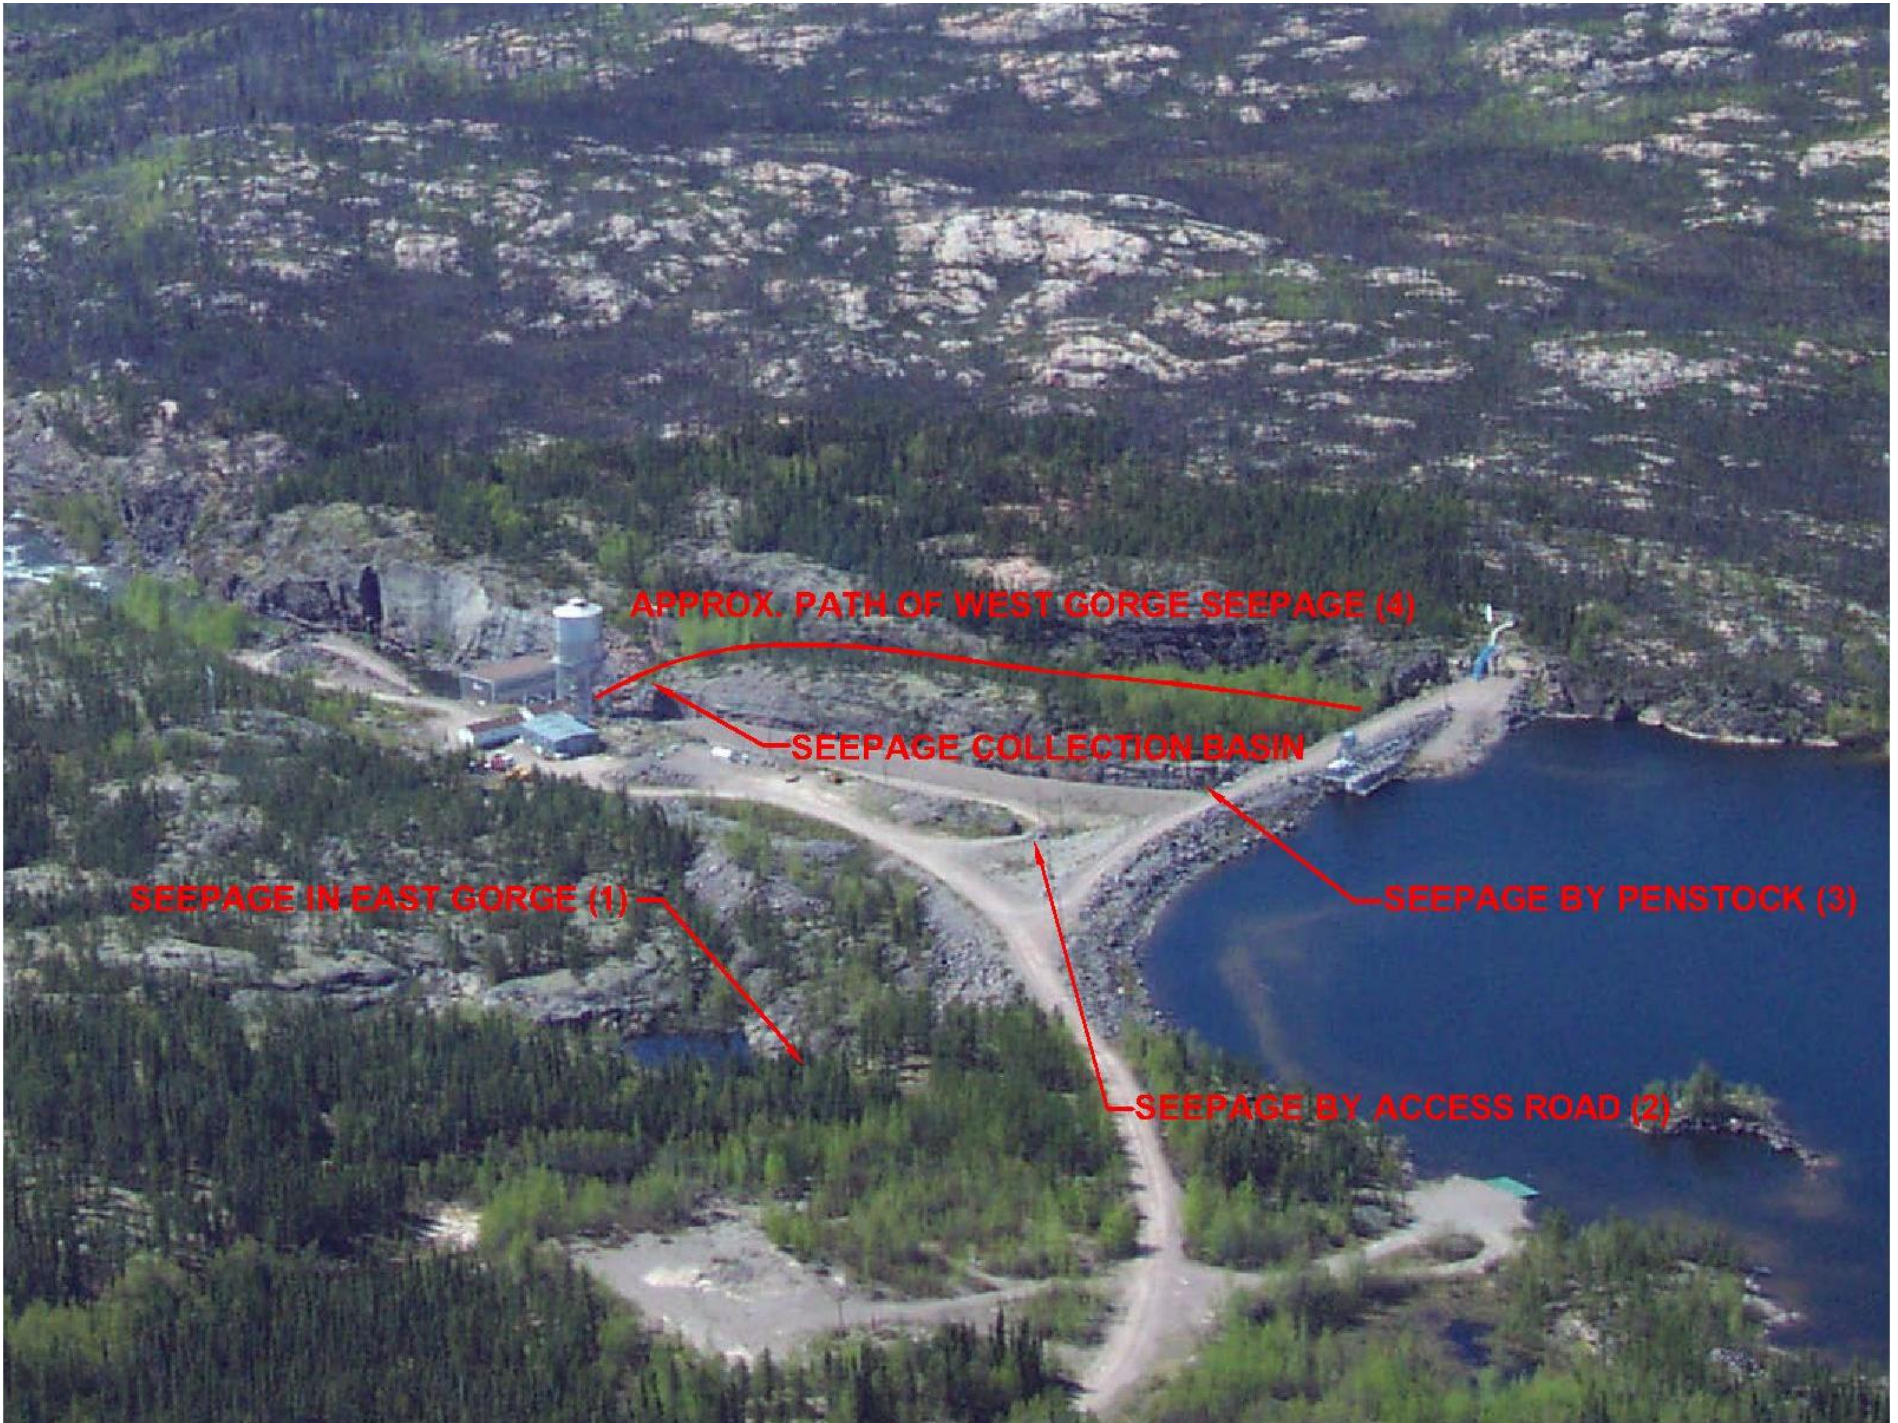
Taltson Dam – Aerial Photo Showing Seepage Locations

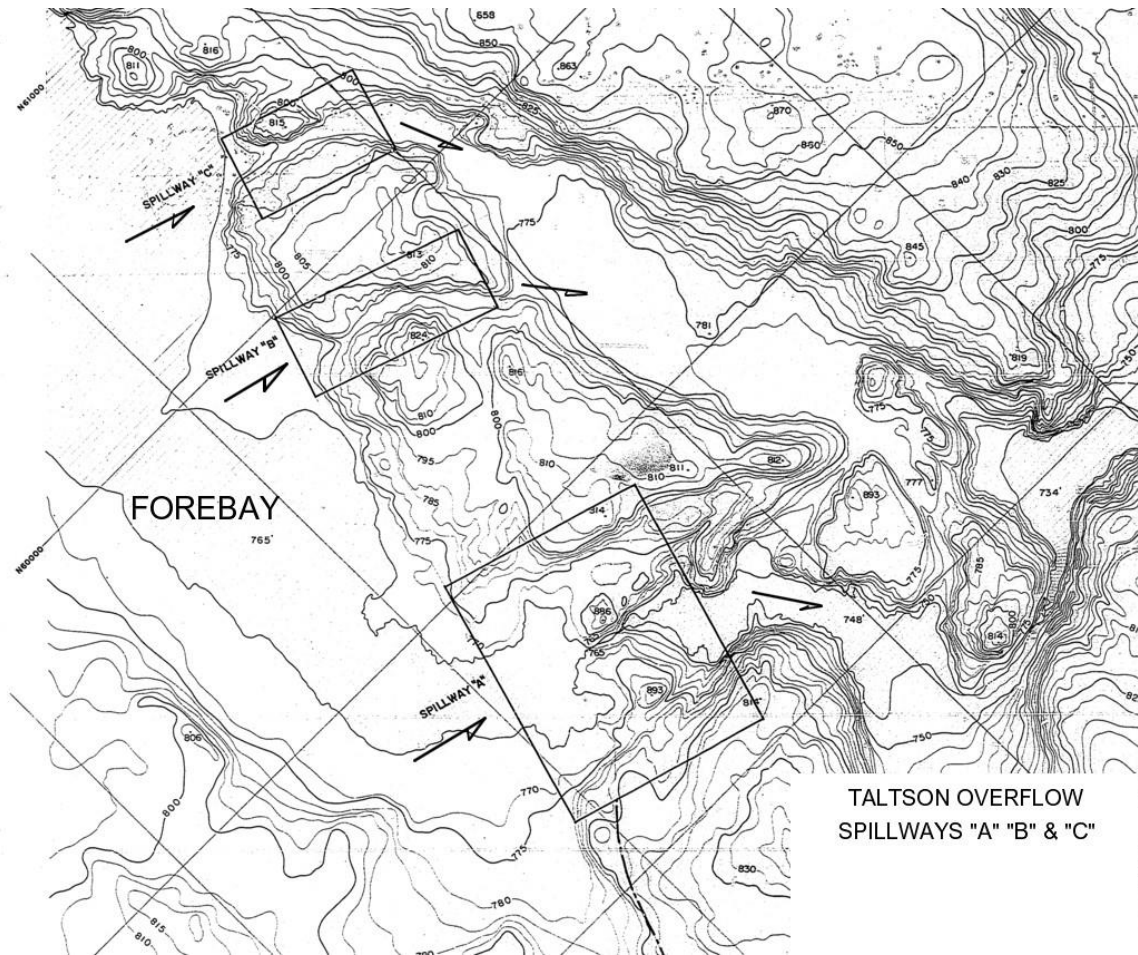
Figure 11. TALTSON SOUTH VALLEY SPILLWAYS.

Shows the topography at the Taltson Overflow Spillways at Sections A, B & C. The channels A & C are provided with a concrete sill overflow. The flow through Section B is contained in a rock cut without a concrete sill.

**Structure:** South Valley Spillway  
**Location:** Approximately 6 km northeast of the Twin Gorges.  
**Constructed:** 1966  
**Type:** Two reinforced concrete ogee-type weirs separated by a rock outcrop, and a third small natural channel  
**Length:** 200 m  
**Height:** 6 m  
**Foundation:** Bedrock  
**CDA Consequence**  
**Classification:** High, due to economics  
**Crest Elevation<sup>1</sup>:** 239.27 m (785.0 ft)  
**Allowable Res. Levels<sup>2</sup>:** Minimum: 238.90 m (783.8 ft)  
Normal Max: 239.27 m (785.0 ft)  
High Flow Max: 240.90 m (790.4 ft)

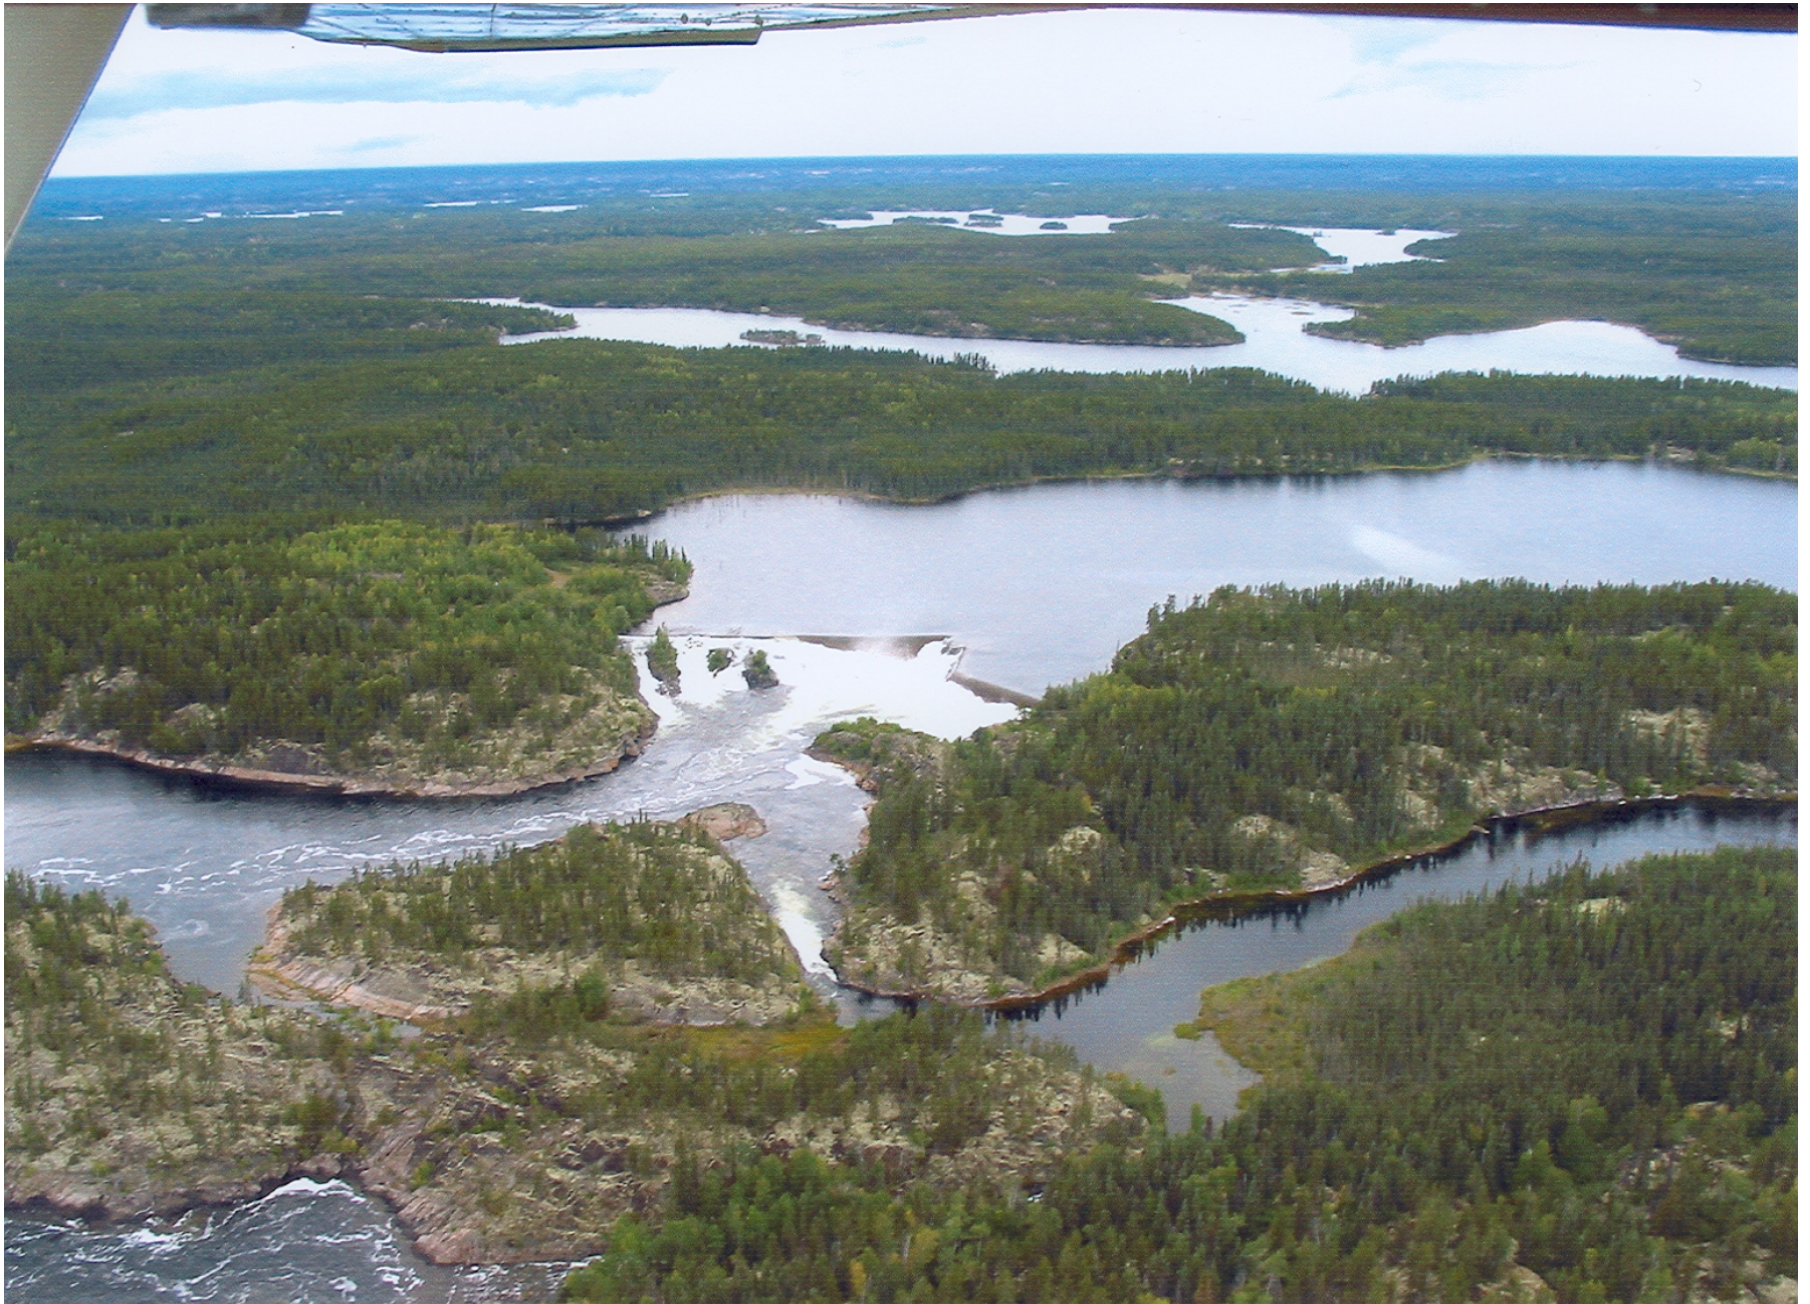
South Valley Spillway – Aerial Photo

- Most vulnerable to deformation from ice loading. However, ice loading does not currently occur since water is constantly spilling.
- The spillway has been in overflow mode for the past 33 years since the Pine Point Mine closed in 1988.
- Potential for erosion at concrete/bedrock contacts and at the crest.
- Not likely to fail due to foundation movement or settlement.

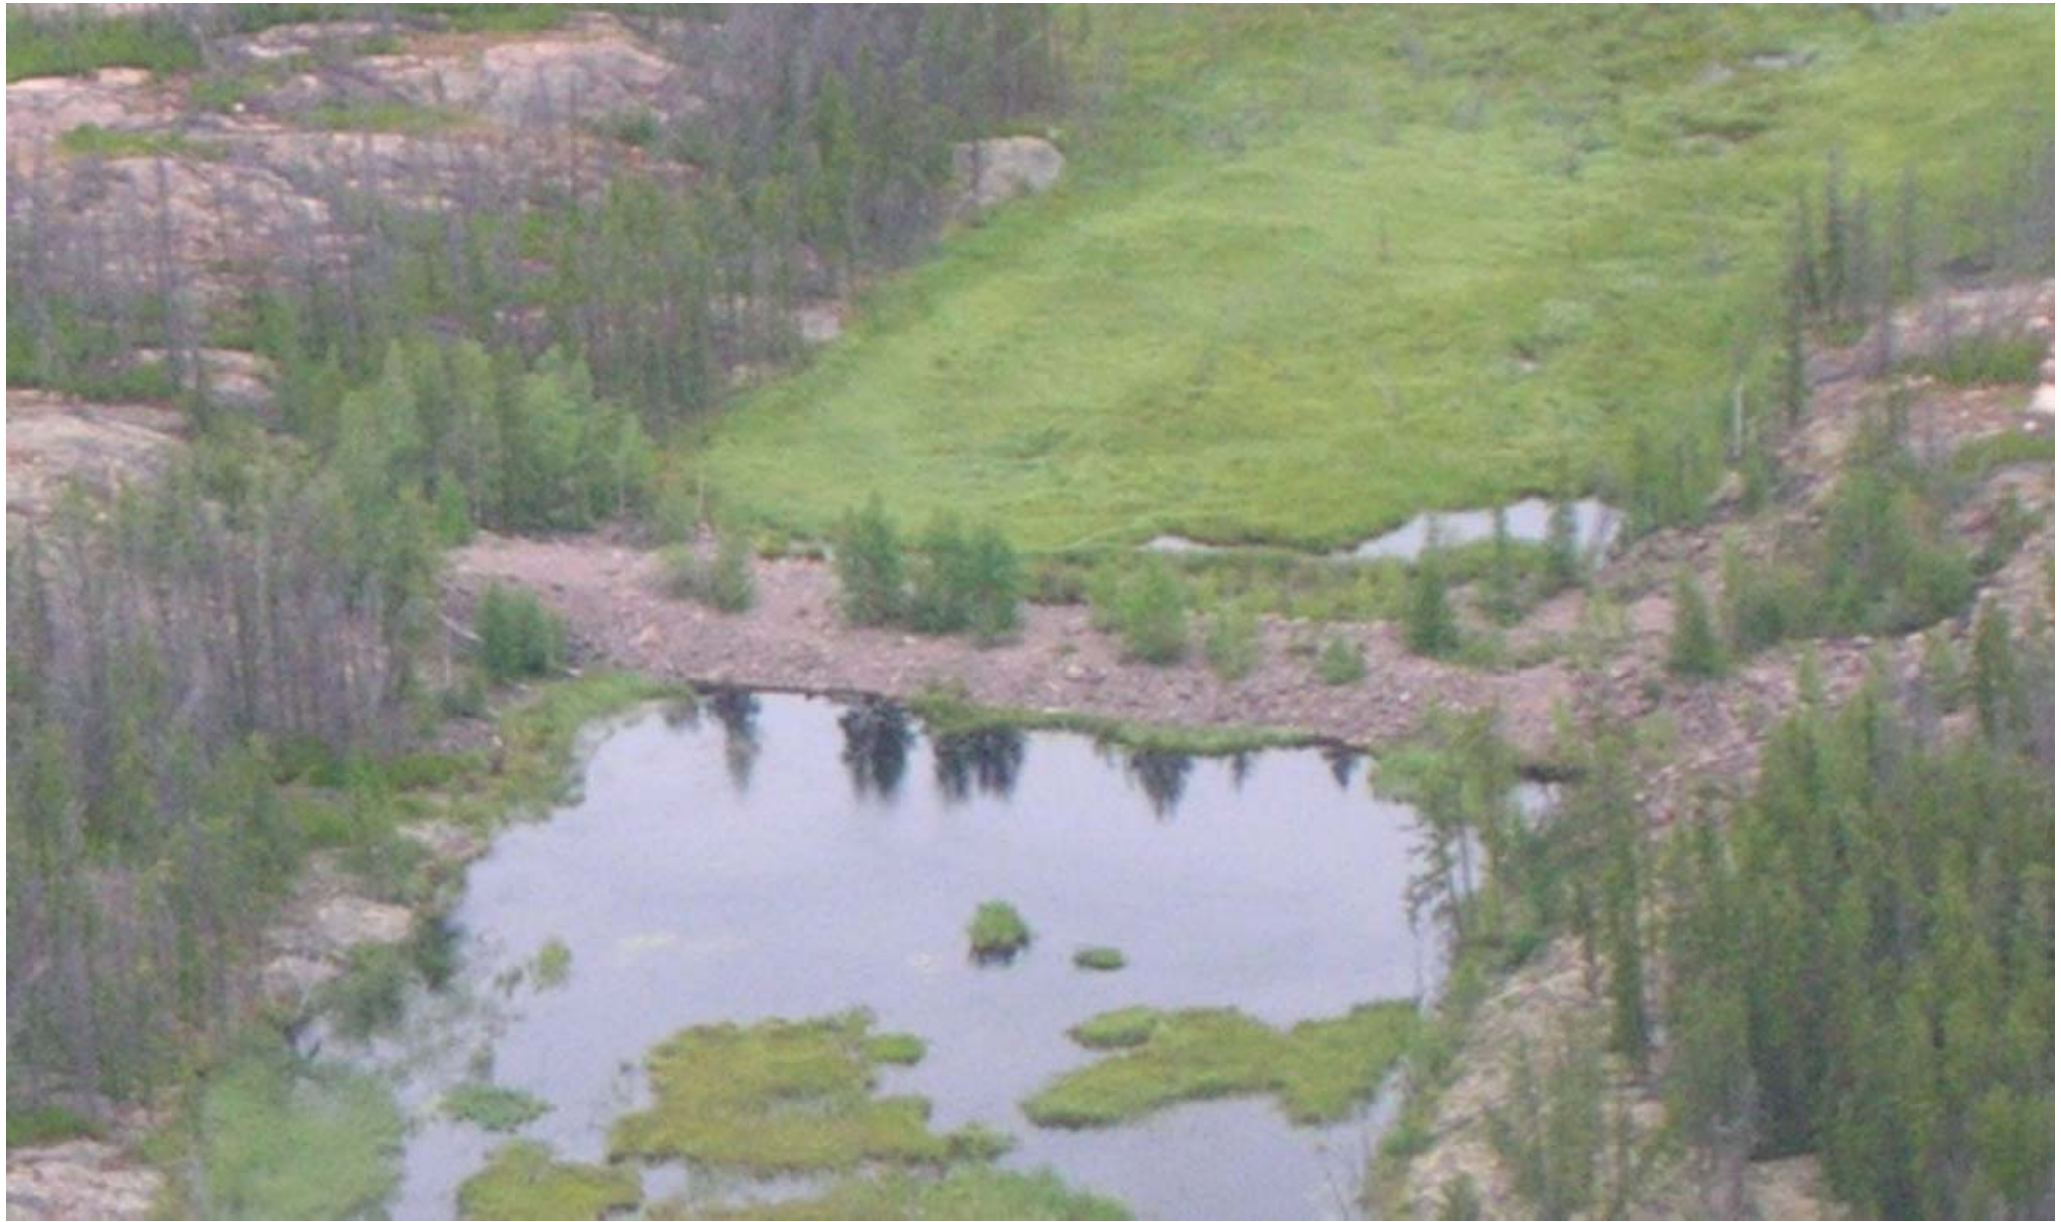
North Valley Dam – Aerial Photo

**Structure:** North Valley Freeboard Dam  
**Location:** Approximately 4 km north of the Twin Gorges.  
**Constructed:** 1966  
**Type:** Rock Fill Embankment  
**Core:** None  
**Length:** 95m (312ft)  
**Height:** 2.44 m (8.0 ft)  
**Foundation:** Bedrock  
**CDA Consequence**  
**Classification:** High, due to economics  
**Elevations:** Crest: 243.39m  
Spillway<sup>1</sup>: 239.27 m (785.0 ft)  
**Allowable Res. Levels**<sup>2</sup>: Minimum: 238.90 m (783.8 ft)  
Normal Max: 239.27 m (785.0 ft)  
High Flow Max: 240.90 m (790.4 ft)

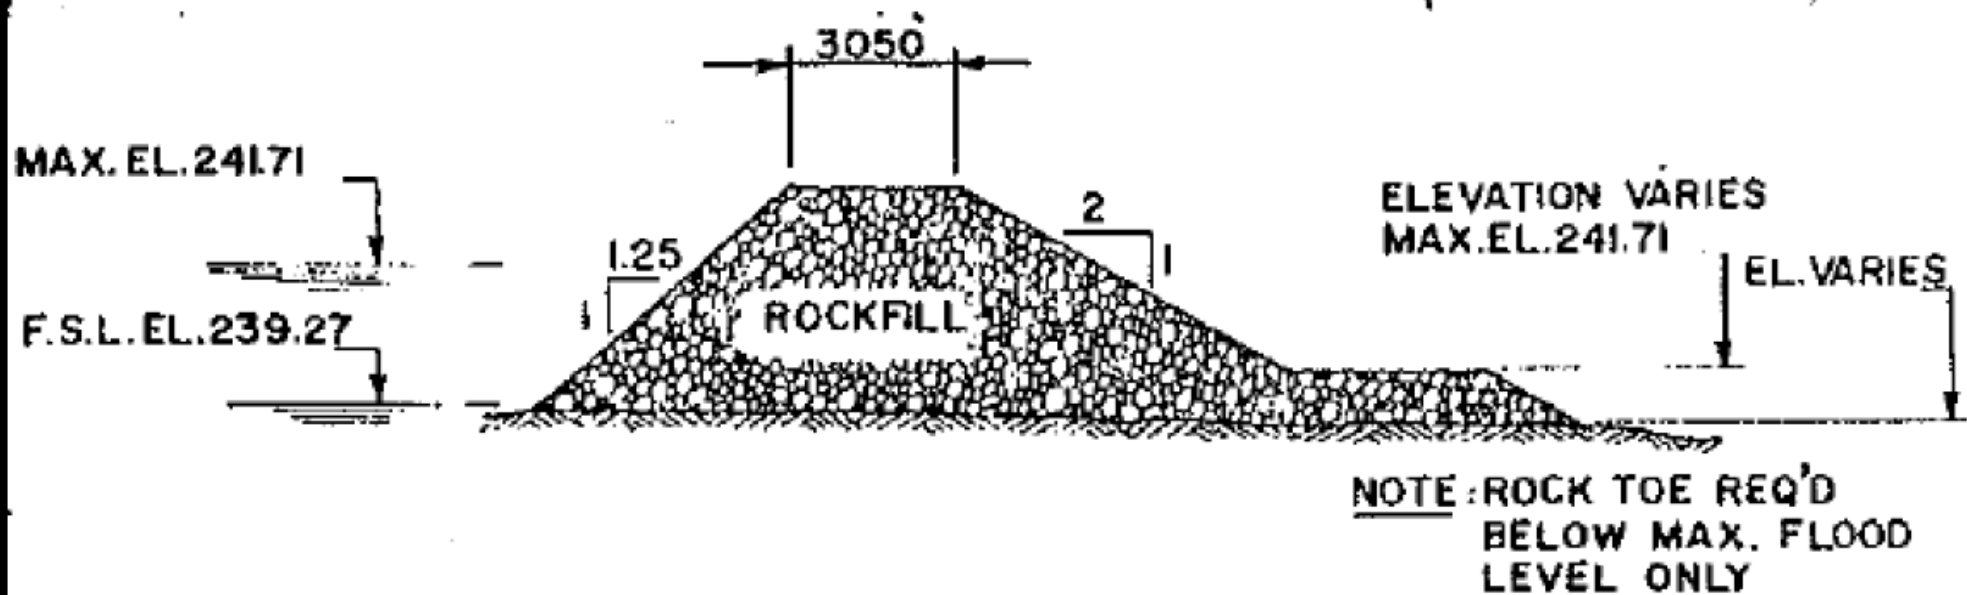
SECTION THROUGH NORTH VALLEY DAM

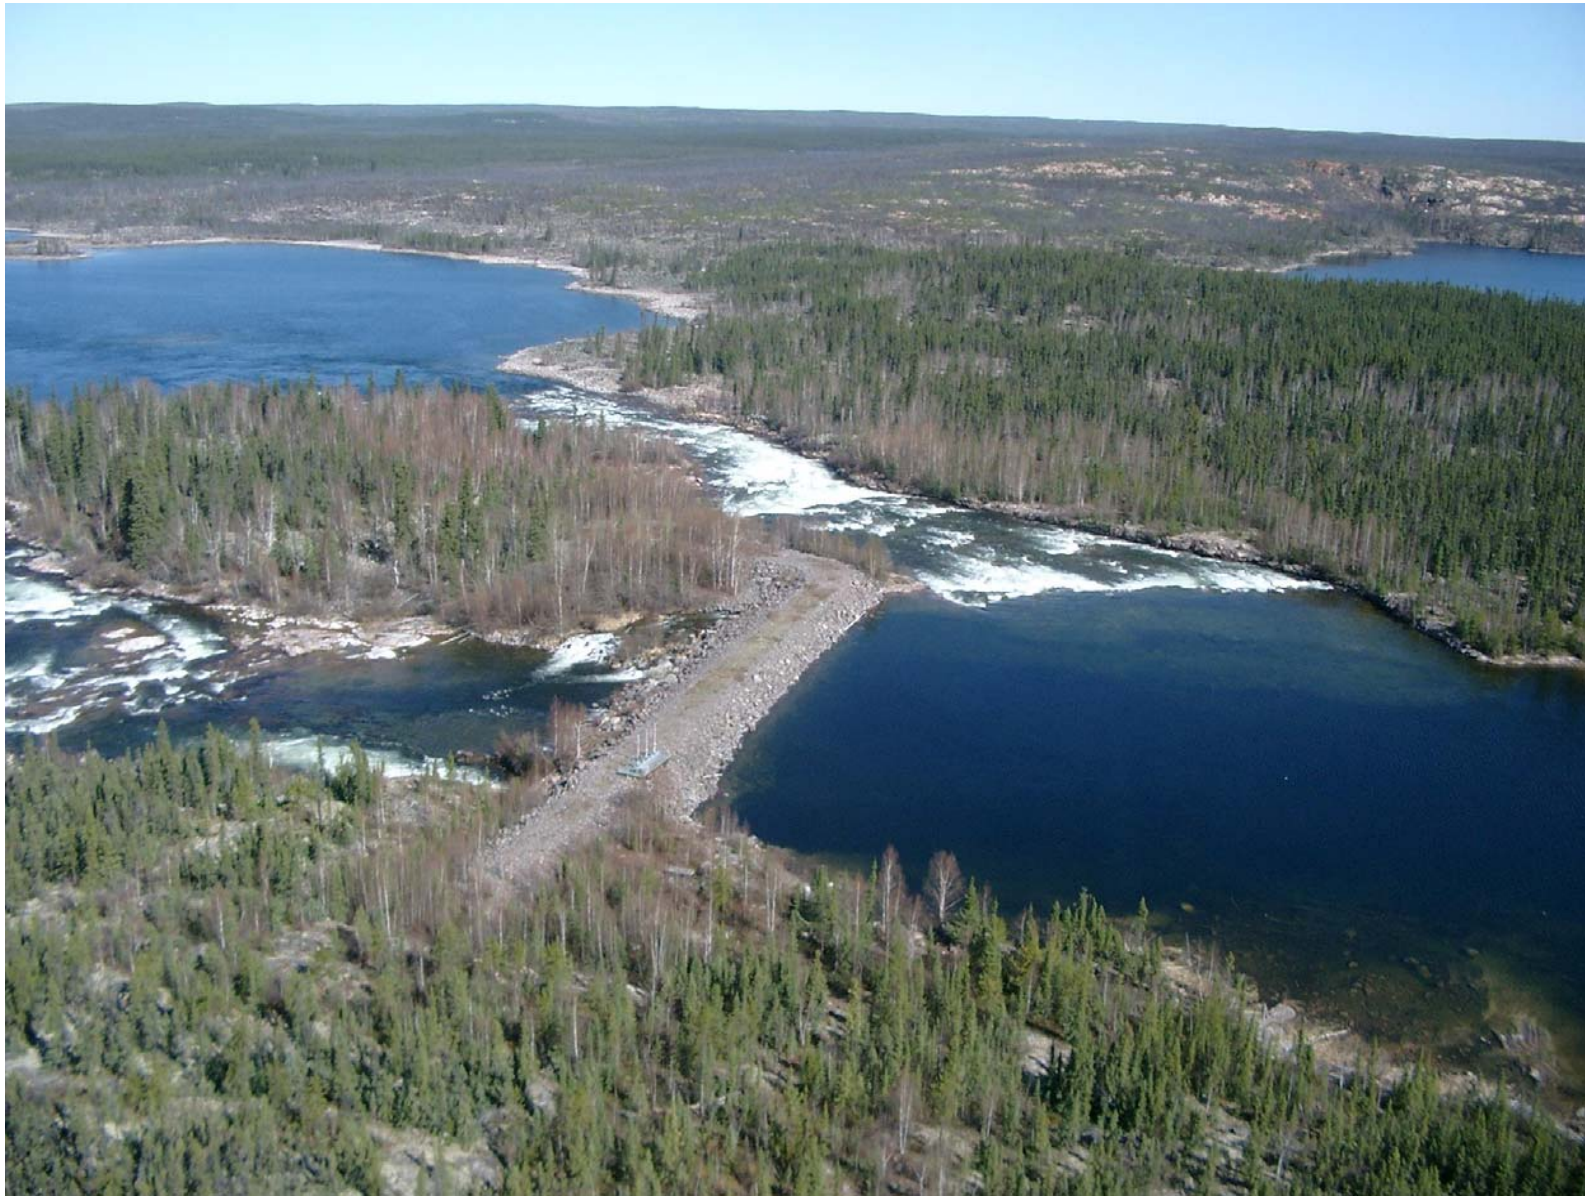
Nonacho Lake Control Structure

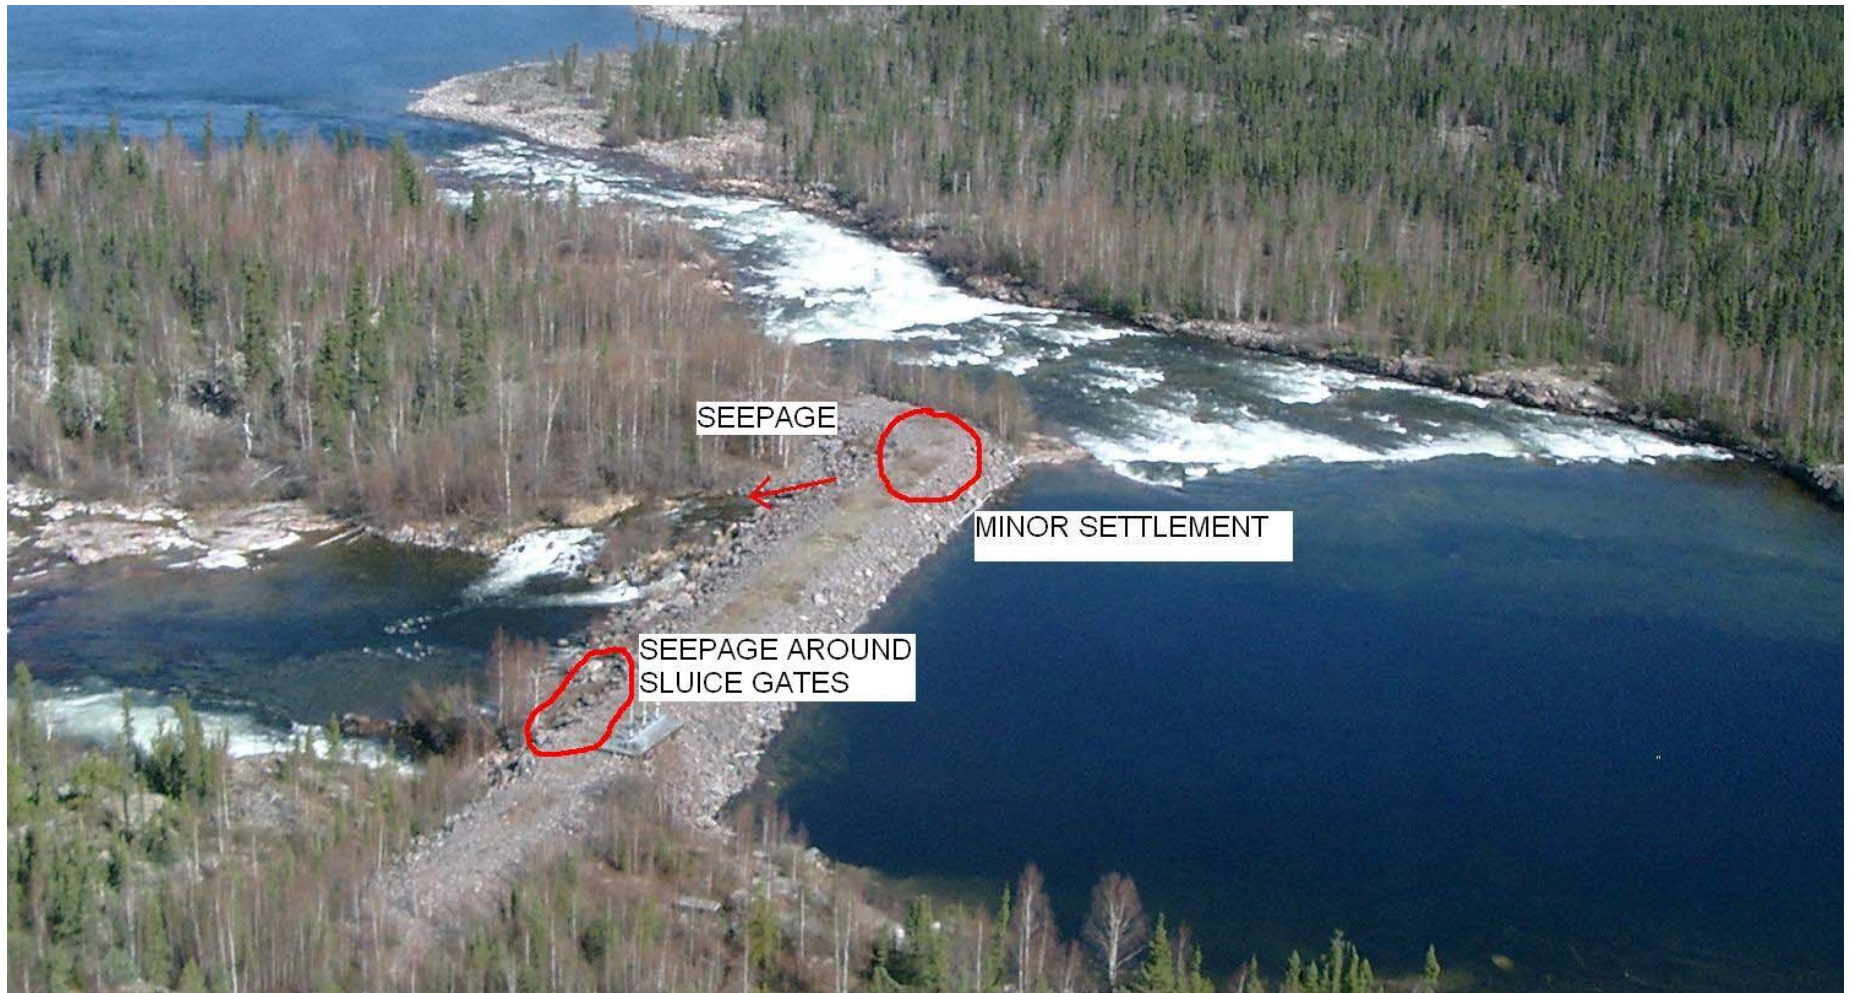
Nonacho Lake Control Structure – Seepage and Settlement Locations

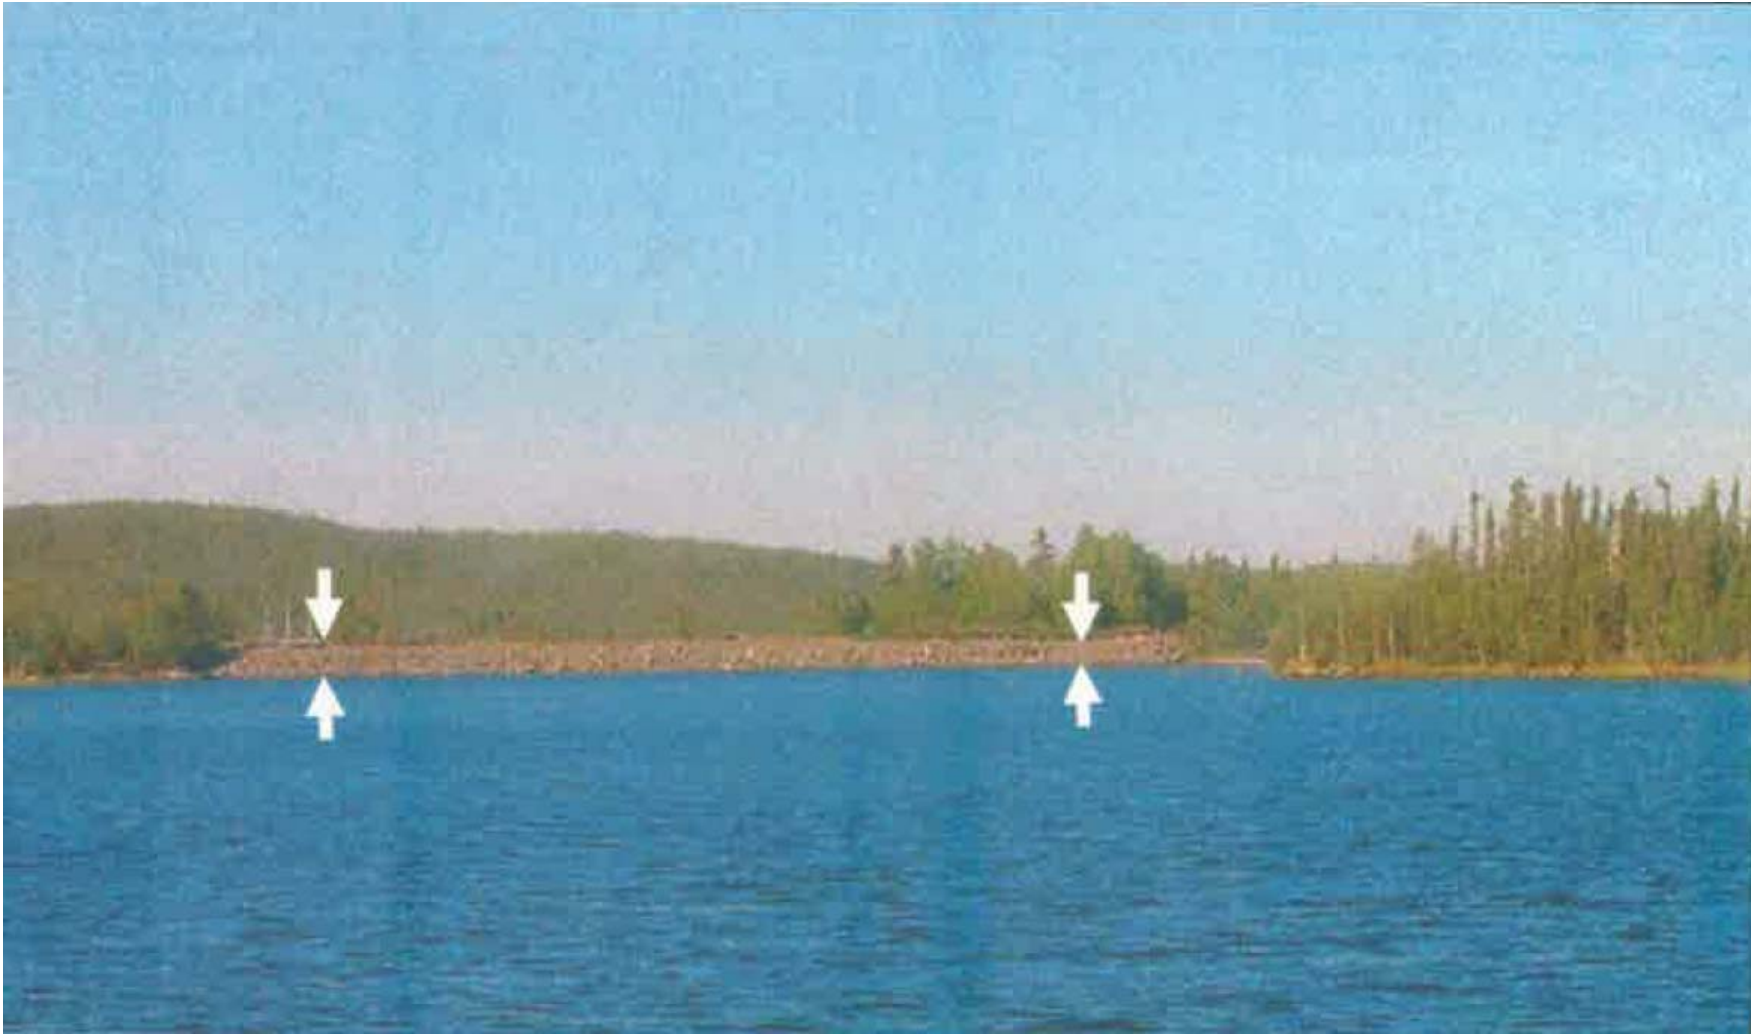
Settlement on the right near the right abutment

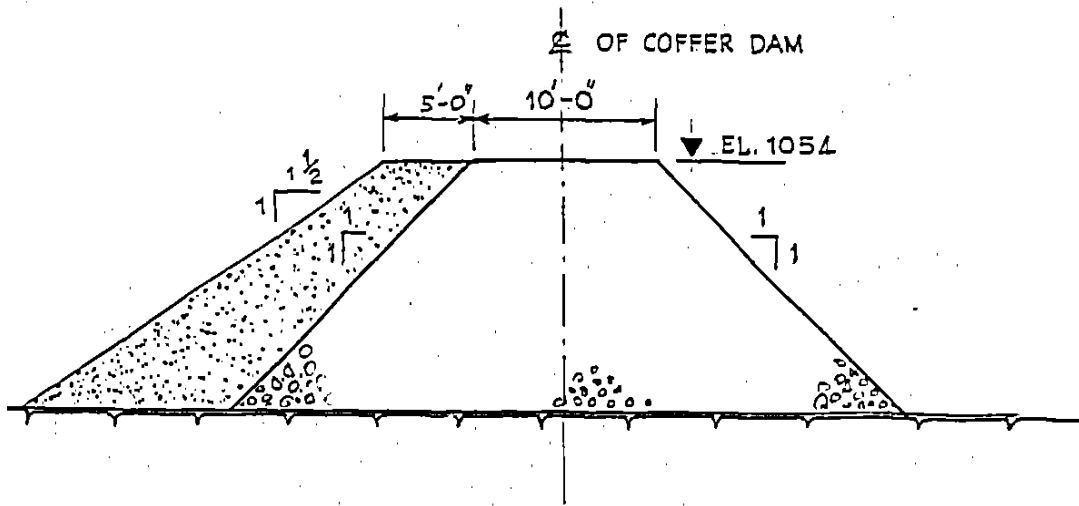
Typical Cross Section

SCALE 1" = 10'-0"

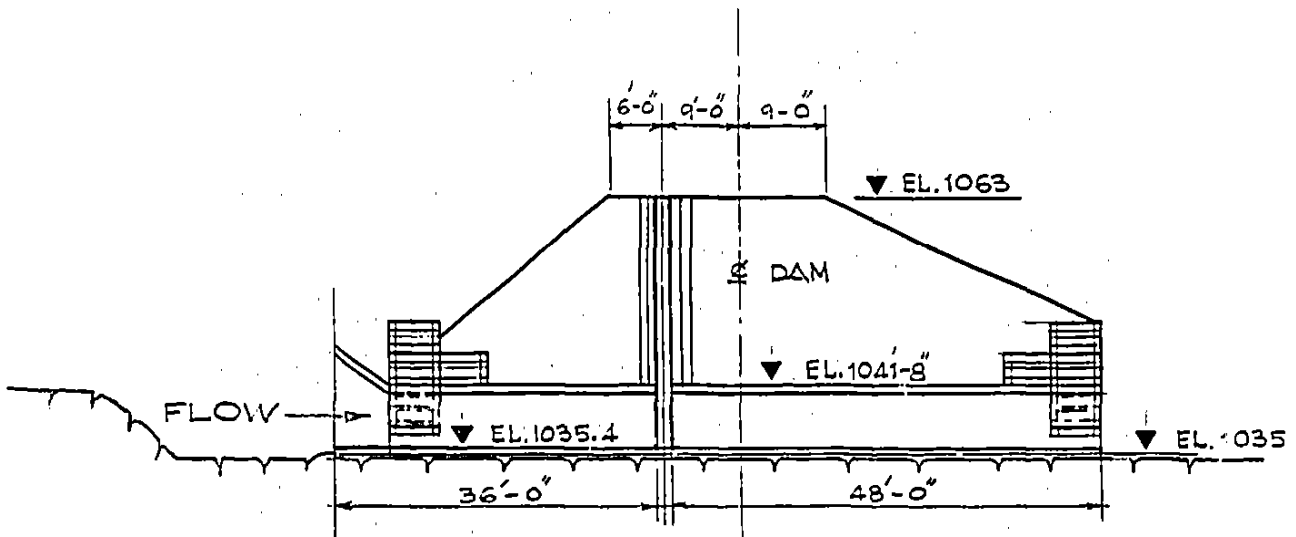
SECTION A-A

SCALE 1" = 20'-0"

Nonacho Lake Control Structure – Cross Sections

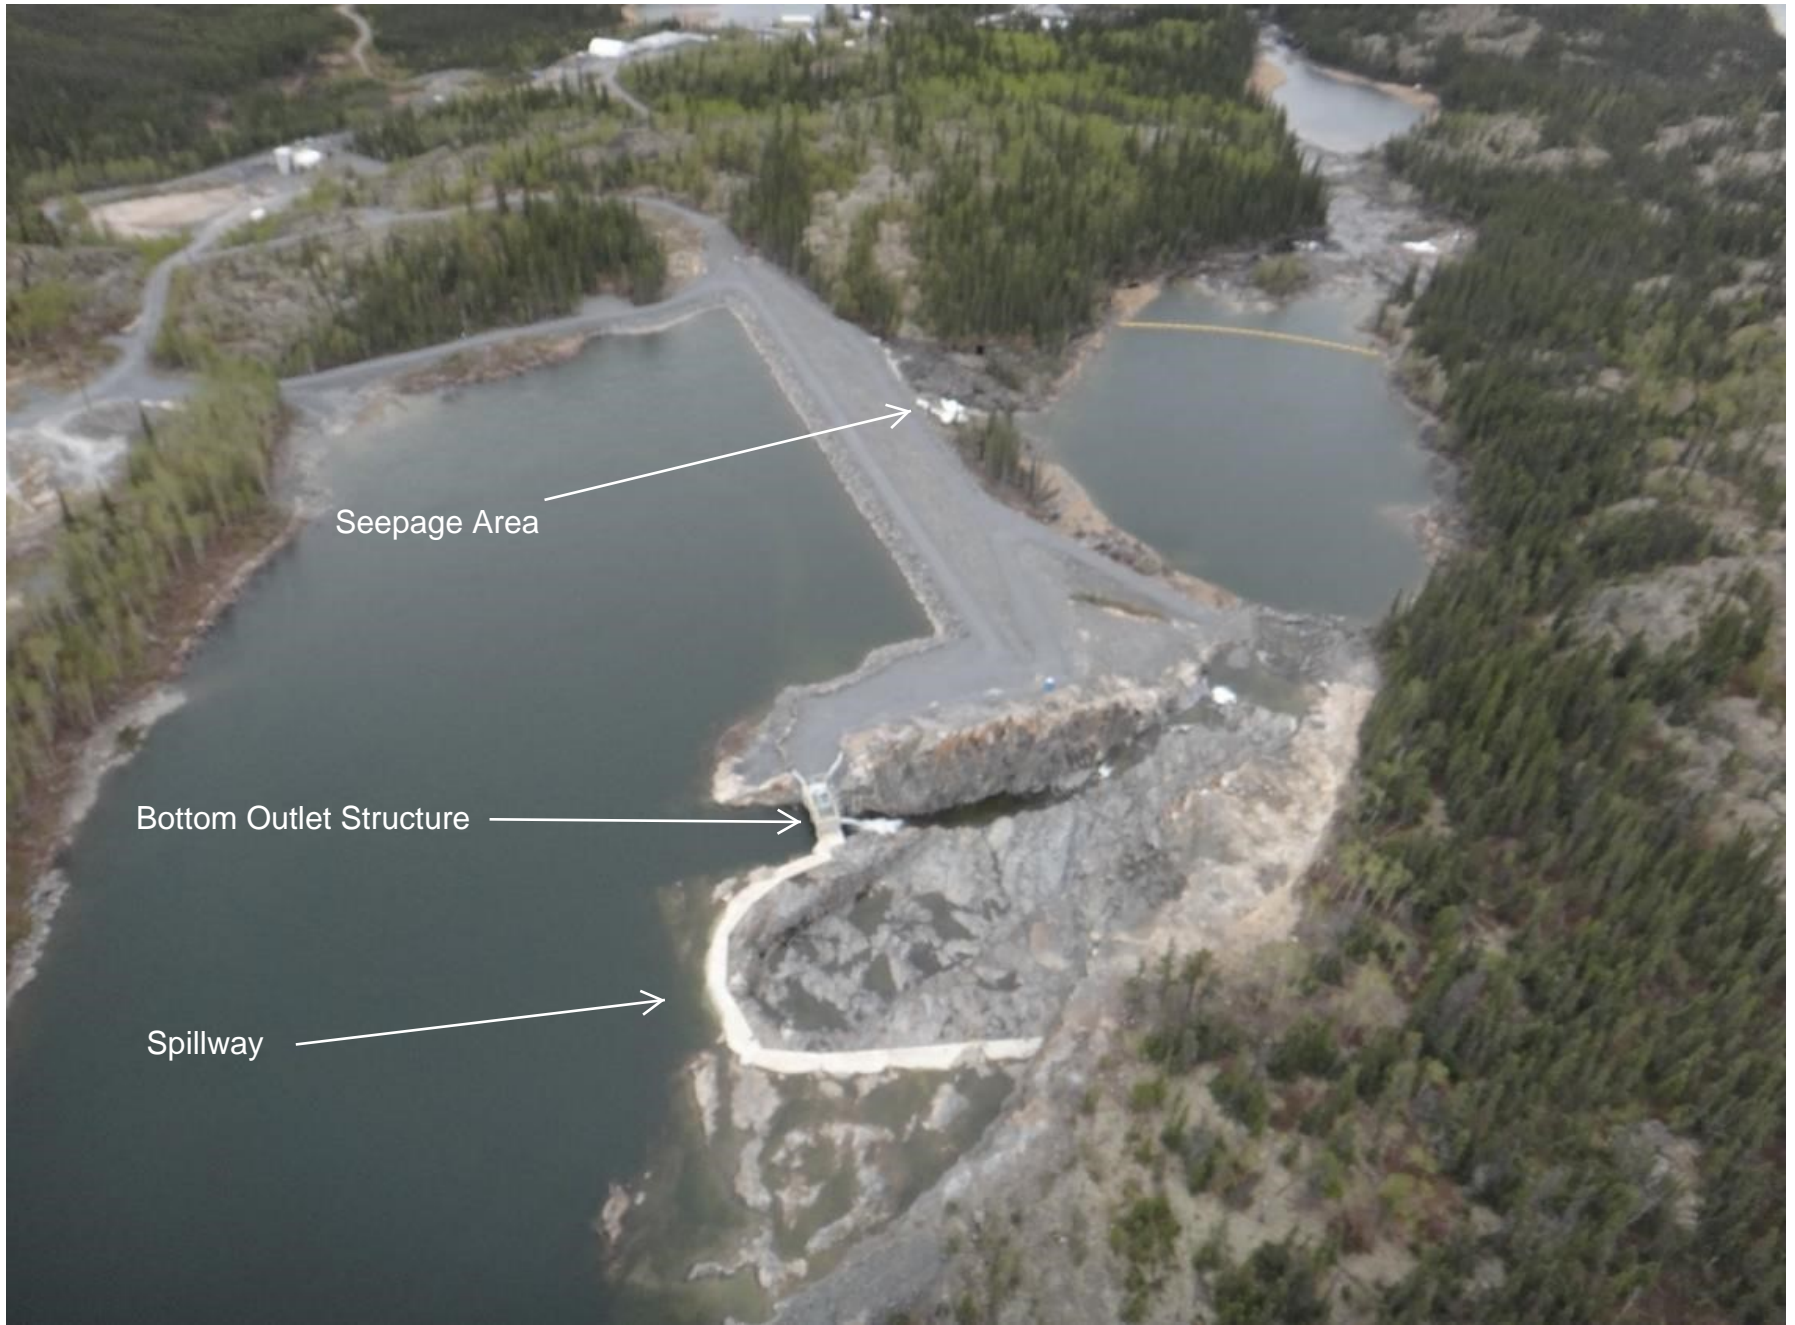
Bluefish Dam Aerial View

- Stainless steel membrane in the core mitigates against any potential piping.
- Newest and most instrumented dam with thermistors, piezometers, corrosion monitoring tabs, and settlement monitoring.
- Concrete key trench on a solid bedrock foundation.

1. **Old River Channel** – There is a small amount of seepage in the original riverbed along the toe which cannot be seen but flows beneath the downstream shell where a trickling sound can be heard. Pond level is high at the toe location in the riverbed such that this leakage cannot be measured, consideration is being given on how to lower the pond level and enable monitoring.
