**2021 DAM MONITORING  
GUIDE FOR OPERATORS**

**NORTHWEST TERRITORIES  
POWER CORPORATION**

This Document provides information to assist the Operators in the Inspection of the Dams in The Northwest Territories Power Corporation's Hydro System

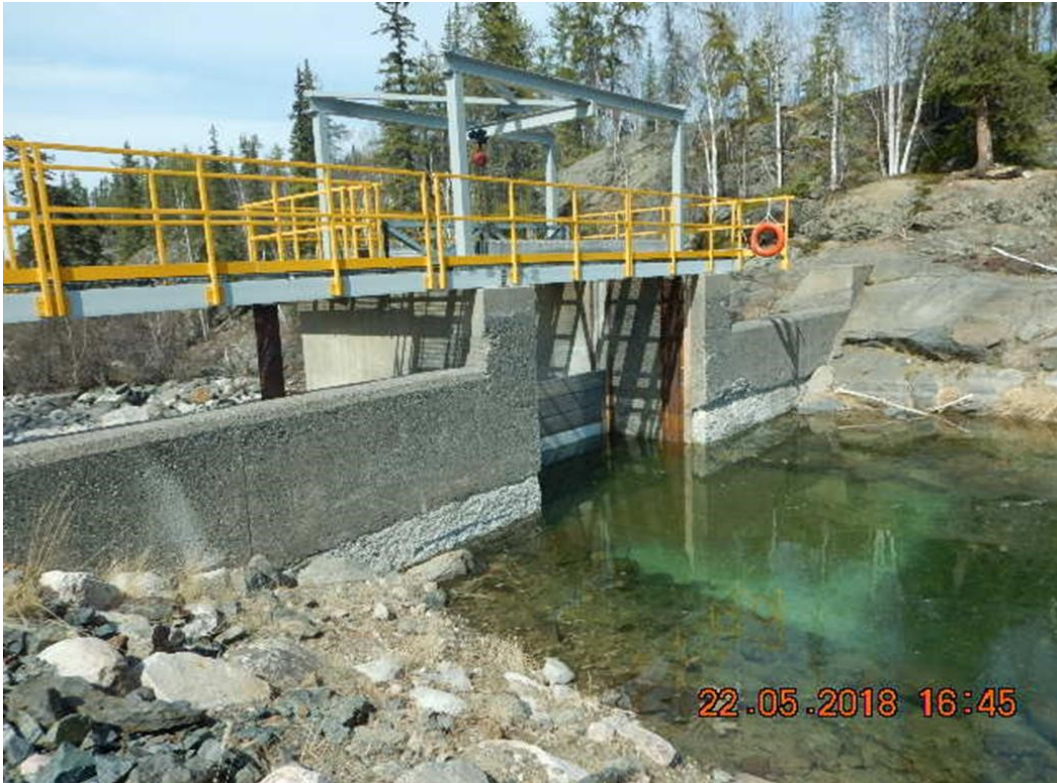
Duncan Dam Upstream

- Watch for concrete weathering and erosion.
- Concrete rehabilitation was completed on the dam in 2017.
- The right abutment is founded on bedrock and the remaining two-thirds of the dam on a boulder field infilled with gravel. Wash out of this gravel in 1994 led to eventual upgrades in 2007 including an upstream bentomat blanket, foundation grouting, and filling of voids between boulders with concrete.
- Since 2007 dam performance is good with no significant leakages, sinkhole activity, signs of settlement or movement.

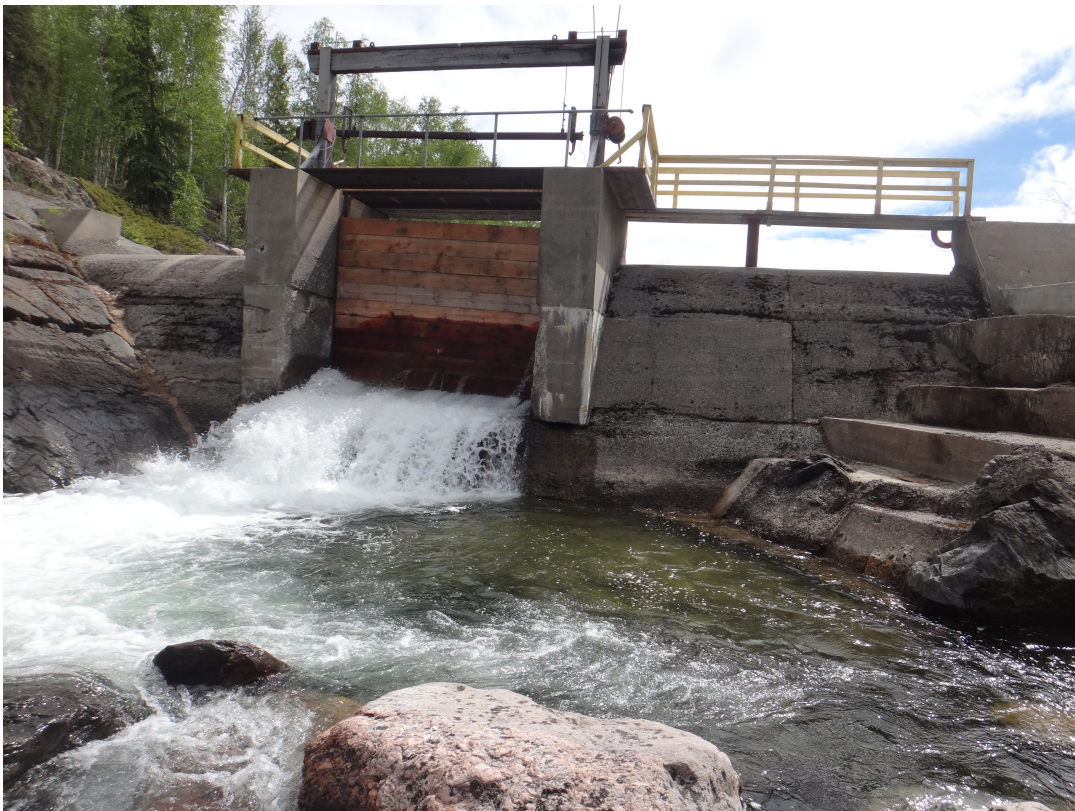
Duncan Dam Downstream

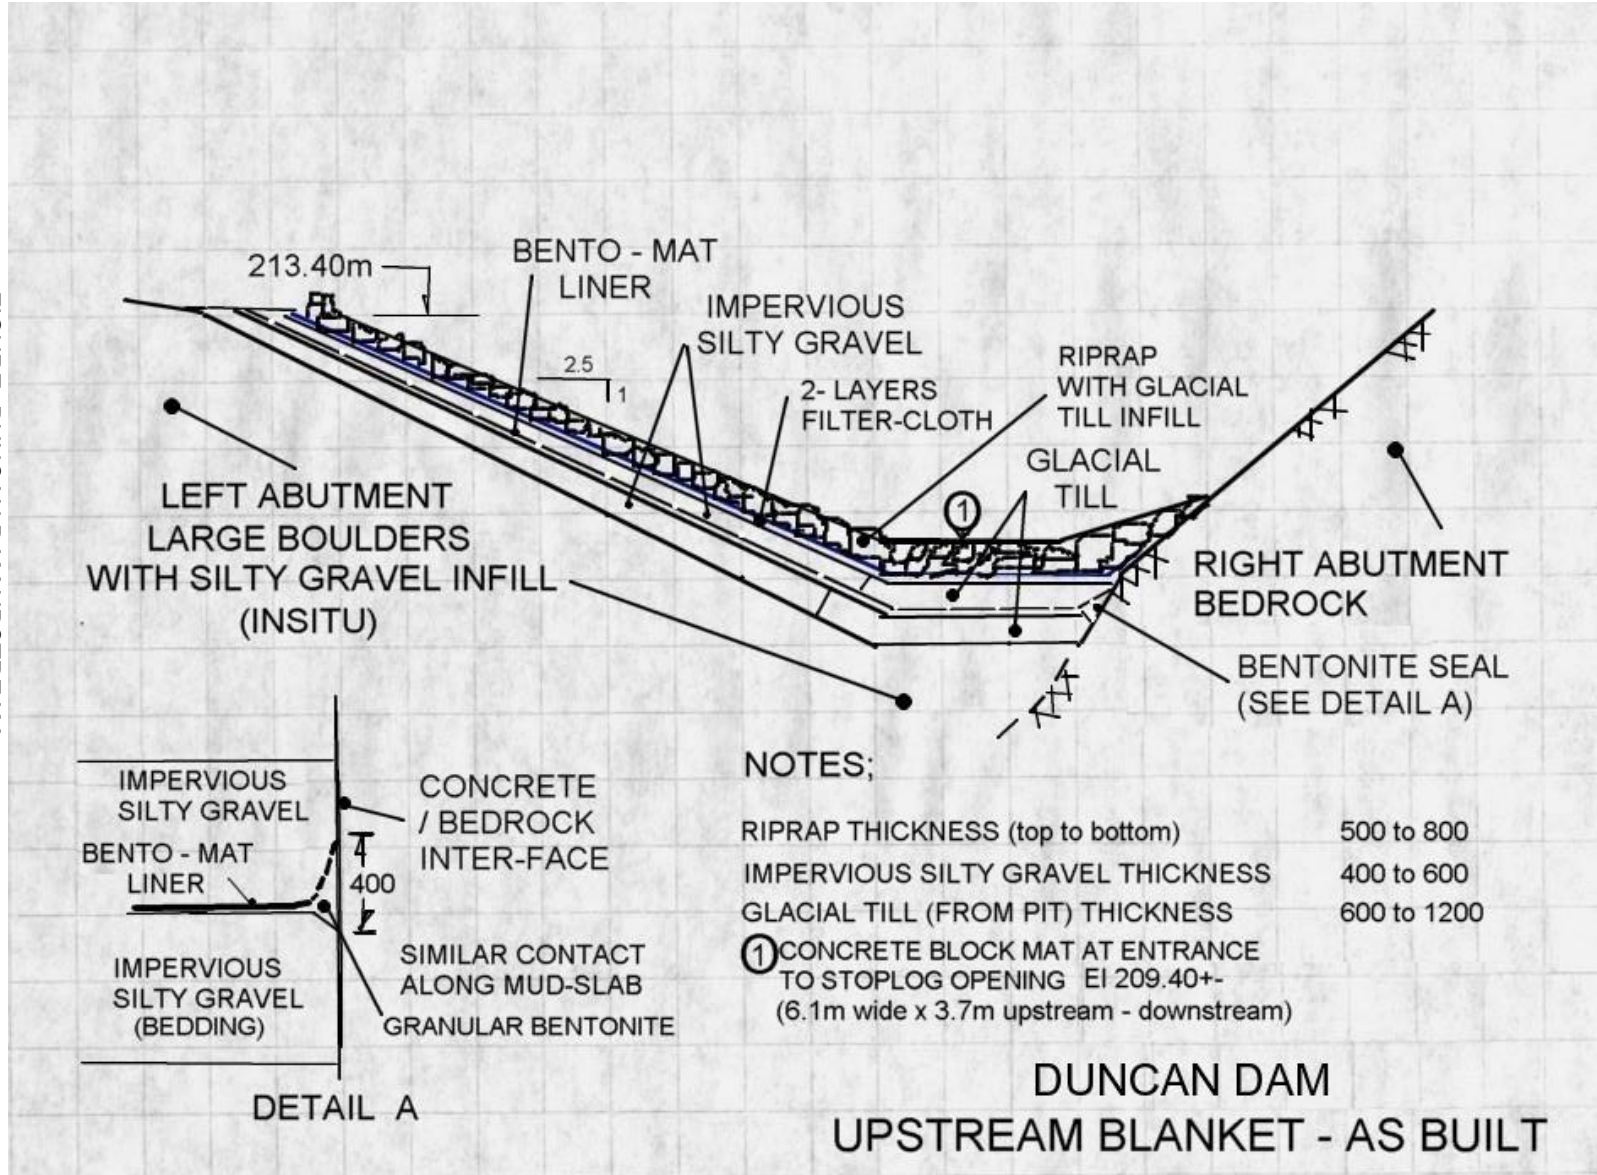
# Duncan U/S Blanket As-Built

FIGURE DUNCAN DAM UPSTREAM BLANKET. X-SECTION
