NTPC Health & Safety Alert

Electrical Contact Near Miss

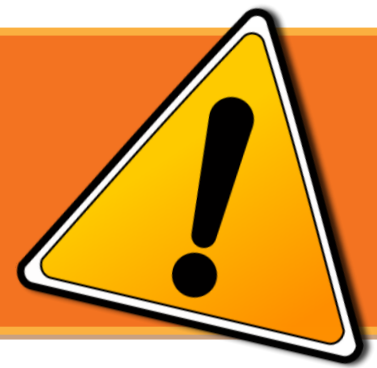
A contractor was pulling de-energized cables out the top of an isolated Motor Control Center (MCC) cabinet. There was a gap in the wall of the cabinet that led to an adjacent cabinet, which was live. The contractor was aware of the gap and identified electrical shock and arc potential as a hazard on the Tailboard. The control chosen to reduce the risk was to tape the ground wire to the conductor cables. While pulling the cable through the cabinet the tape was caught and ripped off, freeing the ground wire. The ground wire slid back into the cabinet, entered the gap, and contacted a live conductor resulting in an electrical short and arc flash event within the closed cabinet. Fortunately, there were no injuries.

The safest option is to eliminate the hazard. In this case if the adjacent cabinet was also de-energized the hazard would have been eliminated.

If the hazard cannot be eliminated it is good practice to implement various levels of controls. If the contractor also installed a barrier (engineering control) over the gap leading to the live cabinet the ground wire would not have been able to contact the live conductor, even if the tape was accidentally removed. The ground wire should also have been taped to the conductor cables in multiple locations with multiple pieces of tape, rather than just one.
